Loss of operator control involving an Aeronavics SkyJib 8 remotely piloted aircraft

Near the Melbourne Cricket Ground, Melbourne, Victoria, 29 March 2015

ATSB Transport Safety Report
Aviation Occurrence Investigation
AO-2015-035
Final –27 August 2015

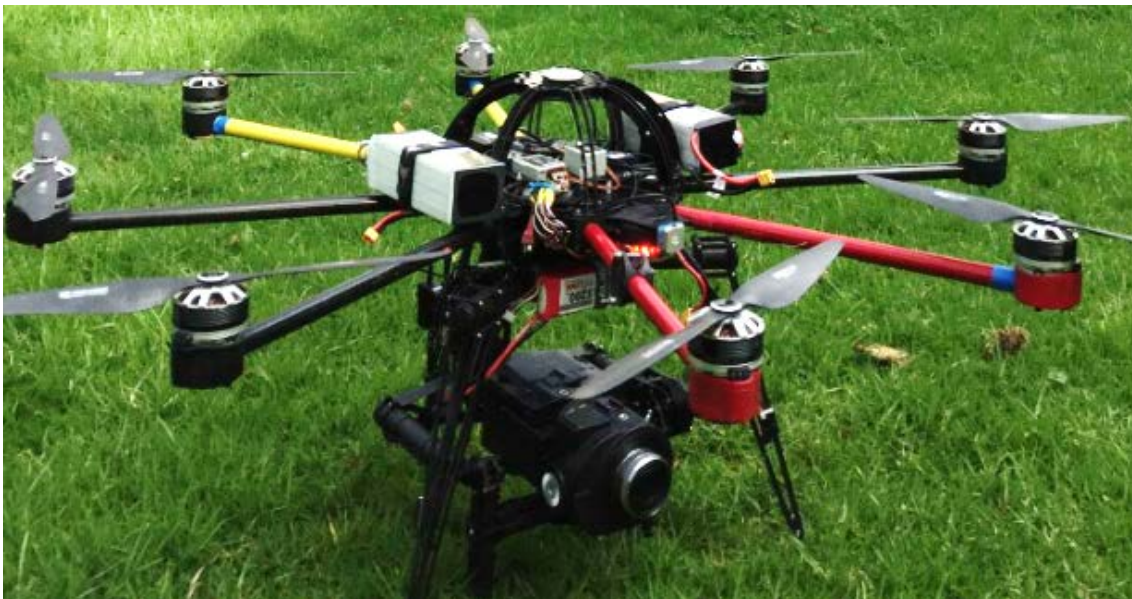
On 29 March 2015, an Aeronavics SkyJib 8 remotely piloted aircraft (RPA) (Figure 1) was being used to assist with media coverage of the International Cricket Council World Cup Final, at the Melbourne Cricket Ground (MCG), Melbourne, Victoria. The RPA was being operated from the top of the south-western scoreboard of the MCG. The operating team consisted of:

Figure 1: RPA prepared for flight with camera mounted beneath

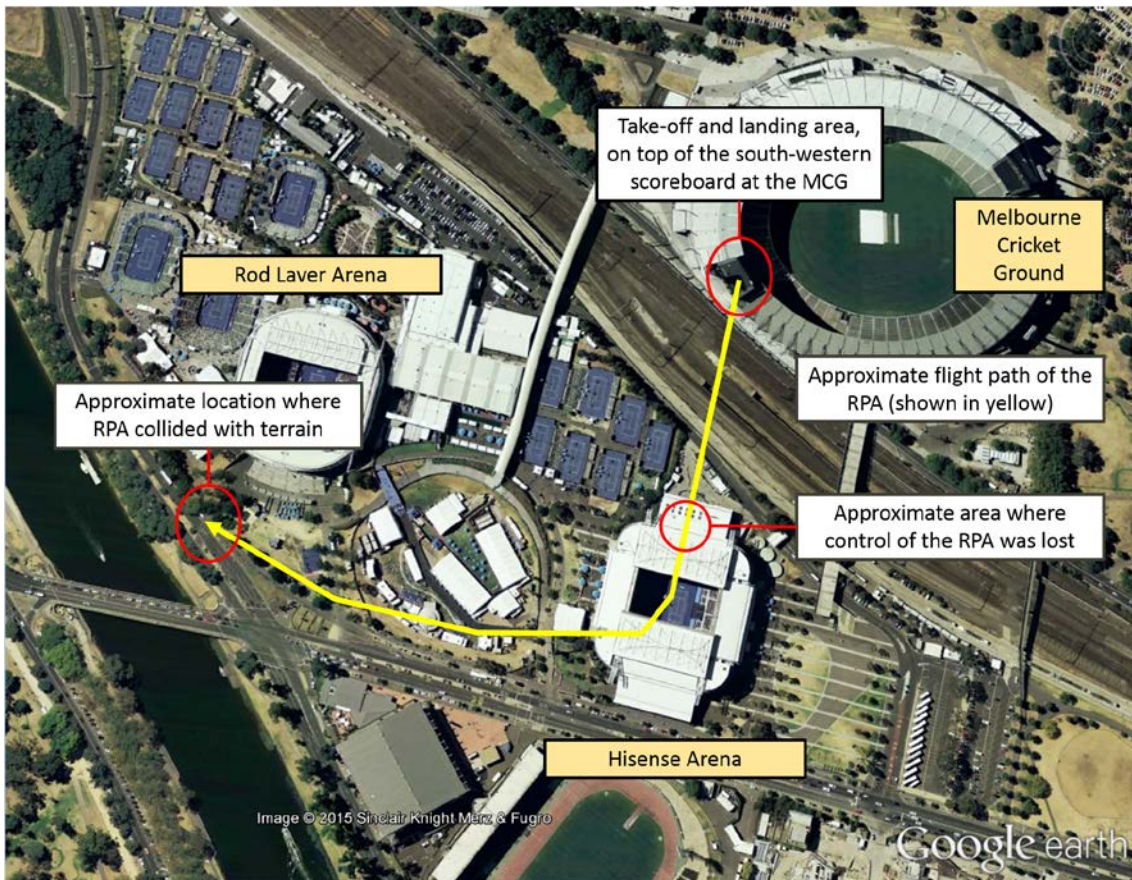
The RPA collided with terrain on the median strip on Batman Avenue to the south of Rod Laver Arena, a little over 3 minutes after the flight had commenced. The operating crew had maintained line of sight with the RPA until it descended beneath the treetops. Initial control difficulties were experienced when the RPA was just over 200 m from the position of the operating crew. The collision with terrain was about 450 m from their position (Figure 2).

Figure 2: Approximate flight path of the RPA, from the take-off location on top of the south-western scoreboard at the MCG, to where control was lost over Hisense Arena and the collision location on Batman Avenue
