Engine failure and collision with terrain involving Van's RV-9A, VH-KLV

39 km NNW of Albany Airport, Western Australia, 4 September 2016

ATSB Transport Safety Report
Aviation Occurrence Investigation
AO-2016-109
Final – 22 November 2016

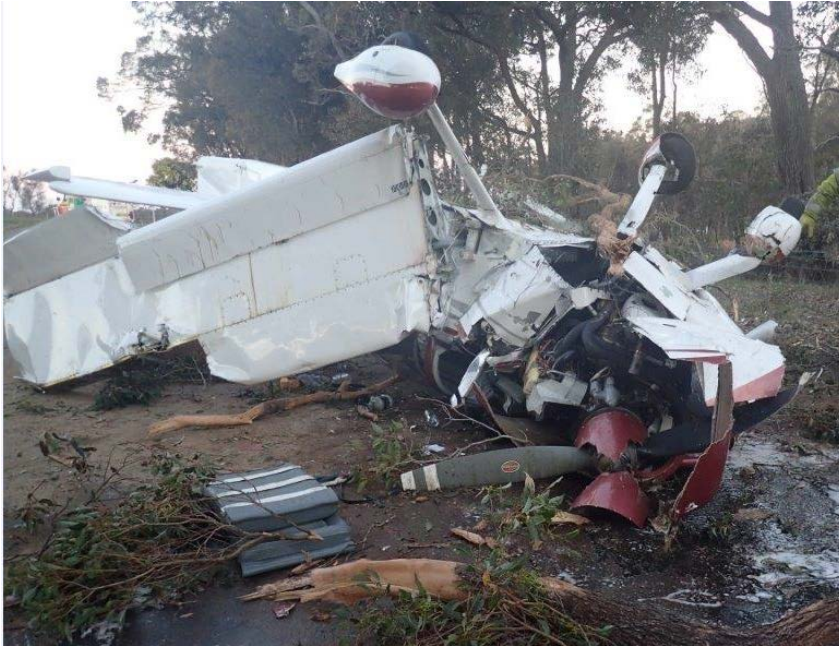
Figure 2: VH-KLV after the accident

The aircraft struck the tree canopy and slowed to a near stop before falling onto the disused road. The aircraft landed nose first before overturning and coming to rest inverted (Figure 2). The weight of the aircraft prevented the pilot from opening the sliding canopy. The pilot and passenger exited through the broken windscreen.

The pilot and passenger sustained minor injuries and the aircraft was substantially damaged.

Due to the limited scope of this investigation a post-accident engineering examination was not conducted. The cause of the high oil temperature indication was not determined.

The RV-9A is not an aerobatic aircraft, however, KLV was fitted with a four-point aerobatic type harness. Four-point harnesses provide superior occupant protection during an accident, in particular when an aircraft overturns. The fitment and use of the four-point harness most likely prevented more serious injuries to the occupants.
