Aviation Occurrence Investigation – AO-2006-007

**In-flight engine failure
93km N of Perth Airport, WA
27 November 2006
Beechcraft King Air 200, VH-XDB**

In-flight engine failure – 93km N of Perth Airport, Western Australia – 27 November 2006 – Beechcraft King Air 200 – VH-XDB

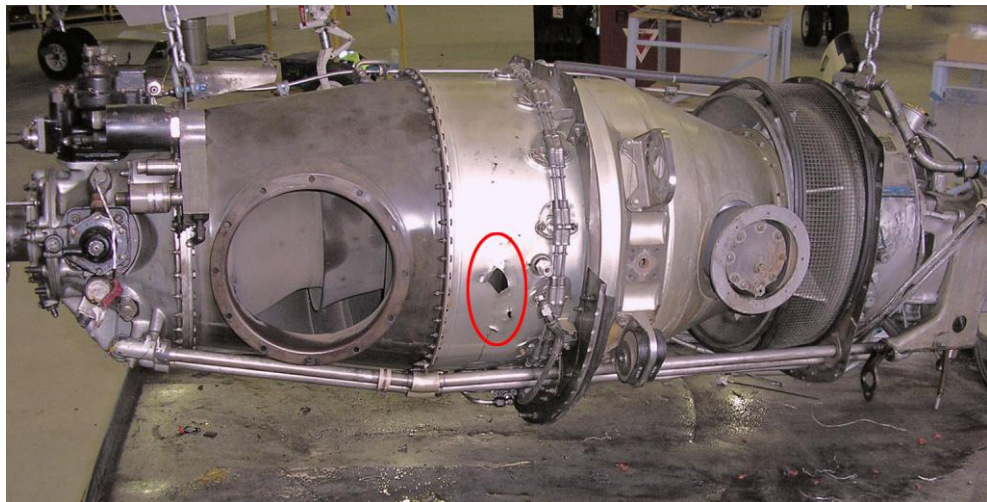
- The PT housing had been outwardly deformed in line with the trajectory path of the liberated first- and second-stage PT blade assembly.
- As a consequence of the PT blade fractures, the gas generator outer case had been outwardly punctured. One large (~25 mm by ~25 mm) and three smaller holes had been produced in the case.

Figure 1: The failed engine as removed from VH-XDB. Note the punctures (circled) in the gas generator case

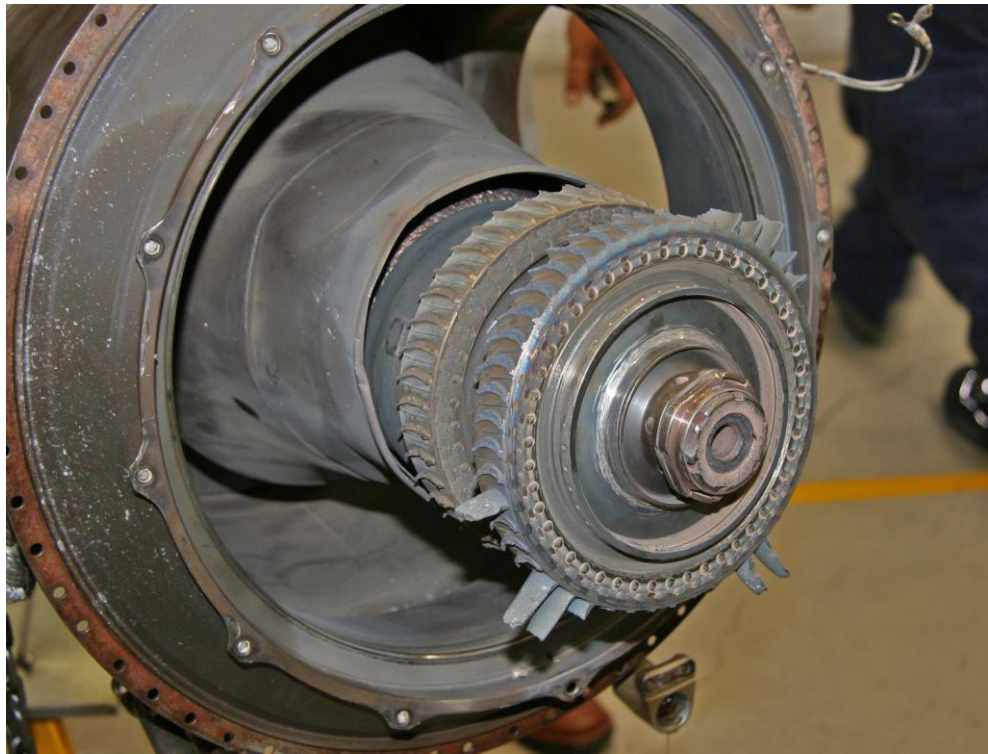
- The power turbine (PT) had sustained a total failure of the blade assembly, with the fracture and loss of nearly all of the first- and second-stage blades near their airfoil platforms.

Figure 2: View of the power turbine after engine teardown showing complete first-stage and majority second-stage blade loss

Examination of the first- and second-stage PT blade fracture surfaces revealed only features consistent with the application of a single excessive loading occurrence. No pre-existing defects were associated with the fractured blades. The entire first-stage blade set (43 in total) had fractured in the region of the fir-tree root form.

Examination of the second-stage PT blade set (47 in total) showed that 36 of the blades had also fractured in a similar manner; close to the blade root. The remaining 11 second-stage blades had fractured through the airfoil section. In the absence of any pre-existing defects, the fracture features observed were indicative that the turbine blade assembly had been exposed to excessive stresses created by an over speed of the power turbine.

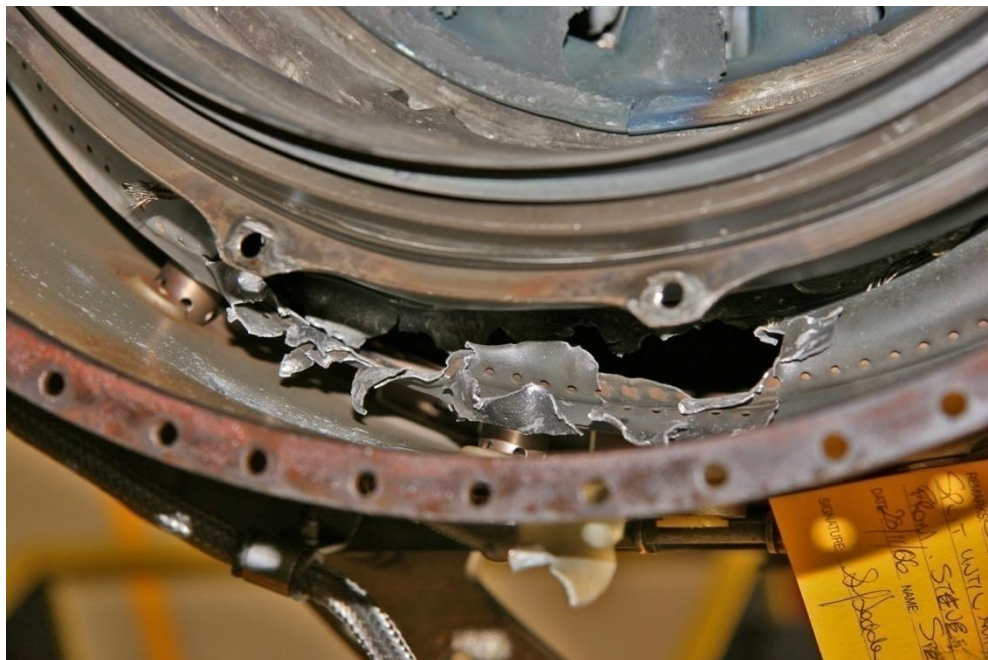
Figure 3: Close-up of the ruptured gas generator case showing the exit path of the fractured power turbine blades

While most of the fractured power turbine blades from the right engine exited via the exhaust section, several blade fragments punctured the gas generator case. It was noted that while the blades contained sufficient kinetic energy to penetrate the outer engine casing, they did not possess the energy to penetrate the nacelle of the aircraft surrounding the engine.

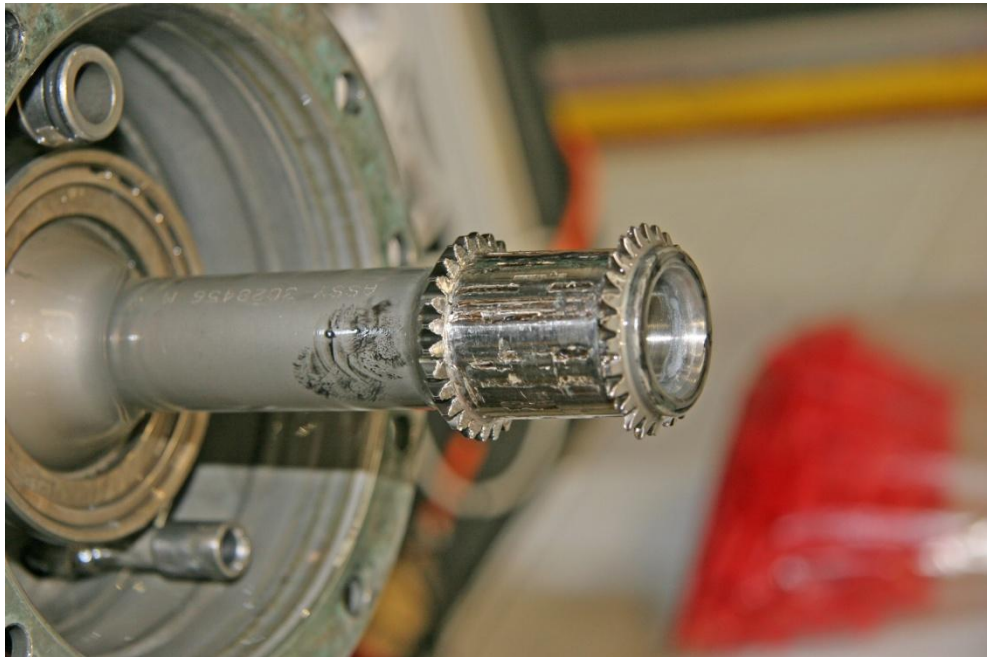
- The sun gear that coupled the power turbine shaft to the first-stage planetary gear set was severely damaged. All of the sun gear teeth that normally intermeshed with the planet gears had been heavily worn during the failure event.

Figure 4: Decoupled sun gear showing complete loss of the teeth

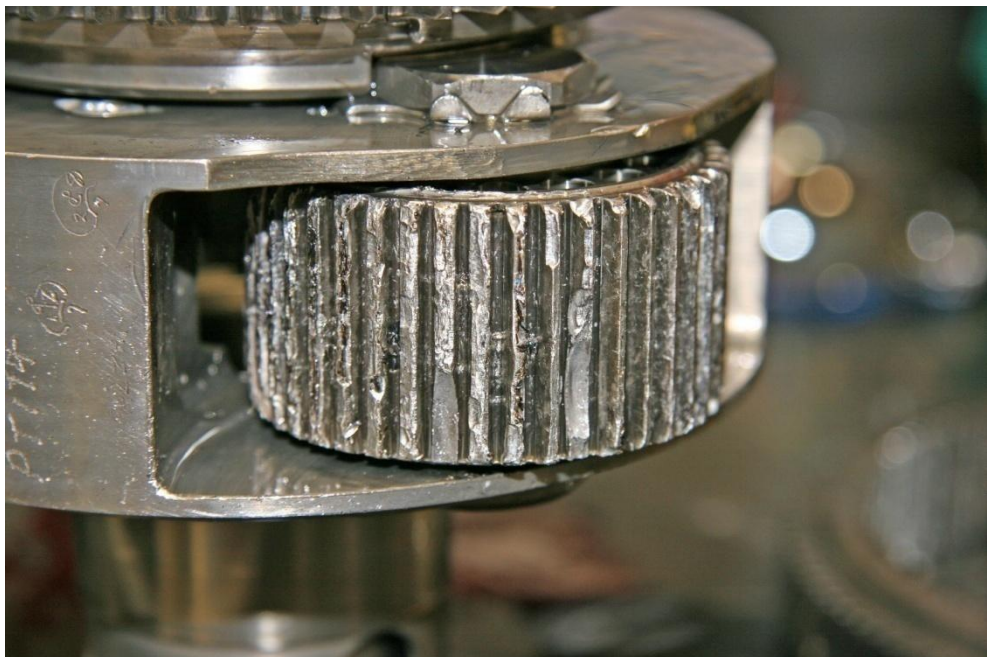
- All of the first-stage planet gears displayed significant mechanical damage with many of the teeth either chipped or fractured.
- Both the magnetic chip detector to the reduction gearbox and the engine oil filter, were found to be heavily contaminated with metal.

Figure 5: A first-stage planet gear, as-removed

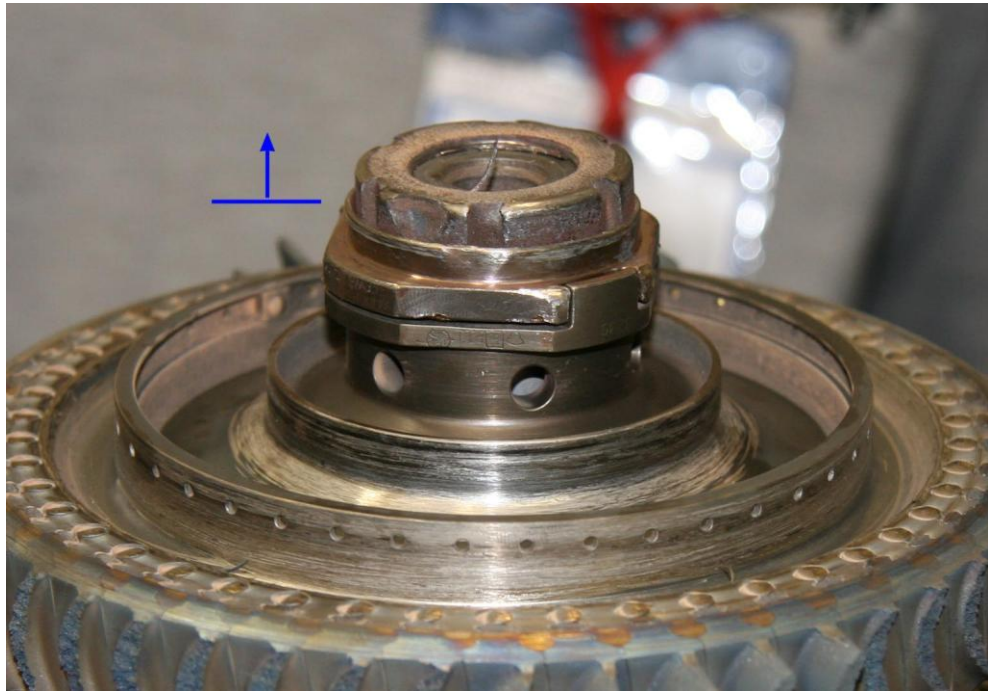
- The internal threads from the slotted lock nut that was used to secure the first stage PT disk assembly onto the rear end of the PT shaft, had been 'stripped'. That loss in security allowed the PT disks to shift axially along the PT shaft.

Figure 6: The slotted lock nut on the end of the power turbine shaft was found shifted rearward from its normally installed position (arrowed) and is shown with 'stripped' threads

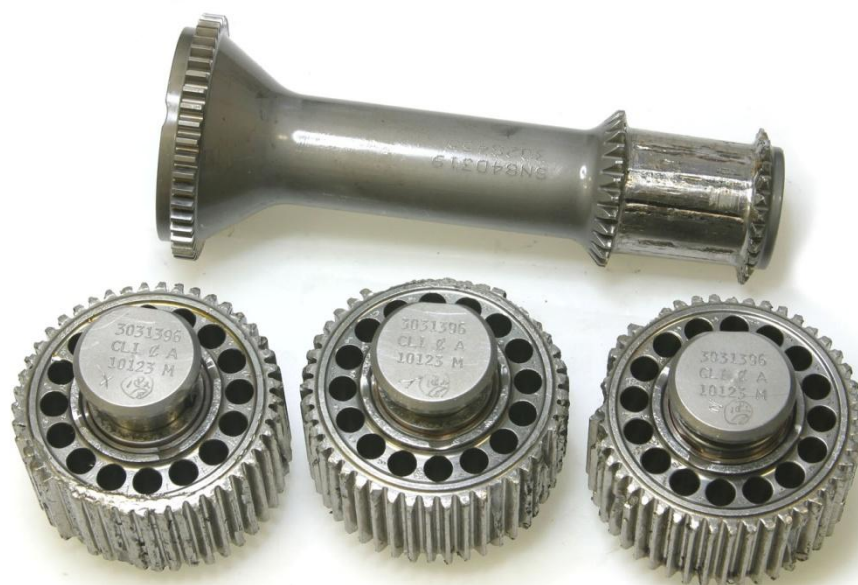
The first-stage sun and planet gears removed from the engine were identified by the hand engraved numbers and letters as shown in Figure 8 and Table 2.

Figure 8: The sun gear and planet gear set from the first-stage reduction gear assembly

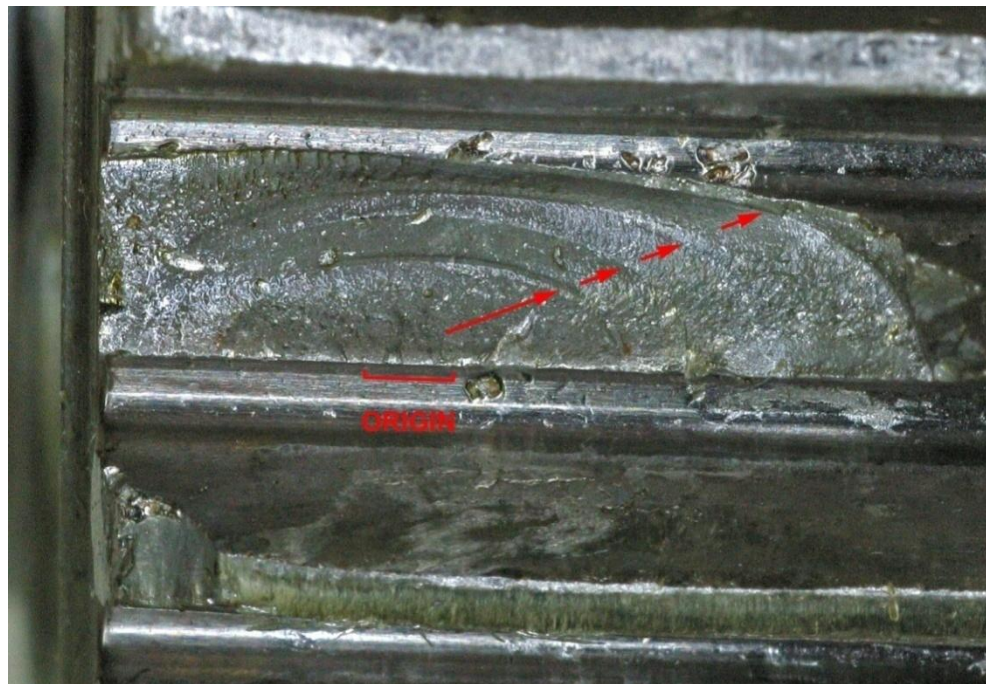
Examination of the first-stage planet gears showed that the five teeth from the ‘Z’ first-stage planet gear (serial number 3511) had fractured due to the initiation and propagation of fatigue cracking. An example of one of the fatigue fractured gear teeth is shown in Figure 9. The origin of fatigue crack growth was at the base of the driven surface in the root radii. The direction of crack growth indicated that uni-directional bending loads from engine operation had allowed the cracks to grow.

Figure 9: Fractured tooth surface from a first-stage planet gear showing clear evidence of fatigue cracking (arrowed)

A metallurgical examination of the recovered engine components showed that several teeth from one of the first-stage planet gears within the RGB had failed due to the initiation and propagation of fatigue cracking. No identifying features that could have initiated the cracking, such as corrosion or mechanical damage, were observed around the gear tooth fatigue crack origins.

In the absence of any contributory damage features, it is likely that the failure was related to a gear mismatch in which a new sun gear had been installed without the planet gears being replaced at the same time. A comprehensive review of the available maintenance documentation for the right engine revealed that the failed first-stage sun gear and planet gears had accumulated 5,772 hours and 13,882 hours of service respectively.

In 1999, PWC issued a service information letter¹¹ (SIL-078) to all operators of the PT6A-38/40/41 engines advising that the first-stage sun and planet gear must be replaced as a matched set at overhaul regardless of the condition of the parts. A subsequent revision of the overhaul manual contained the following statements:

Replacement of the first-stage sun and planet gears is mandatory at overhaul.¹²

CAUTION: If first-stage planet gears are to be replaced for any reason, then the first stage sun gear must also be replaced.¹³

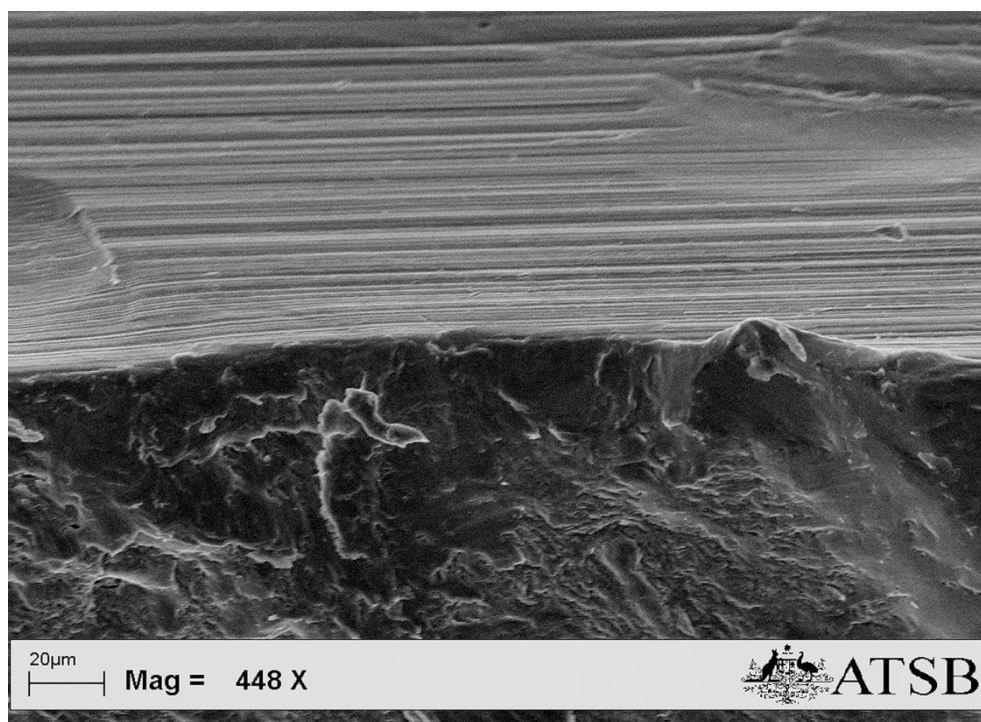
The fatigue crack fracture surfaces were examined at high magnification using a scanning electron microscope (SEM). The surface finish in the root radii at the origin of each fatigue crack was in the as-manufactured condition (Figure 10). Residual marks from the machining process were present. No evidence of mechanical abuse or corrosive attack was present that would otherwise indicate a mechanism for cracking to initiate.

Figure 10: High magnification SEM image of a fatigue crack origin in one of the planet gear teeth. Horizontal machining marks associated with original manufacture can be seen at the tooth root

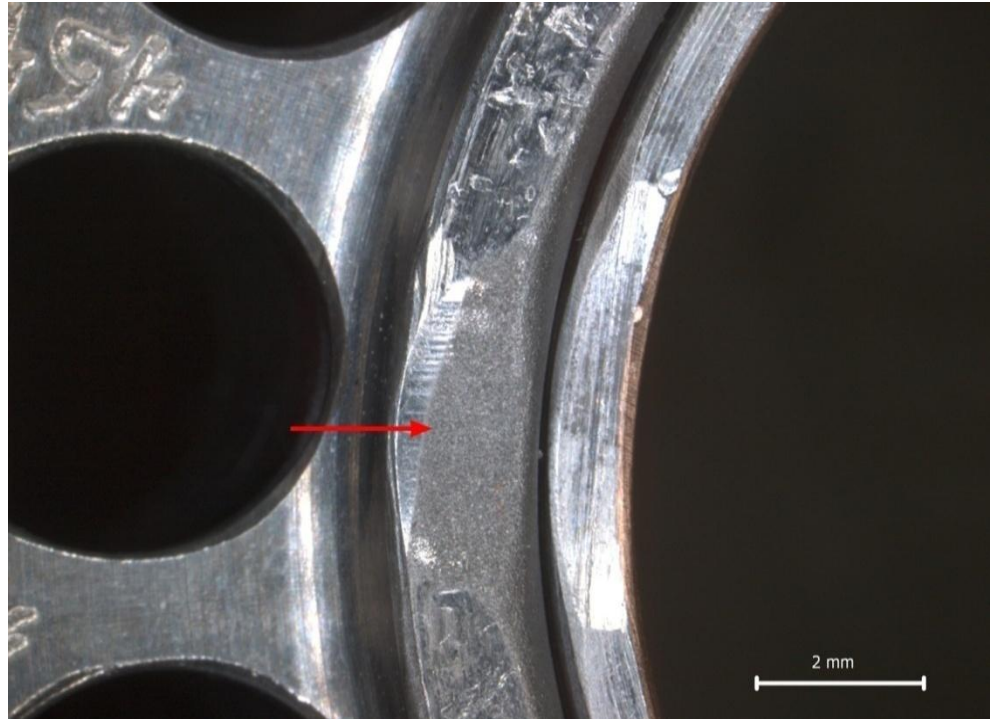
It was noted that a bronze-lined bearing had had been installed in each gear. Grit blasting had been applied within the bore of each planet gear surrounding the bronze bearings. No overspray damage from that abrasive process was identified on any of the gear surfaces that may have otherwise contributed to the gear failure (Figure 11).

Figure 11: Photograph of a planet gear face showing the clear delineation of the extent of grit blasting (arrowed) near the bronze bearing bore

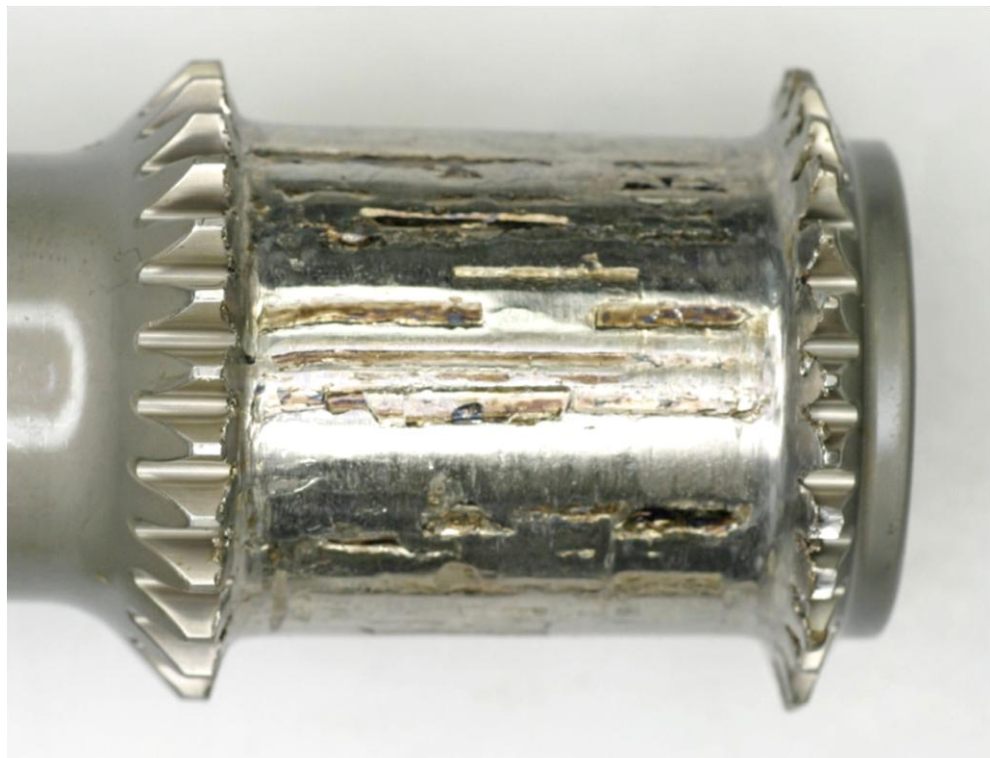
Examination of the first-stage sun gear showed that all of the teeth had been cleanly ‘machined’ through excessive wear against those sections that had engaged with the first-stage planet gears (Figure 12). It was noted that the sun gear’s teeth were longer than the planet gear teeth. Those regions of the sun gear that did not engage with the planet gear teeth were undamaged. Due to the level of damage sustained to the sun gear, a failure mechanism for the sun gear could not be positively identified.

Figure 12: Photograph of the sun gear showing complete 'machining' wear of the teeth that had normally engaged with the planet gears
