ATSB TRANSPORT SAFETY REPORT

Aviation Occurrence Investigation AO-2007-024

**In-flight engine failure 56 km south-south-west of
Newman aerodrome, WA
13 July 2007
VH-NXK
Boeing Co. 717-200**

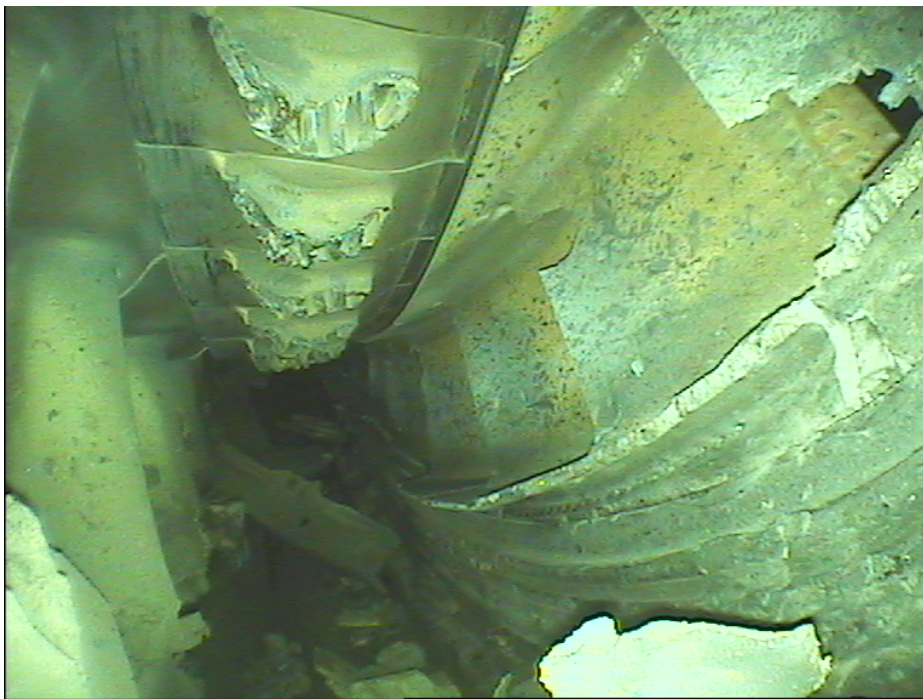
The operator's maintenance organisation carried out an internal inspection of the failed engine and found that all the blades on the high pressure turbine stage 1 (HPT1) disc had sheared off (Figures 1 and 2).

Figure 1: High pressure turbine stage-1 blade damage

The engine was removed from the aircraft for shipment to the engine manufacturer for investigation and repair. A serviceable engine was fitted and the aircraft was returned to service.

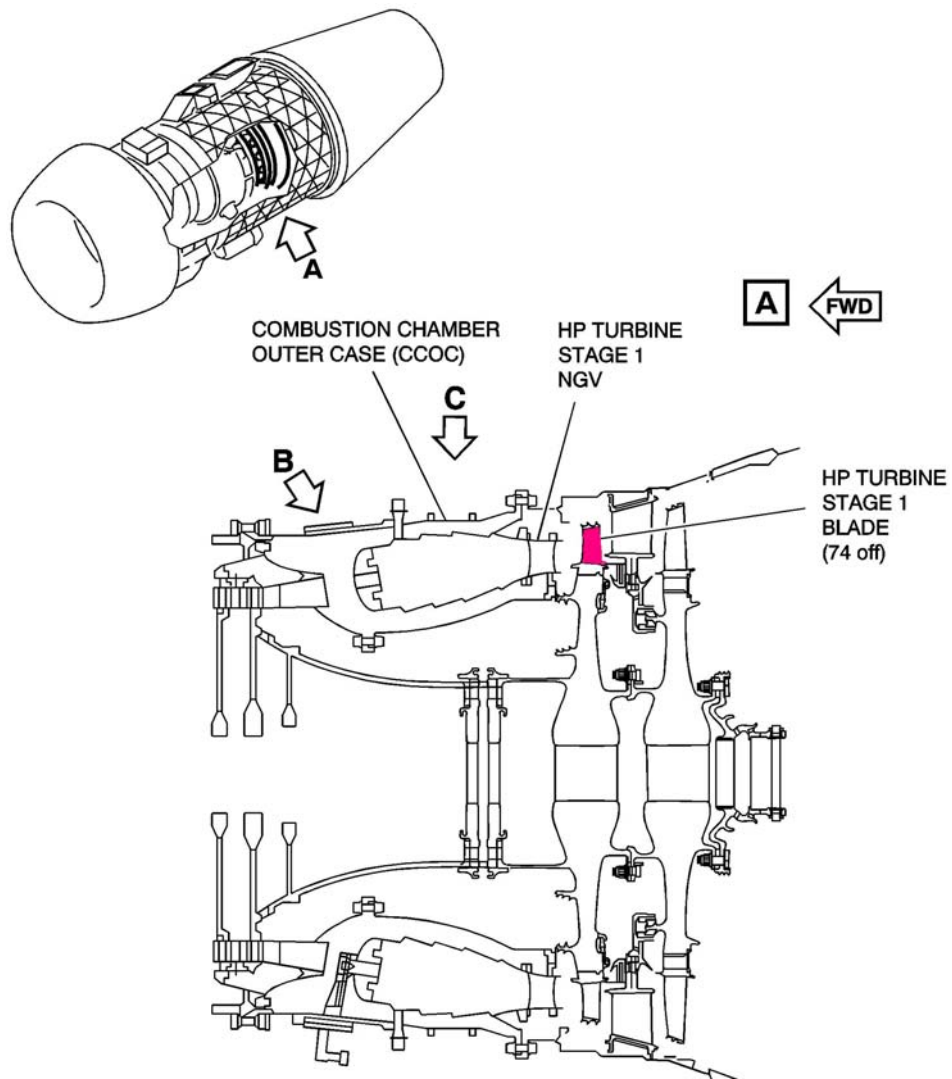
Figure 2: High pressure (HP) turbine stage 1 disc and blade position

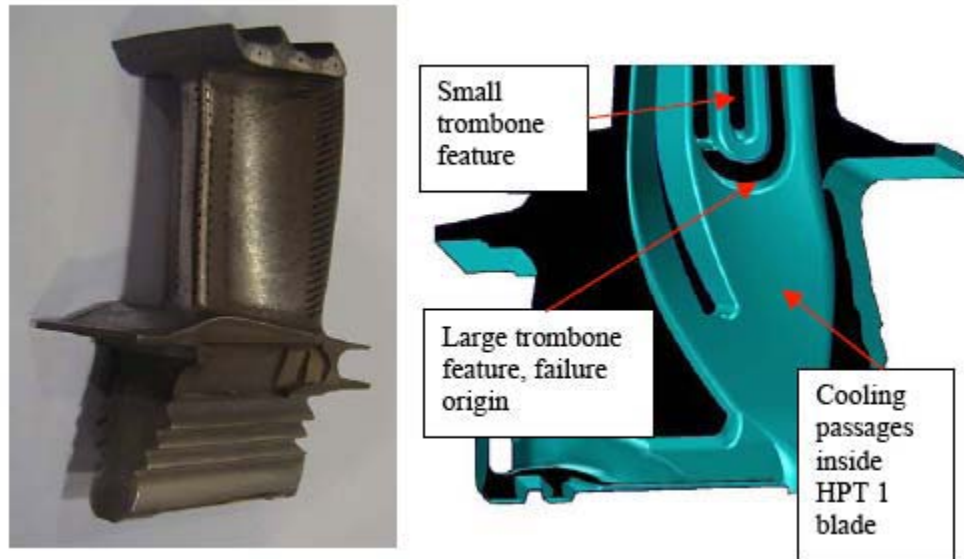
On 16 November 2004, following a series of failures of the LIP 3 HPT1 blade, the engine manufacturer introduced a modified LIP 3 HPT1 blade with the issue of service bulletin BR-700-72-101467. The service bulletin recommended that all LIP 3 HPT1 blades from those engines, prior to engine serial number 13419, be replaced with modified HPT1 blades as there was a possibility of cracking occurring at the bottom trombone fillet radius on the blades due to low-cycle fatigue⁵ (Figure 3). This cracking could result in a blade failure during engine operation and result in the remaining HPT1 blades being sheared off.

Figure 3: Intact LIP 3 HPT1 blade (left). Blade internal cooling passage showing trombone feature (right)

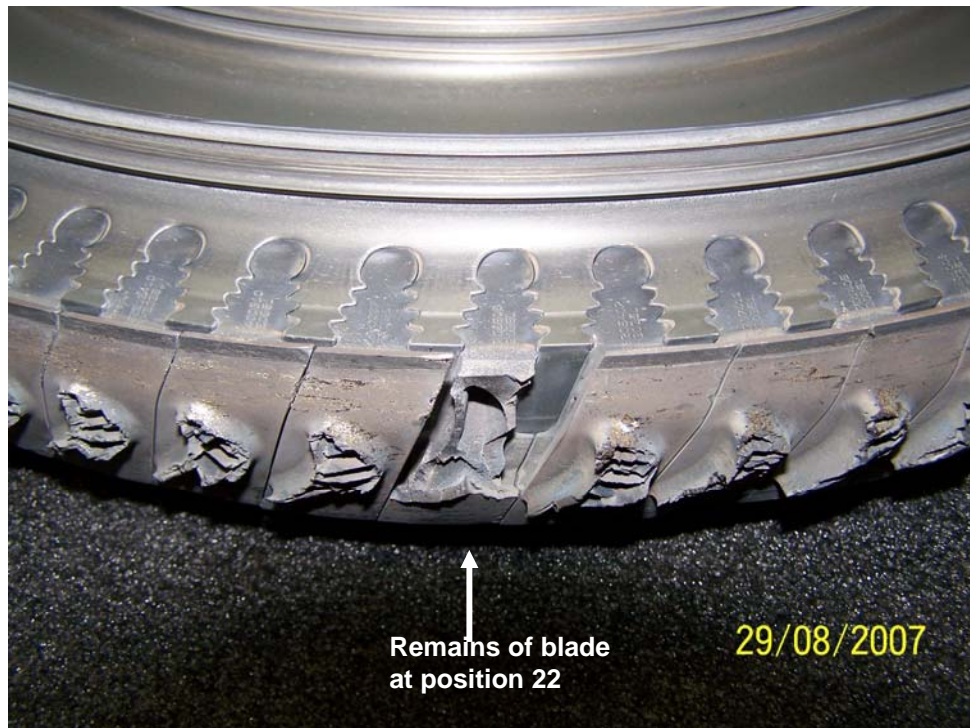
The engine examination showed that one HPT1 blade, serial number 053706508 at position 22, had separated from the blade disc below the blade platform as the result of an internal fracture. The engine manufacturer determined that this was the reason the remaining HPT1 blades had separated from the disc just above the blade platforms (Figure 4) and for the subsequent engine failure.

Figure 4: Damage to high pressure turbine stage 1 rotors

Engine serial number 13286 was repaired at the engine manufacturer's facility in October 2007 by replacing the damaged engine combustion and high pressure turbine module with a module that incorporated the new HPT1 blade. The engine was returned to the operator.

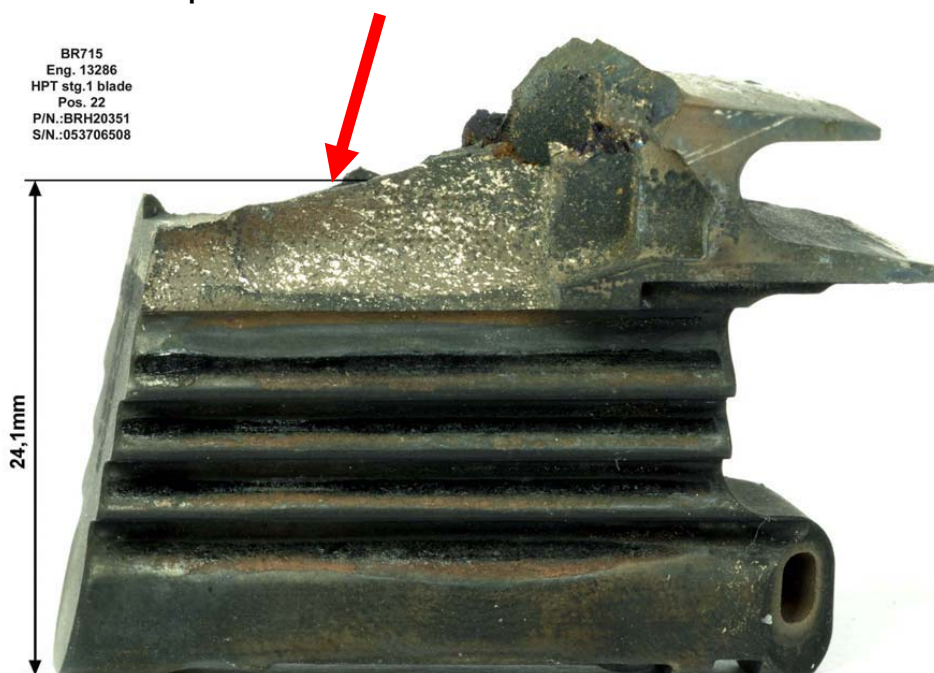
The fracture surface of the blade contained multiple sites of crack initiation at the inner shank wall on the pressure side of the blade (Figures 5 and 6). The crack origin area was located directly adjacent to the internal trombone radius (Figure 3). The crack initiation was considered to be due to an increased thermo-mechanical stress level. However, the engine manufacturer reported that the crack mechanism in the LIP 3 HPT1 blade was not yet fully understood.

Figure 5: HPT stage 1 blade, position 22 showing overview of the blade pressure side where the crack initiation occurred

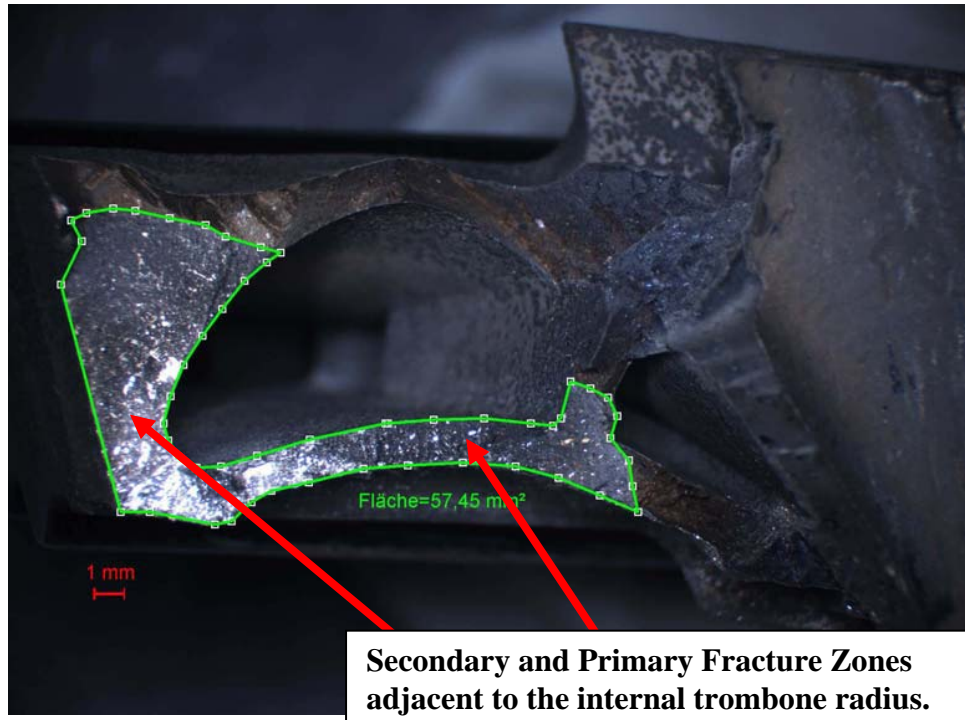
Figure 6: HPT1 blade, position 22 showing primary and secondary fracture zone (trombone cracking)

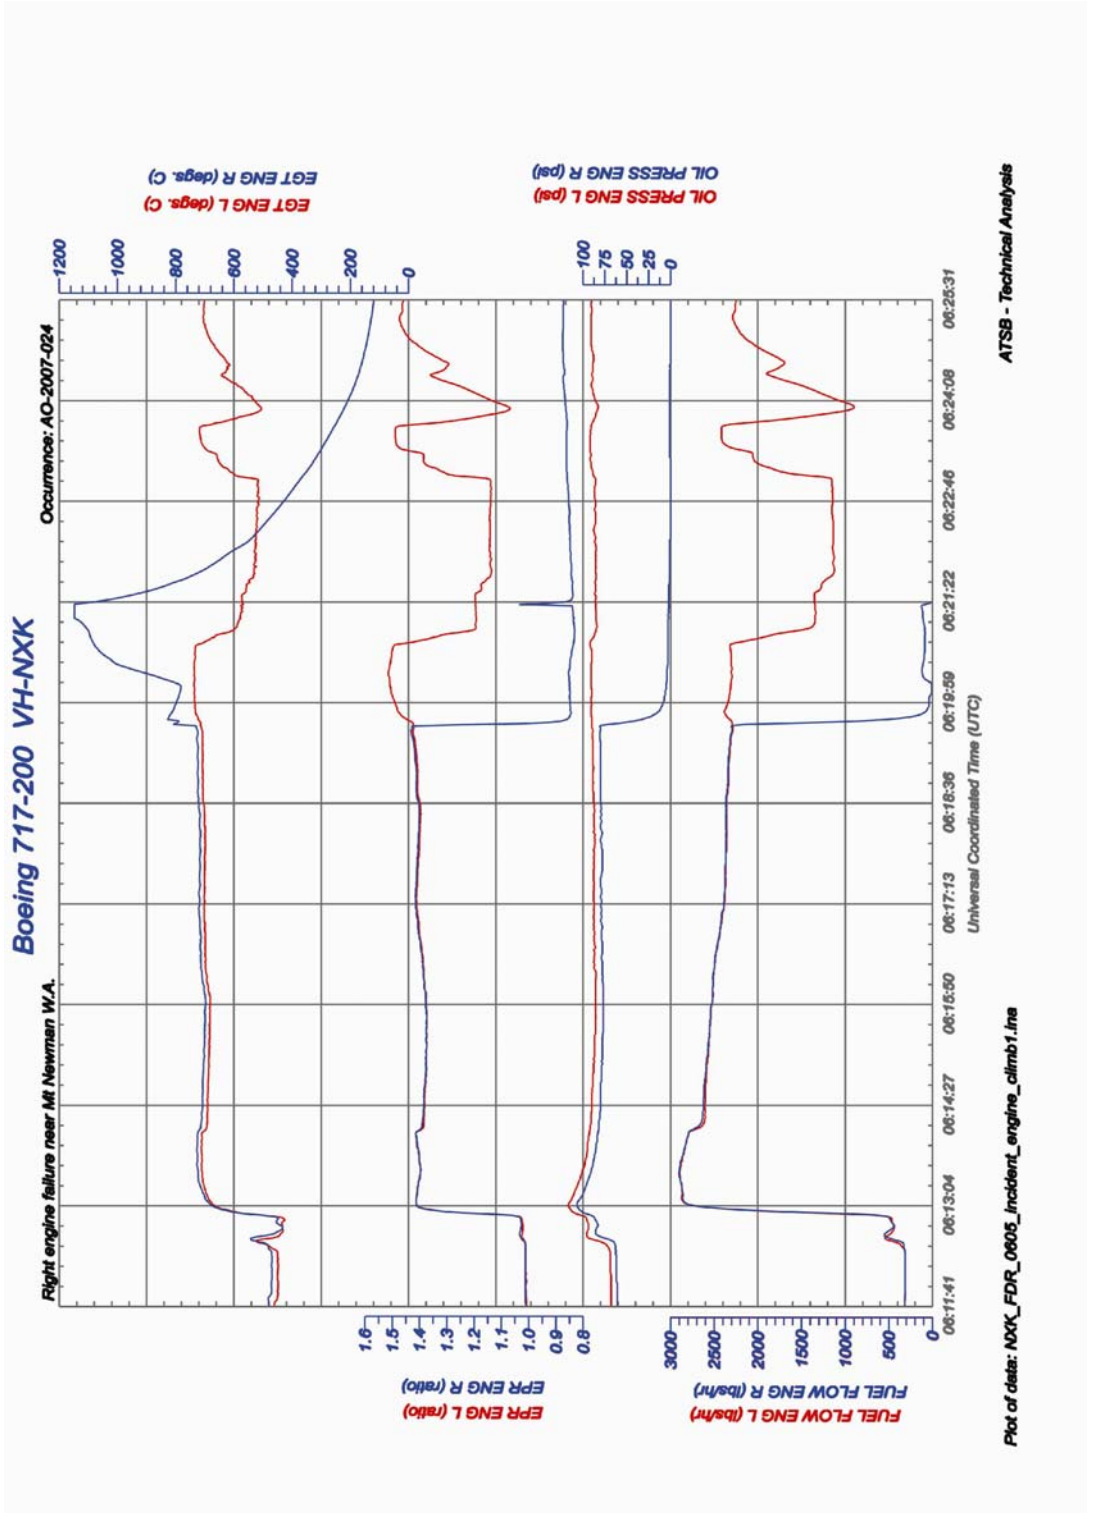
APPENDIX A: FLIGHT DATA RECORDER PLOT

The Australian Transport Safety Bureau (ATSB) examined the flight data recorder (FDR) information for the occurrence flight and found that the right engine had surged as the aircraft climbed through FL150.

The engine pressure ratio (EPR) and engine rotational speed indications decreased rapidly, while the turbine gas temperature (TGT) increased up to a maximum recorded temperature of 1,149°C and then remained at 1,148°C for the next 10 seconds, before decreasing (Appendix A). It is likely that the TGT reached a higher value than that recorded, however the aircraft systems did not record above 1,149°C. The high pressure turbine vibration values for the right engine increased from 0.3 units before the failure to 1.3 units after the engine failure.
