ATSB TRANSPORT SAFETY REPORT
Occurrence Investigation Report AO-2007-036
Final

**Fuel-related event – 50 km NW of
Swan Hill, Vic.
11 August 2007
VH-TJE
Boeing Company 737-476**

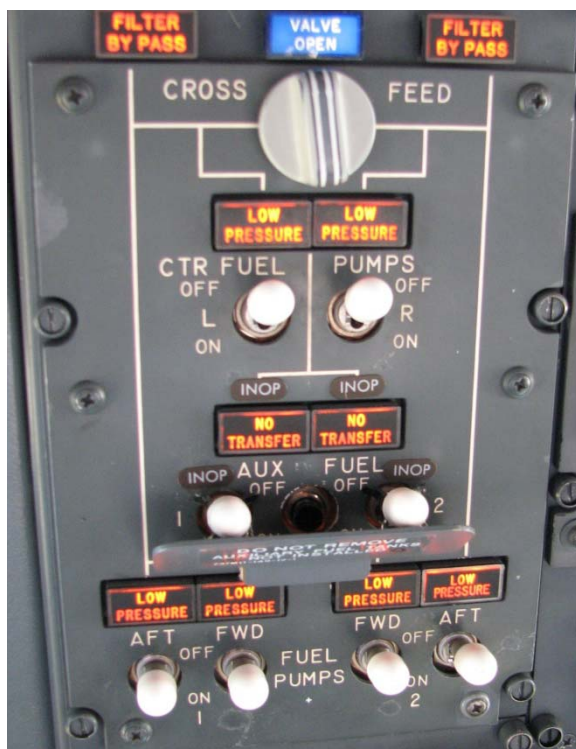
Figure 2: Overhead fuel control panel of VH-TJE photographed from the pilot in command's seat

The pilot in command observed that the centre tank fuel pump switches on the forward overhead panel were selected to the OFF position (Figure 2) and he immediately selected them to the ON position. The main fuel tanks were low on fuel and the investigation estimated that there was about 100 kg in each of the main tanks. The centre fuel tank contained about 4,700 kg of fuel when the master caution occurred.

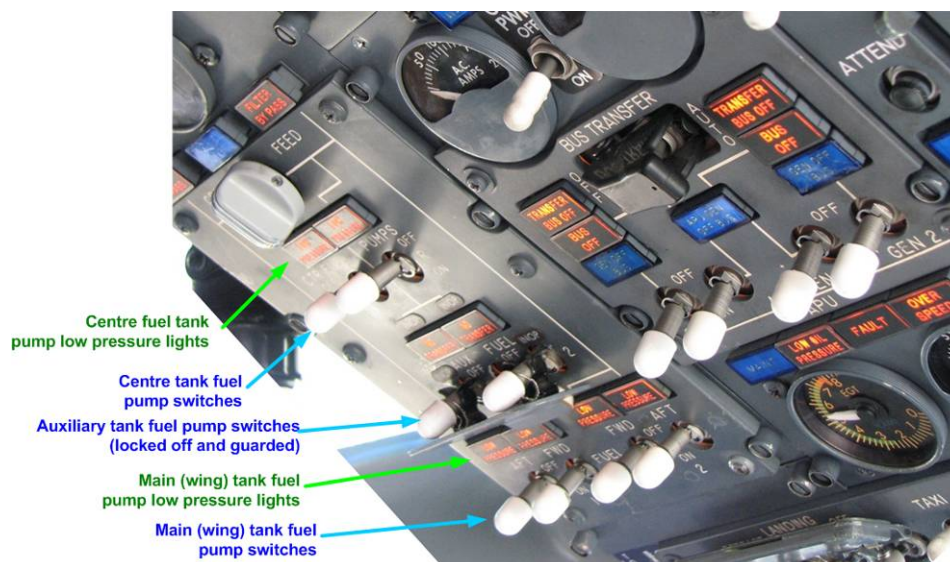
Figure 3: Overhead fuel control panel of VH-TJE photographed from the copilot’s seat

copilot reported that he called ‘13,000 kilograms, pumps on’ and looked up at the fuel control panel. The pilot in command reported that he was probably focused on the fourth item on the checklist at this time (as this required his response), which was to confirm that his cockpit window was closed and locked.

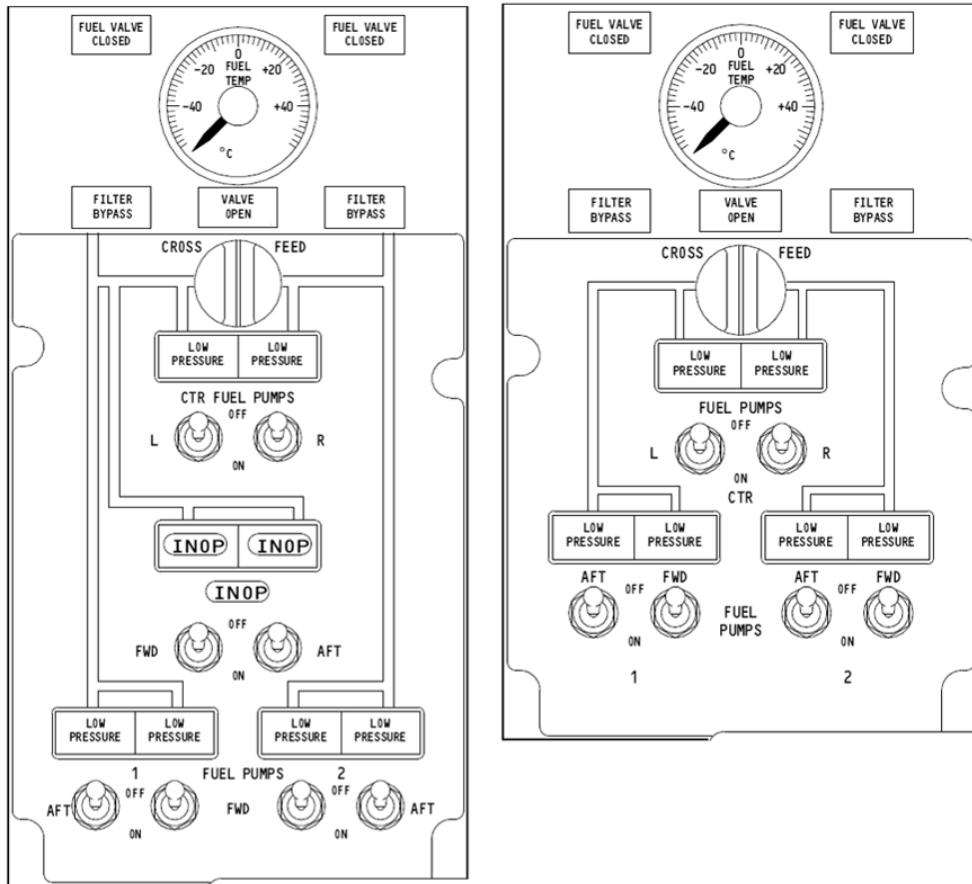
Figure 5: Fuel system control panel for 737-400 series with inoperative auxiliary tank (left) and fuel system control panel for other 737-400 and later model aircraft (right)

The crew reported that the aircraft's overhead fuel control panel was different from some of the operator's other 737-400 aircraft and from all 737-800 aircraft used by the operator, due to the fitment of auxiliary tank fuel pump switches. The centre tank fuel pump switches on those other 737 aircraft were located in a similar position to the auxiliary tank fuel pump switches on VH-TJE (Figure 5).
