Aviation Occurrence Investigation – AO-2007-066

Final

Controlled flight into water
Lake Liddell, NSW – 7 December 2007
VH-LIS
Air Tractor Inc. AT-802

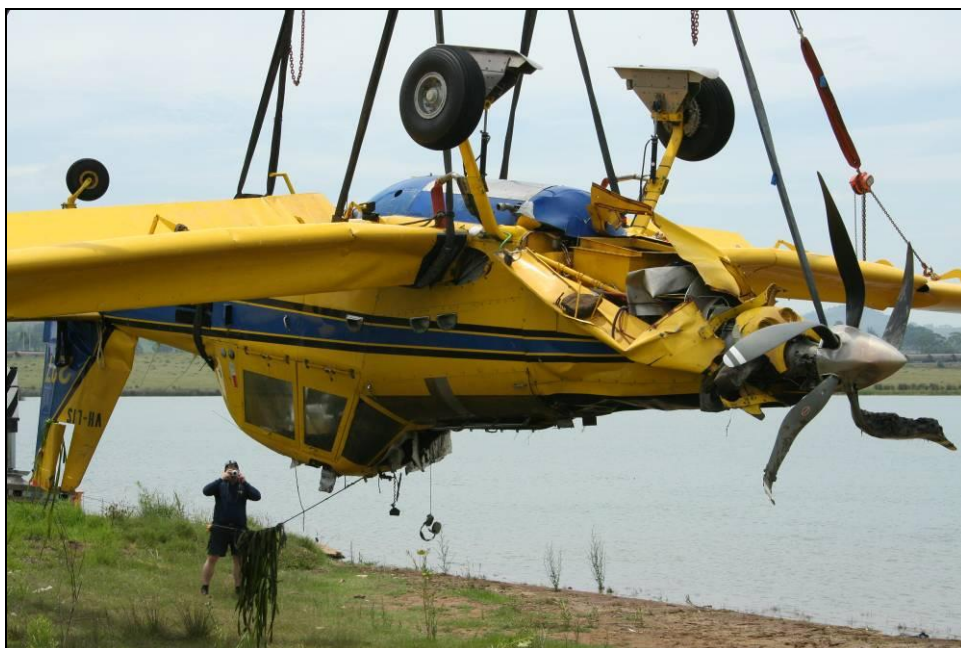
Figure 5: Recovery of the aircraft wreckage

Examination of the aircraft by ATSB investigators showed crush damage to the leading edge of the entire left wing and the inboard section of the right wing. The damage was primarily on the upper surface of those sections. Substantial distortion and disruption of the engine cowling was observed. The lower surfaces had been forced to the left, with rippling observed on the upper cowls. The roof of the cockpit canopy had been torn away and the windscreen had been smashed. The investigation was unable to determine if the damage was the result of the impact sequence or of the recovery process.

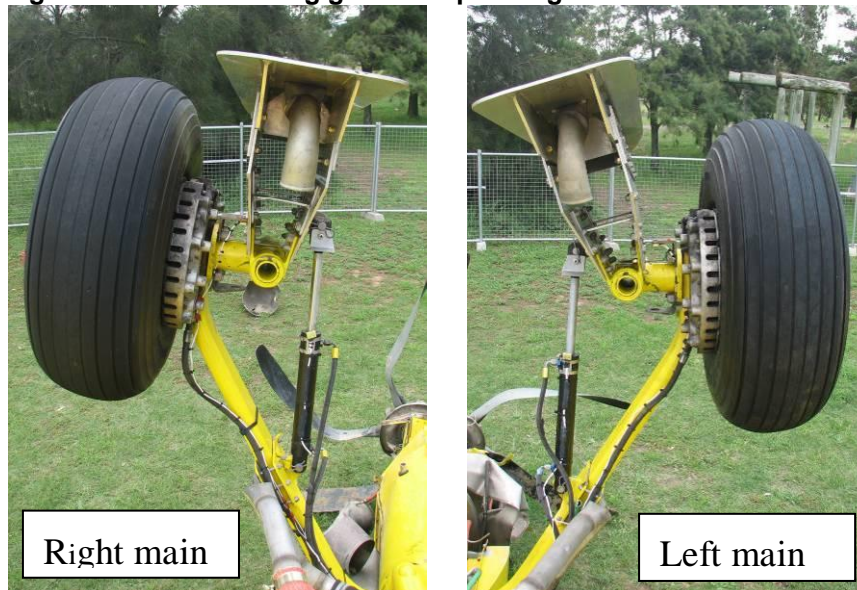
Figure 6: Main landing gear incorporating water collection skis

The main landing gear had been fitted with experimental skis for use in water collection. The skis were mounted on the inboard side of each main landing gear leg and were hydraulically operated between the vertical and horizontal planes by a single ram clamped to each leg (Figure 6).

The hydraulically-actuated skis were found in the extended position with hydraulic locking confirmed. Witness marks on the landing gear legs indicated that both hydraulic rams had moved from their original fitted positions on their legs, with the left ram having moved upward and the right ram in an equal, downward direction.

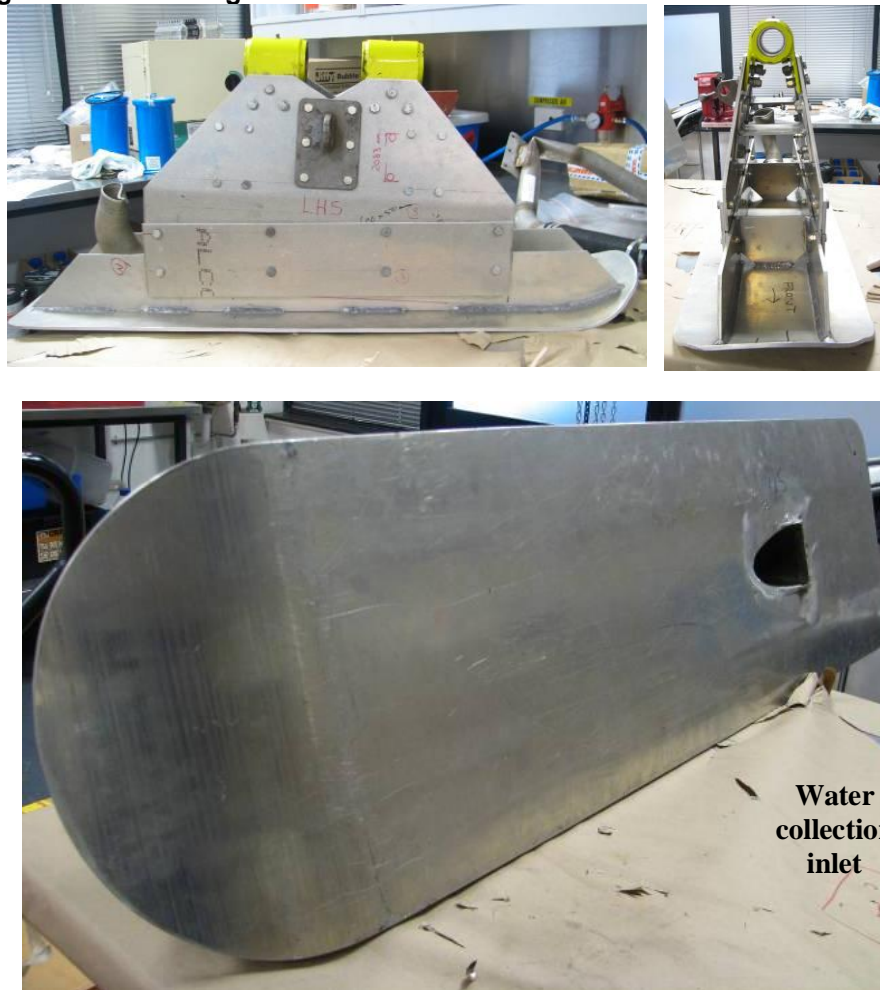
Figure 7: Ski design

The skis were made from aircraft quality aluminium alloy in a box-type design and were approximately 1,060 mm x 300 mm x 450 mm. The ski base had a rolled nose with a water collection duct cut into its aft section (Figure 7).

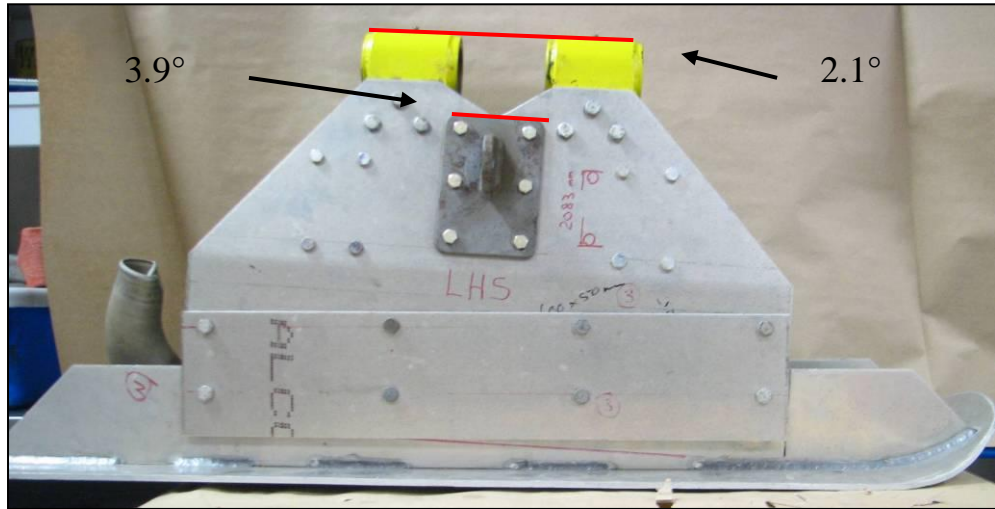
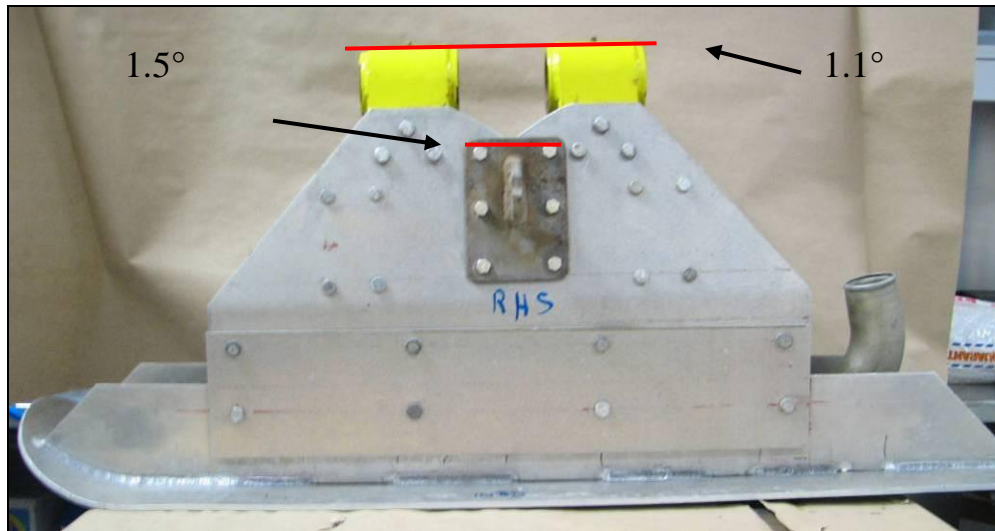
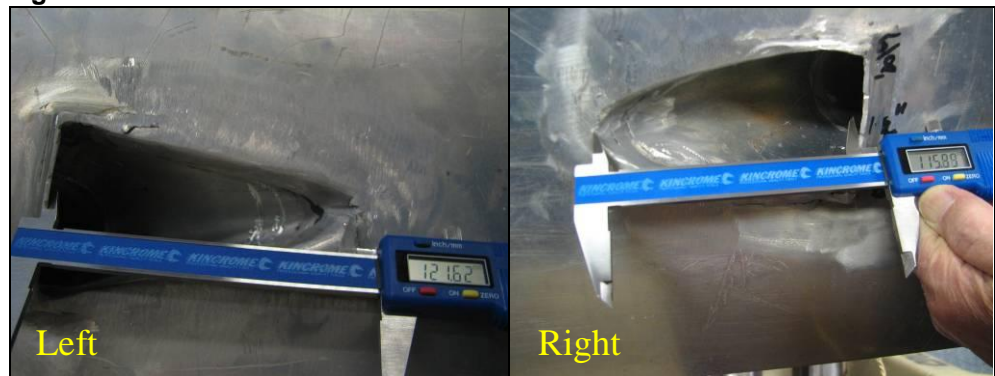
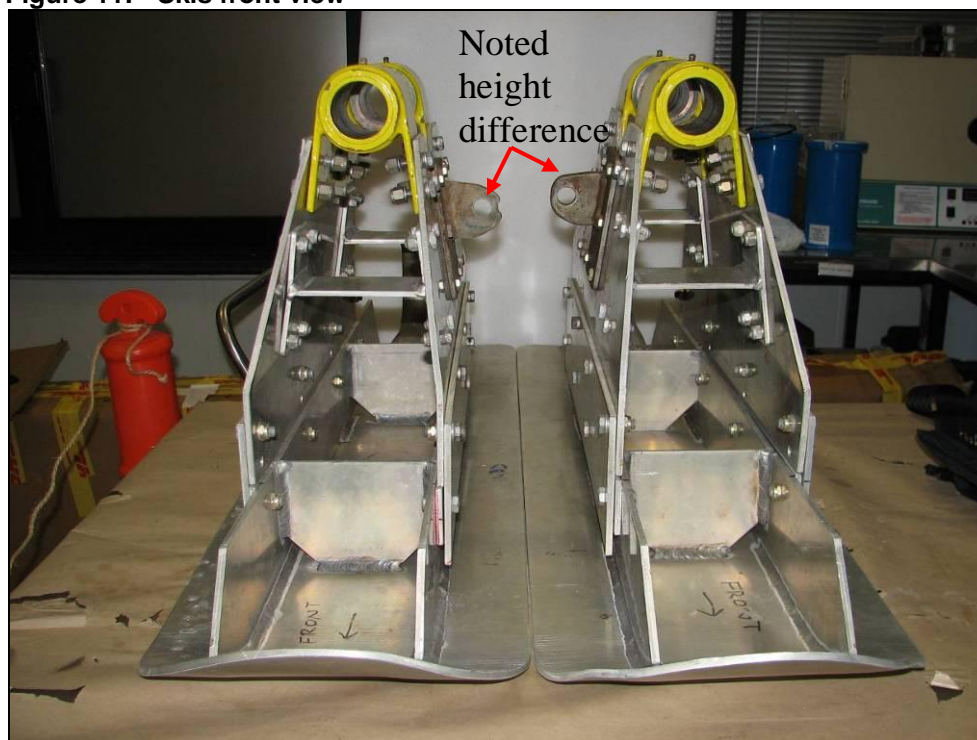
A comparison of the left and right skis (Figures 8 to 11) revealed significant differences between the skis. The main differences were:

- the overall heights of the skis were not the same
- there was a 1° difference in pitch angle between skis due to variations in the angular offset of the axle mount assemblies and hydraulic ram mounts
- the left ski hydraulic ram mount was positioned higher than the right ski
- the size and shape of the water collection inlets on the bottom surface of the skis varied in their diameters.

A number of dimensional inconsistencies were found between the left and right skis. A connection between the dimensional inconsistencies and the accident sequence could not be ruled out; however, there was insufficient evidence to draw any conclusions between the dimensional inconsistencies and the accident.
