ATSB TRANSPORT SAFETY REPORT
Aviation Occurrence Investigation
AO-2008-026
Final

Loss of control
19 km SE Sydney Airport, New South Wales
9 April 2008
VH-OZA
Fairchild Industries Inc. SA227-AC Metro III

Released in accordance with section 25 of the *Transport Safety Investigation Act 2003*

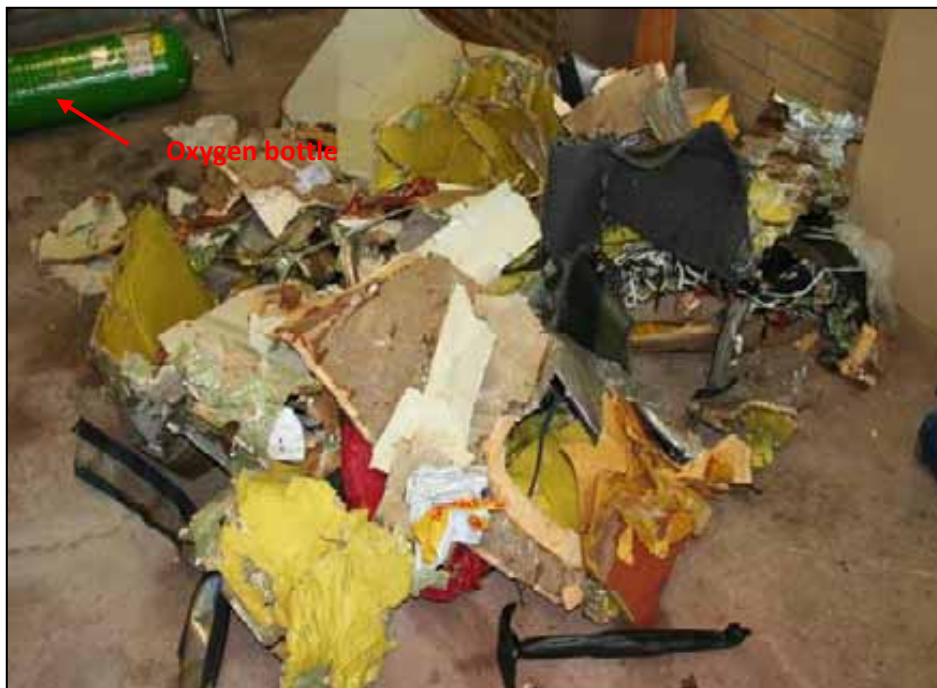
Figure 3: Recovered floating items

The nature of the damage of the recovered items indicated that the aircraft impacted the water at high speed (Figure 3). An examination of the cargo strap indicated that it had failed under gross overstress from exposure to impact loads. The metal medical specimen container displayed crush damage.

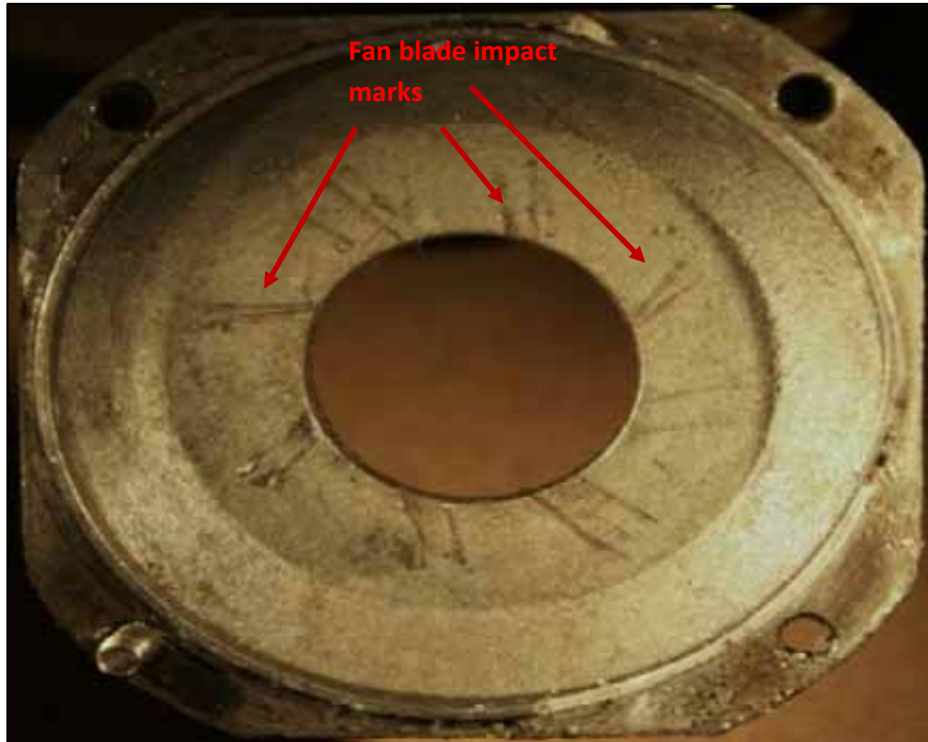
Figure 19: Gyroscope rotor casing fan blade impact marks

Examination of the inside of the gyroscope casing end cap found rotor fan blade impact marks. Those impact marks displayed no evidence of rotational scoring from

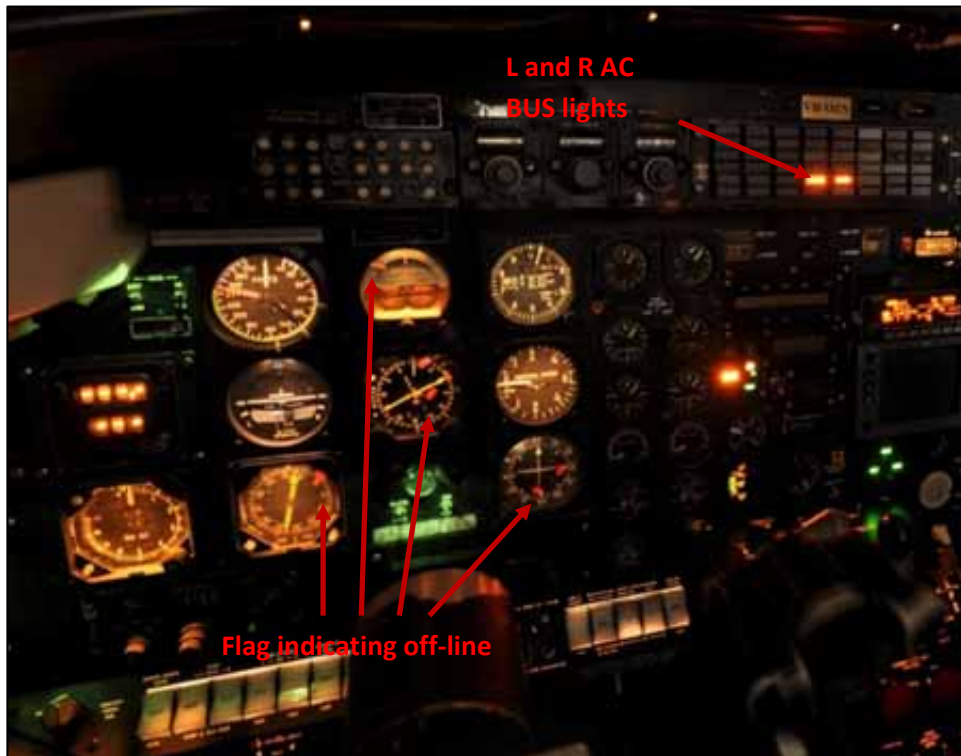
A loss of AC power meant that the pilot's and copilot's AHs would have been inoperative, with the effect that the pilot would have been deprived of any primary attitude information from his instrumentation (Figure 25). The autopilot would also not have been available for use.

Figure 25: VH-OZN instrument panel during simulated night operations (pilot side) with no AC power and showing the resulting annunciator lights and instrument flags

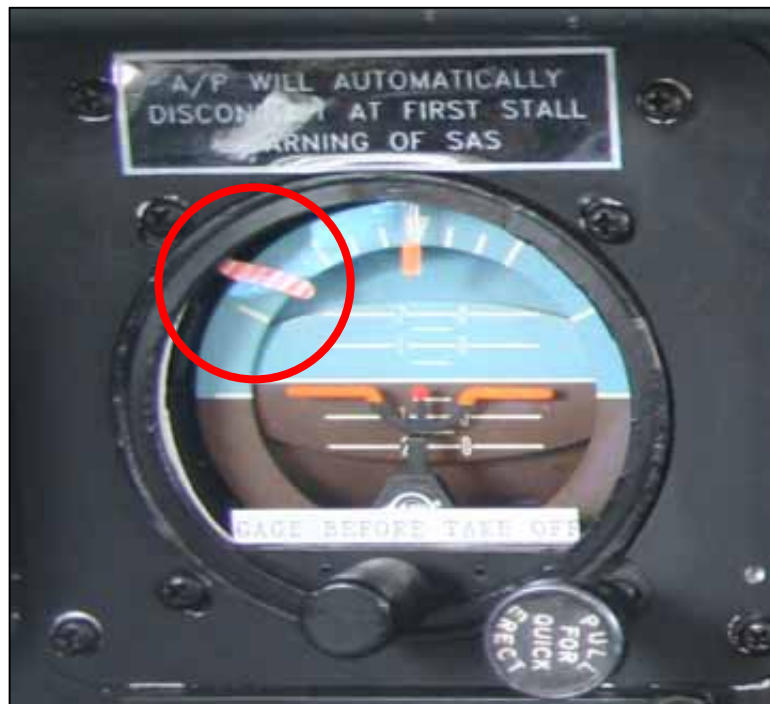
In addition, if the pilot's AH was not powered prior to takeoff, the pilot should have been presented with an orange and white warning 'off flag' on the AH as shown in Figure 26.

Figure 26: VH-OZN, pilot's AH with off flag visible (circled)

The investigation found it improbable that the pilot might not have noticed the numerous caution lights and instrument off flags associated with an AC power failure during the pre-flight checks and taxi. Similarly, the investigation could not explain why the pilot would have continued the takeoff without primary attitude reference. To have done so markedly increased the risk of spatial disorientation and the subsequent loss of control of the aircraft.

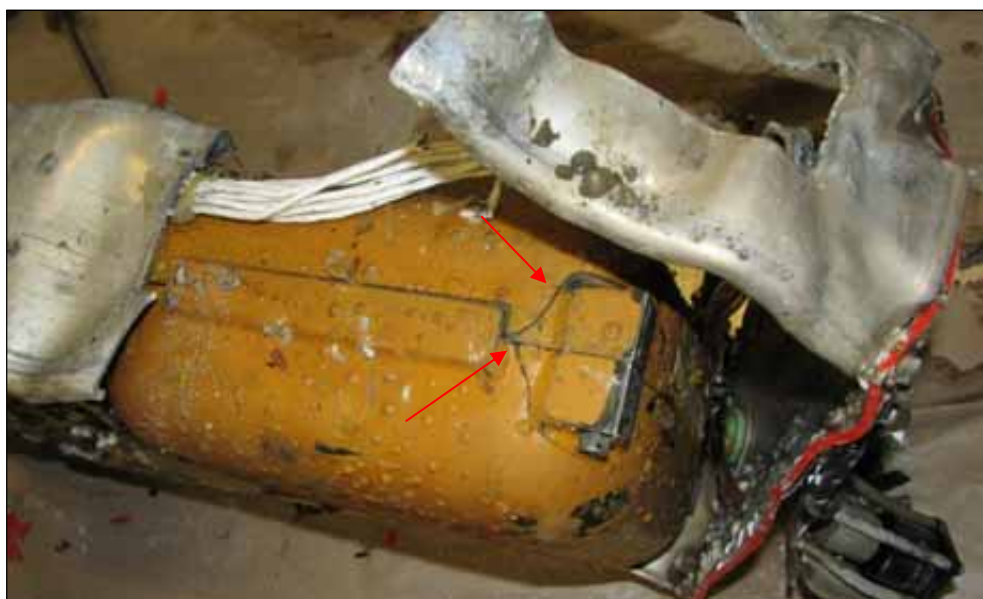
Figure B-7: FDR crash protected enclosure showing fracture damage (arrowed)

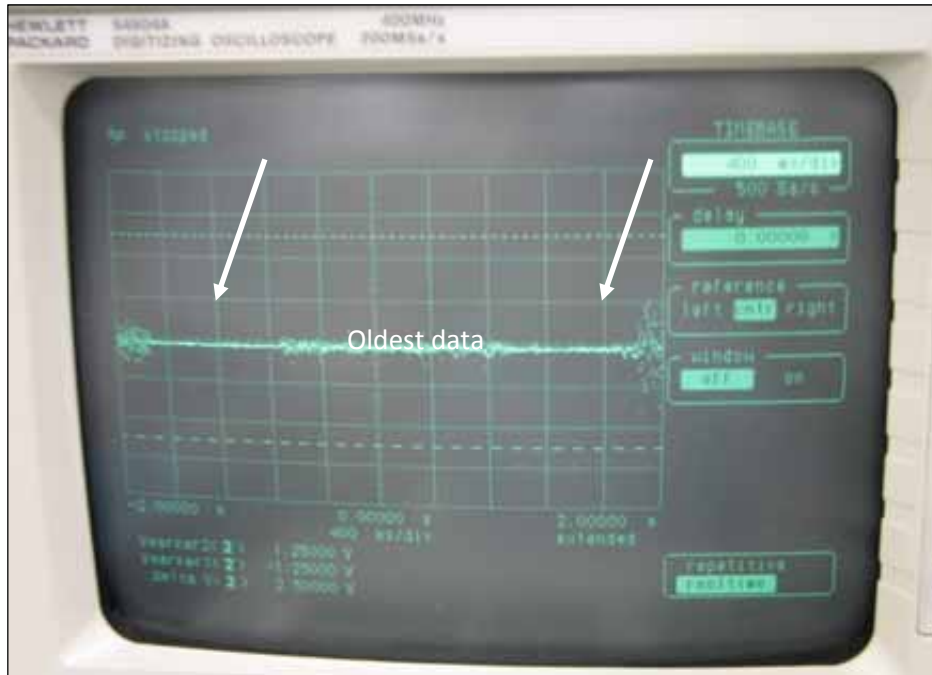
Figure B-14: Oscilloscope screenshot of Track 6 at location of tape stoppage (i.e. transition from newest to oldest data). Reduced signal strength arrowed. This was typical across all eight tracks

Additional work was undertaken on track 6 only to recover as much data as possible. There is a gap of approximately 1 inch between the erase and read/write heads on the FDR tape transport, and only about 3.75 inches of tape could not be recovered (denoted by the arrows above). Therefore, since the tape between the heads had been erased, only 2.75 inches of tape was not recovered, which equated to 6.7 seconds of recorded data. Typically a 3-second distance between data blocks occurs between the end of one flight and the start of another. Therefore, in reality only about 3.7 seconds of data were potentially not available from the final flight. It was considered unlikely that this would include a period of FDR activation.

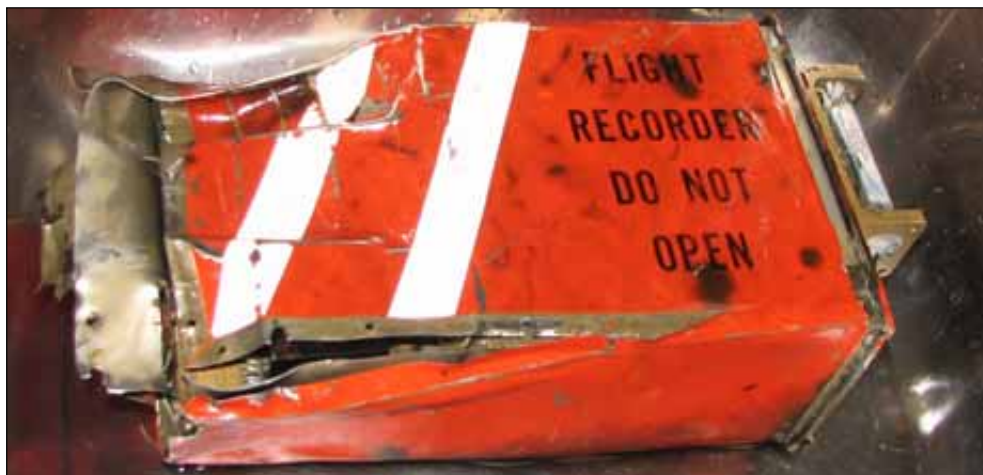
Figure B-21: Fairchild model A100A Cockpit Voice Recorder from VH-OZA following removal from shipping container on 1 July 2008

The CVR had been subjected to substantial impact forces and saltwater immersion, which had resulted in extensive damage to the recorder. The recovered CVR was identified from the manufacturer's data plate as a Fairchild model A100A CVR, part number 93-A100-80, serial number 55650 (Figure B-22). The maintenance records for VH-OZA confirmed that this CVR was fitted to VH-OZA at the time of the accident.

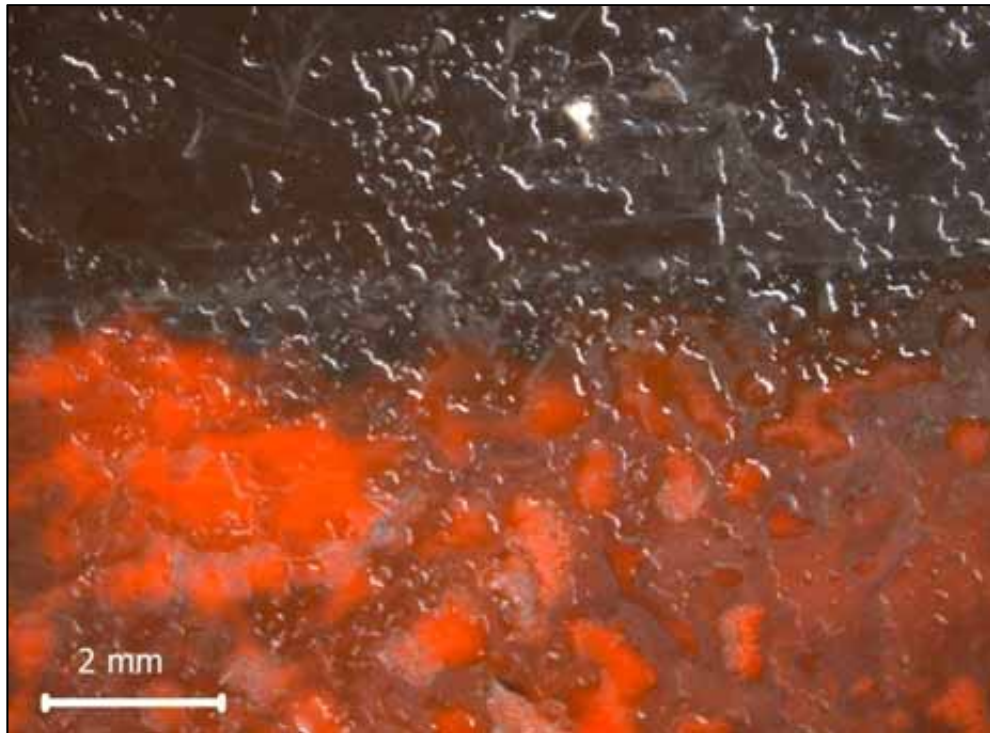
Figure C-4: Magnified view of the discolouration observed on the CVR face plate

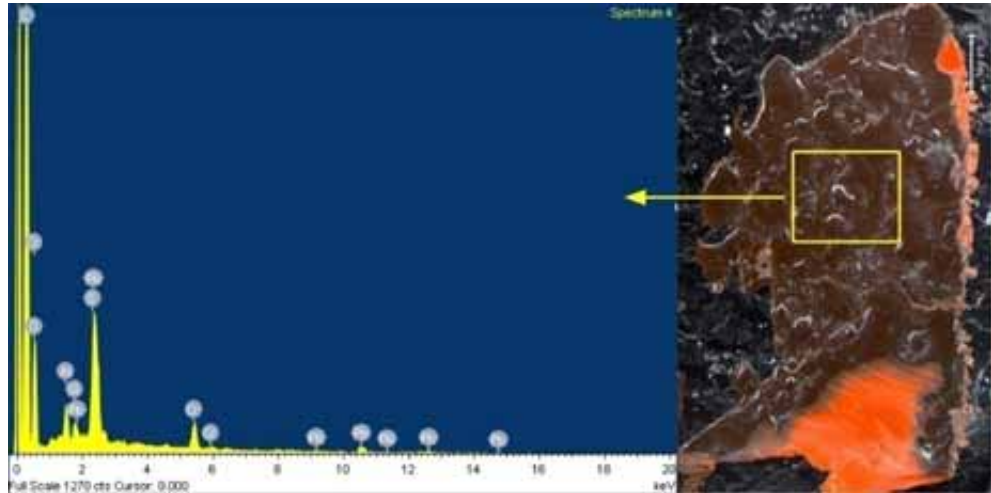
Figure C-6: Damaged paint sample from CVR and its chemistry

Note: A discoloured paint chip from CVR. Original colour can be seen on the lower right of the image where the paint has been sectioned with a scalpel blade.
