Flight Control System Event

19 km west of Camden, NSW – 8 May 2008

INFRA-08549

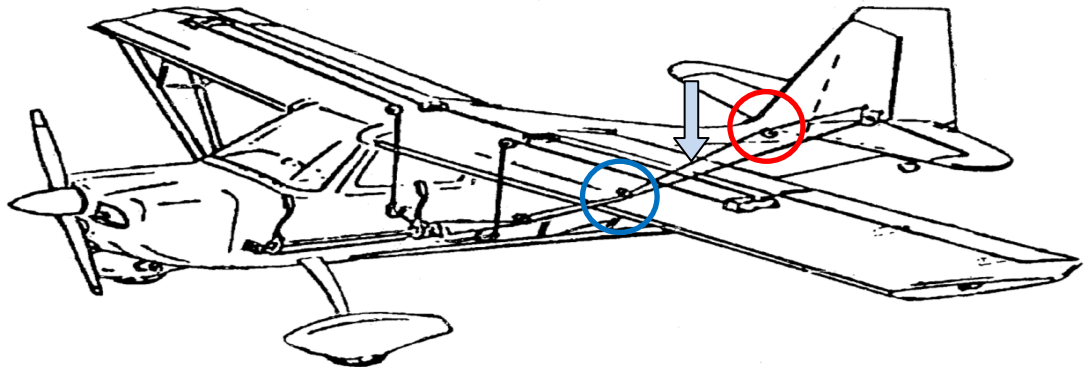
During the initial examination of the aircraft, maintenance personnel found that the upper of the two elevator control cables (Elevator UP cable, part number 3-1072) had fractured at a location corresponding with its passage over a mounted guide sheave (pulley) located in the upper empennage area (Figure 1). Australian Transport Safety Bureau (ATSB) investigators who later attended and examined the aircraft, found the associated sheave (part number MS24566-3B) to

Figure 1: Location of 'up' elevator control cable (arrowed), with failure at rear upper sheave (red circle) and damage at the central sheave (blue circle)

be in good condition and able to freely rotate without resistance. Further damage to the cable, in the form of localised strand fracture and fraying, was also found in a location associated with the cable run across the next sheave forward in the fuselage.

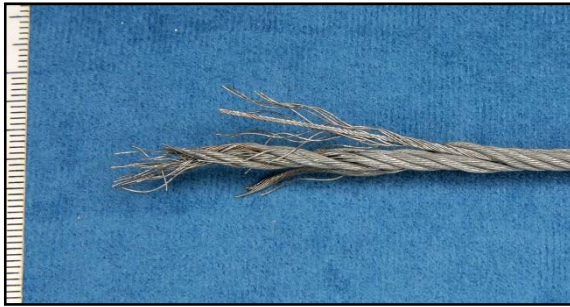
The elevator cable fracture occurred approximately 600 mm (24") from the interconnection with the elevator control horn. The failed area was characterised by fraying and separation of the strands and wires for a length of approximately 60 mm (2.4") from the point of failure (Figure 3).

Figure 3: Cable fracture and associated strand separation

The ATSB's examination of the elevator cable attributed the failure to the localised and progressive fatigue cracking and fracture of individual wires within the cable structure; progressively weakening the cable to a point where it failed in flight, as it was no longer able to sustain normal operating loads. A second area of wire damage found on the same cable was also confirmed to be the result of fatigue cracking.

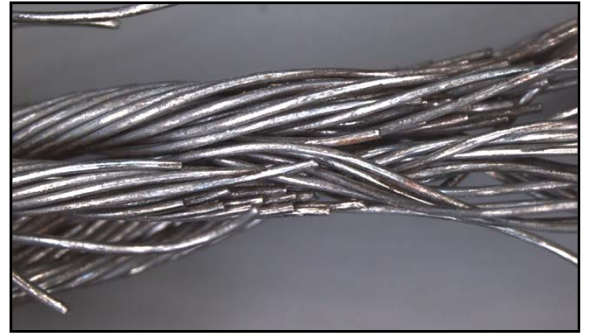
Figure 5: Strand fractures – main failure

At low magnifications under the stereomicroscope, the majority of wire failures from the fractured (Figure 5) and damaged areas (Figure 6) showed sharp, square-edged transverse fractures, with little or no evidence of necking³ or plastic deformation typically associated with tensile overstress fractures.

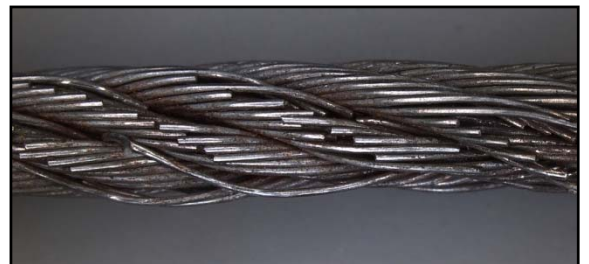
Figure 6: Wire fractures – damaged area

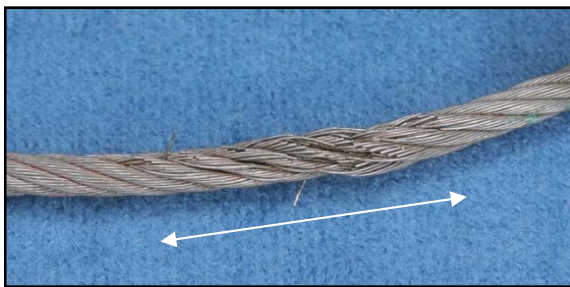
Around 1.7 m (5.5') forward from the point of fracture was a second area of cable damage – presenting as a localised zone of individual wire breakage and separation from the associated strands (Figure 4).

Figure 4: Secondary elevator cable damage

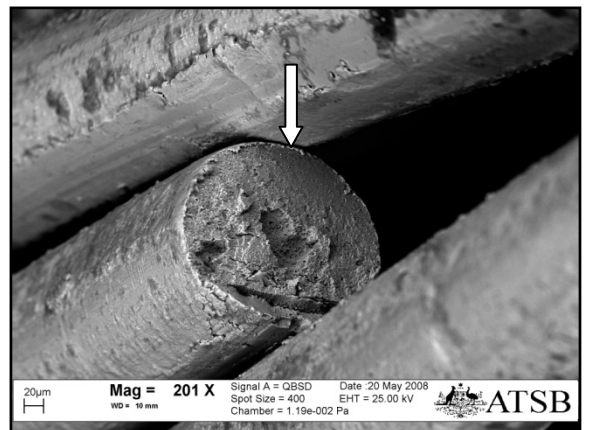
When examining several fractured strands under the scanning electron microscope (SEM), it was evident that the majority of failed wires displayed features typical of a fatigue cracking mechanism, with the crack origin areas associated with the contact surfaces between the wire and its immediate neighbour (Figure 7). Fatigue cracking extended part-way across the section, with the remainder presenting a more uneven, woody appearance associated with final tensile failure of the wire.

Figure 7: Wire fracture – fatigue area origin indicated at arrow

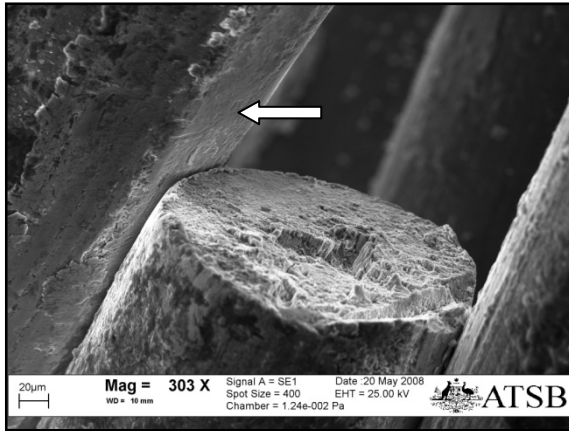
Many of the strand wires showed evidence of movement, fretting and wear of the contact surfaces and smearing of the surface metallic material (Figure 8).

Figure 8: Rubbed and worn wire surface (arrowed)

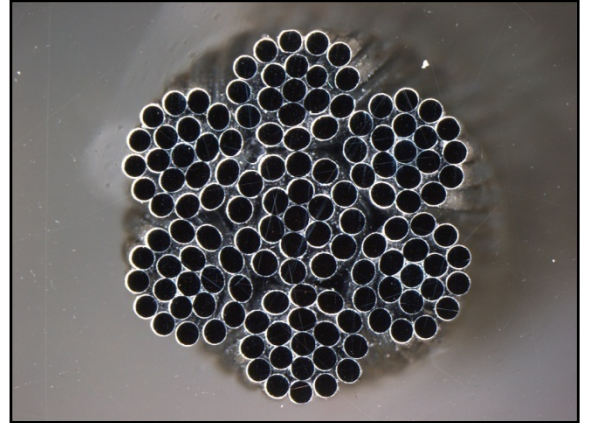
Figure 9: Failed cable cross-section. Zinc coating evident as white material on the surfaces of each wire

Metallographic sections were taken through both failed and exemplar cable samples and prepared to present a cross-sectional view. Optical measurements confirmed the individual wire diameters to fall within a 0.23 – 0.24 mm (0.0090 – 0.0094”) range for both cables. Both cables showed a surface coating of a bright metallic material – verified as zinc using SEM x-ray spectrometry techniques. Comparing the coatings between cables, it was evident that the failed cable showed considerably less overall zinc mass – particularly within the void spaces between wires in each strand (Figures 9 and 10). Zinc is provided primarily for corrosion protection, but its low hardness and ductility also allow it to act as solid lubricant.

The investigation found evidence that the failed elevator cable from VH-MWY had not been manufactured to the accepted standard for aircraft control cables (MIL-DTL-83420). Although comparable in general dimensions and material, the cable did not contain the manufacturer's colour indicator filaments within the strand windings, and it carried a visibly lower level of zinc coating over and amongst the strands and wires, when compared to a sample of known MIL-DTL-83420 cable.

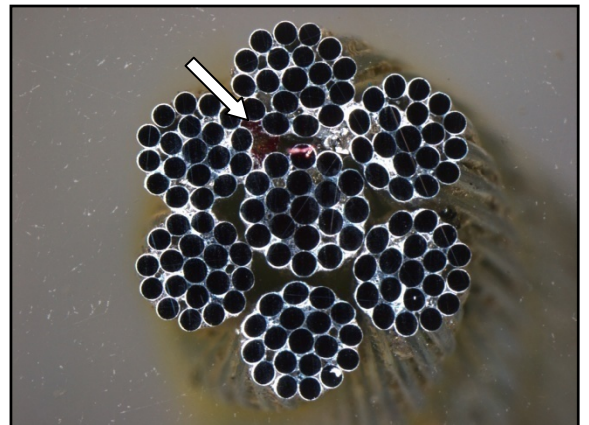
Yellow and red coloured, non-metallic filaments were noted within the void spaces between the core strand and the six outer strands of the exemplar cable. The failed cable from VH-MWY did not contain any coloured filaments within the internal structure.

Figure 10: Exemplar cable cross section. Note the greater zinc mass between the strand wires and the red coloured filament (arrowed)
