Aviation Occurrence Investigation AO-2008-033

Final

Operational non-compliance
Perth Airport, WA
9 May 2008
PK-GEF
Boeing Company 737-8CX

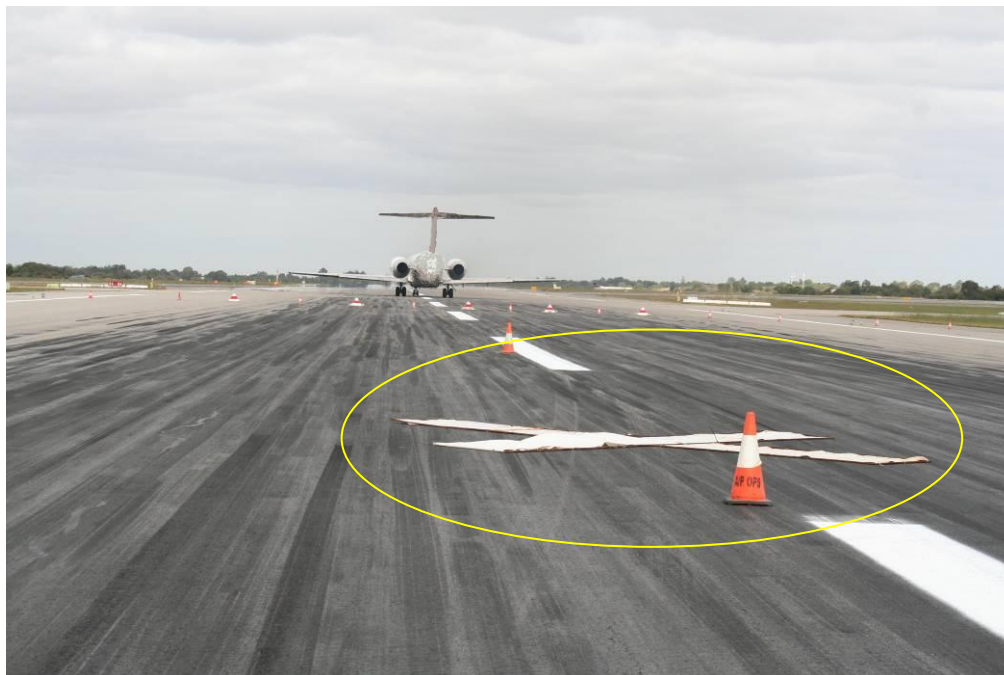
The temporarily displaced landing threshold was marked by 'vee bar'⁸ markers and strobe lights on each side of the runway. The permanent threshold and touchdown markings were not obscured, and the works area was marked by four, 6 m closed runway crosses (Figure 1).

Figure 1: Runway 21 works area looking south. Note the 6m cross (circled)

The flight crew recalled that, during the first approach and subsequent go-around, they did not see the closed runway crosses and that, on the second approach, they saw the closed runway crosses ‘too late’.

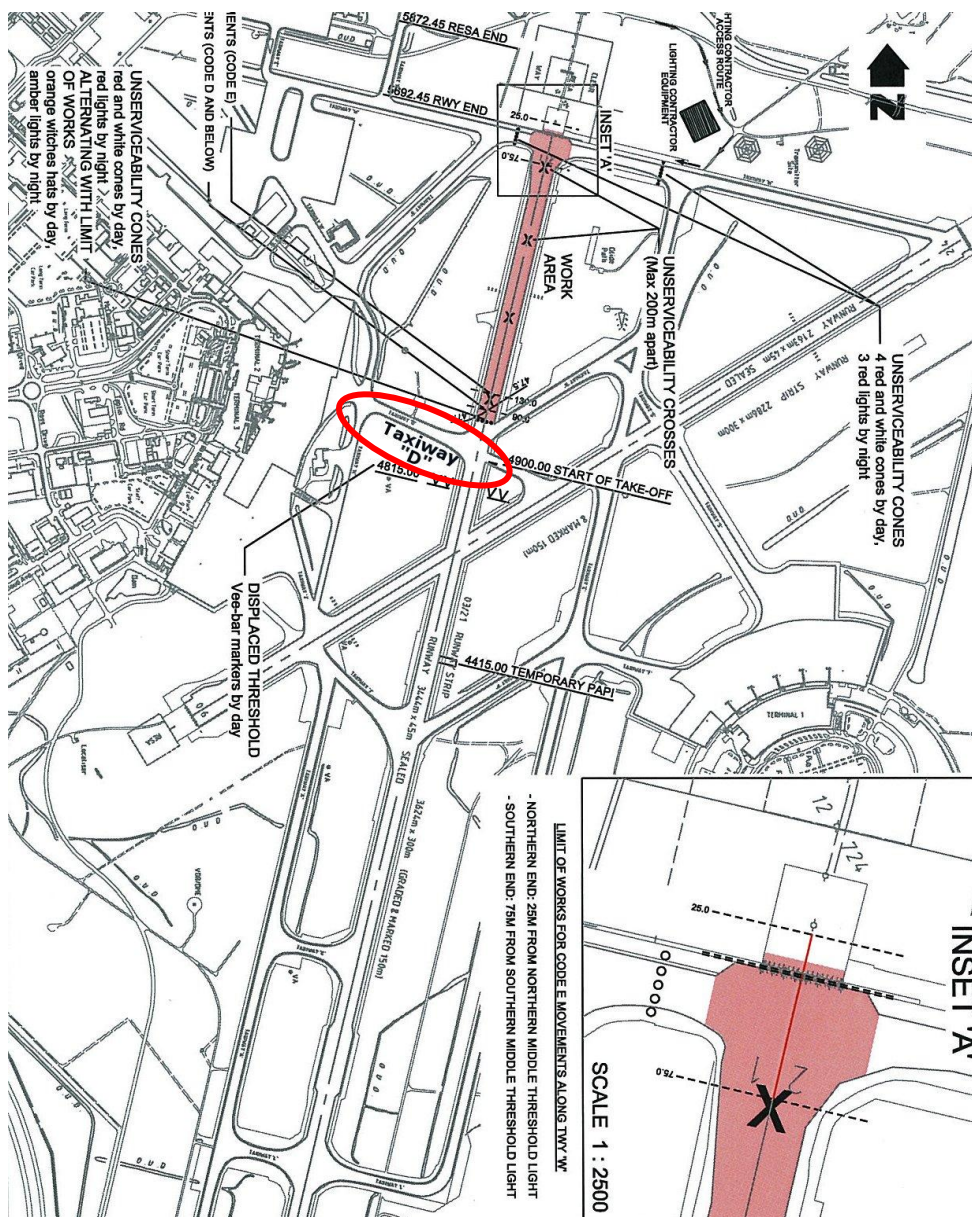
plan view of the works (Figure 2) and a number of draft NOTAMs for promulgation at the appropriate stage of the works. There was no indication in the MWOP or draft NOTAMs of the consideration of the effect of those works on the final approach profile to the displaced threshold from the MDA of the runway 21 LLZ approach.

Figure 2: Part of the MOWP showing the stage 2 runway works area

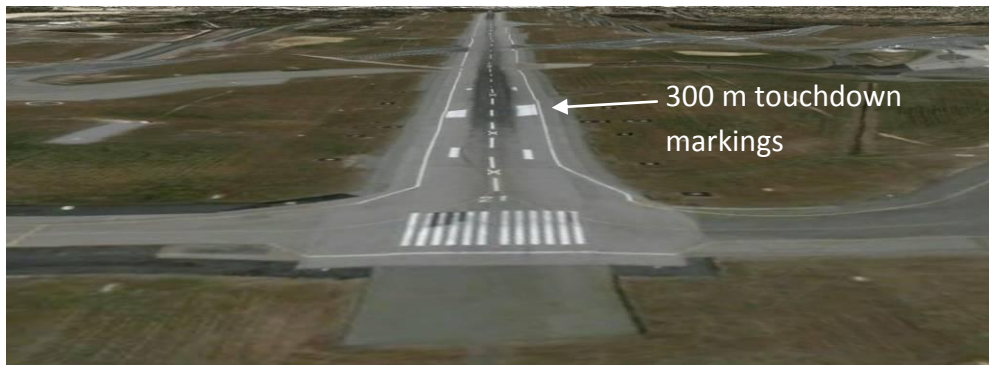
Simulated views of the 6 m and 36 m closed runway markings are at Figures 8 and 9 respectively. Those markings are indicative of the final approach to a runway as viewed by the flight crew just prior to touchdown. Note the 300 m touchdown marking as normally used by this type of aircraft.

Figure 8: Closed runway 21 markings (6 m) as used at the time of the incident

- The existing runway 21 threshold and touchdown markings were not required to be obscured and were clearly visible to the flight crew. Those markings continued to provide approach and landing cues to the normal touchdown zone, which was located within the runway works area. *[Safety issue]*
- The use of the 6 m closed runway markings in lieu of the recommended 36 m markings increased the risk of a flight crew conducting a visual approach to the permanent threshold/touchdown area. *[Safety issue]*

The use of the 6 m closed runway markings in lieu of the recommended 36 m markings increased the risk of a flight crew conducting a visual approach to the permanent threshold/touchdown area.

In response to that meeting and the Directly Involved Party process (see Appendix C) CASA advised that, 'any changes to runway marking standards will be subject to mandatory consultation with industry. The proposal for the use of the International Civil Aviation Organization (ICAO) recommended 36 m closed runway markings will be incorporated into the Part 139 amendment work program.'

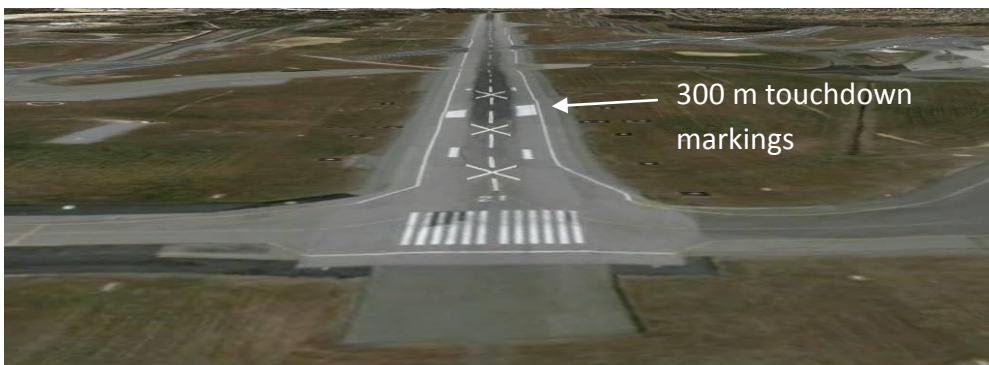
Figure 9: 36 m closed runway markings

During the development of this draft report, the ATSB met with CASA officers to discuss the possible safety benefits of the use of the International Civil Aviation Organization (ICAO)-recommended 36 m closed runway markings in Australia when the affected permanent threshold and touchdown markings were not required to be obscured.
