Aviation Occurrence Investigation – AO-2008-035

Collision with terrain

83 km NE Georgetown, Qld

VH-IDM

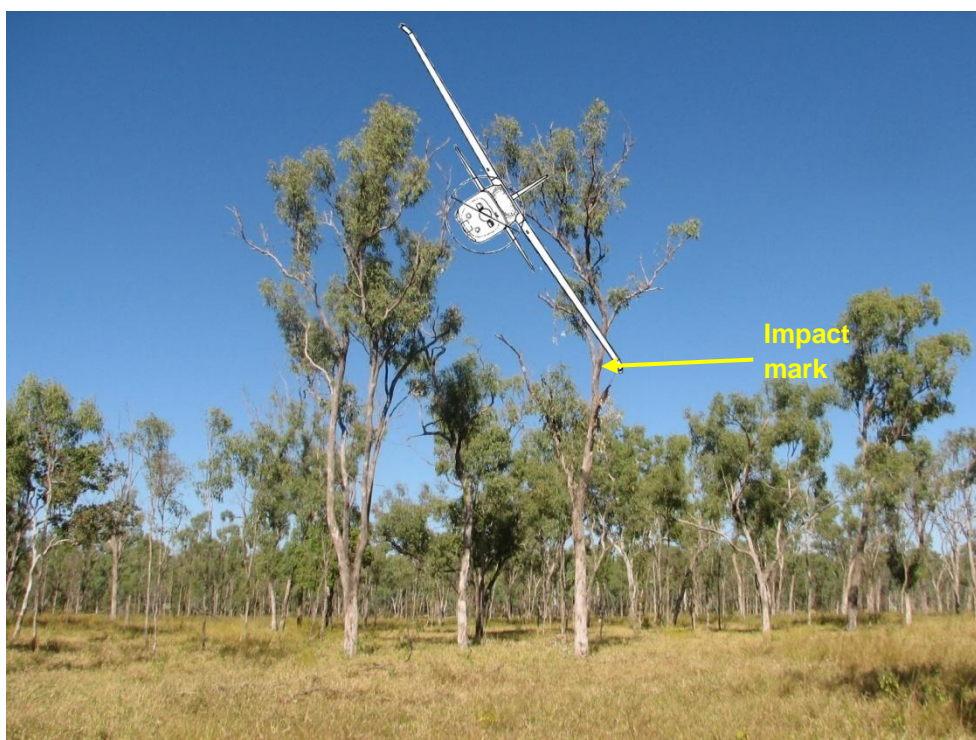
Figure 3: Likely bank angle of the aircraft when it impacted the initial tree

The location of some parts of the wreckage, ground marks and damage to trees indicated that the aircraft impacted a tree at a steep bank angle, while heading in a northerly direction (Figure 3). The left wingtip and aileron separated as a result of the impact and were located on the right side of the wreckage trail (Figure 4).

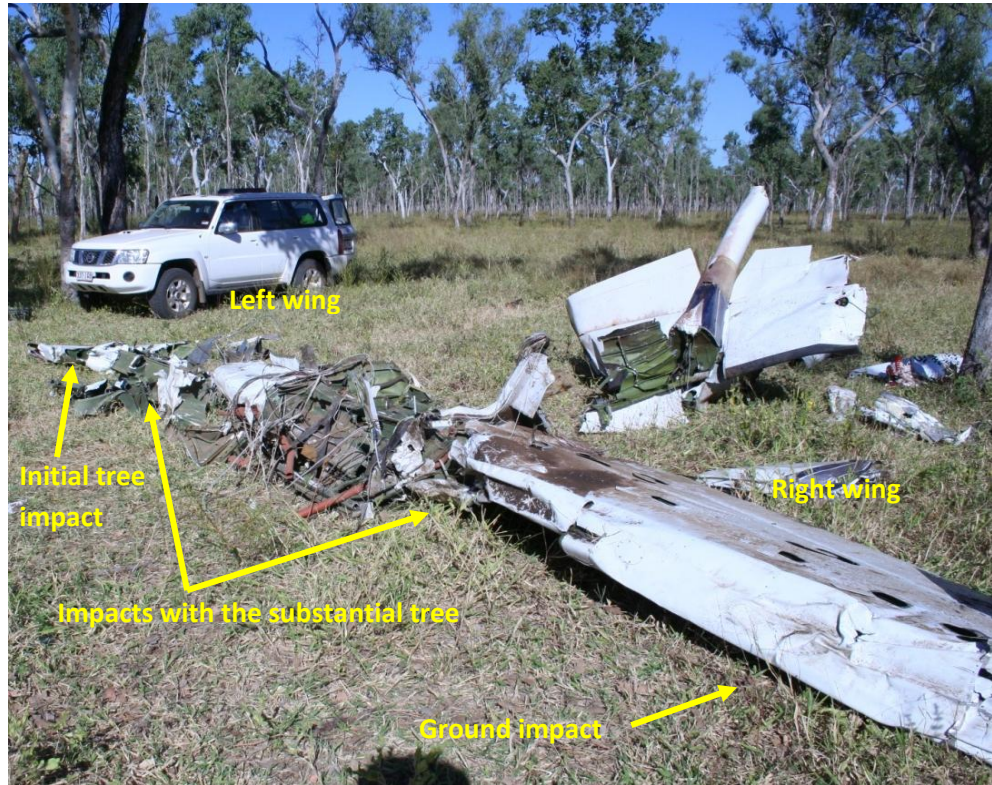
Figure 5: Orientation of wing and tail pieces (inverted)

The aircraft then felled a substantial tree, located about 35 m beyond the initial tree impact, propelling some sections of the tree up to a distance of 75 m. There was evidence of propeller strike marks on the tree and tree impact damage to the left wing and right wing root (Figure 5).

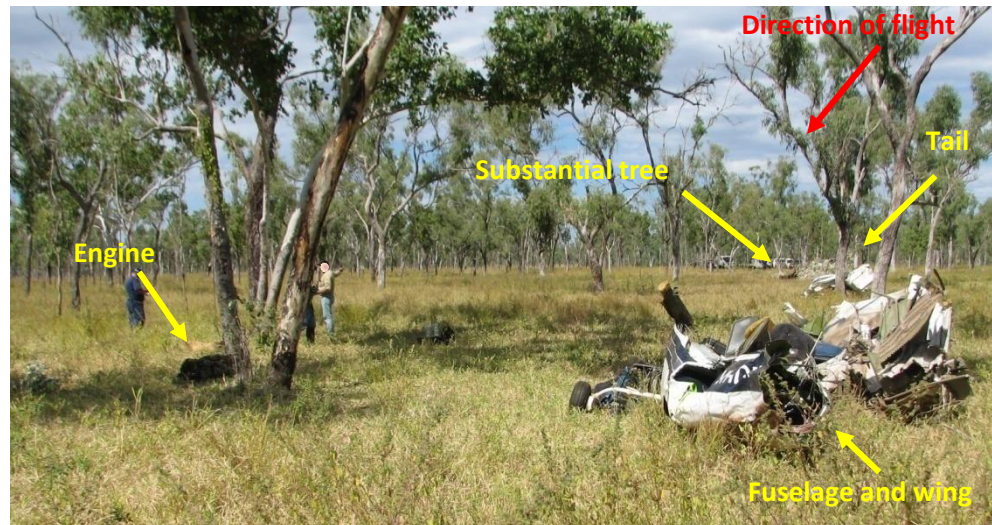
Figure 6: Accident site and aircraft wreckage

The fuselage and most of the wing structure came to rest approximately 66 m from the ground impact point, with the engine found nearby (Figure 6). The fuselage was upright and facing back in the direction of approach. Damage to the forward fuselage was severe and the wing structure had detached from the upper fuselage.

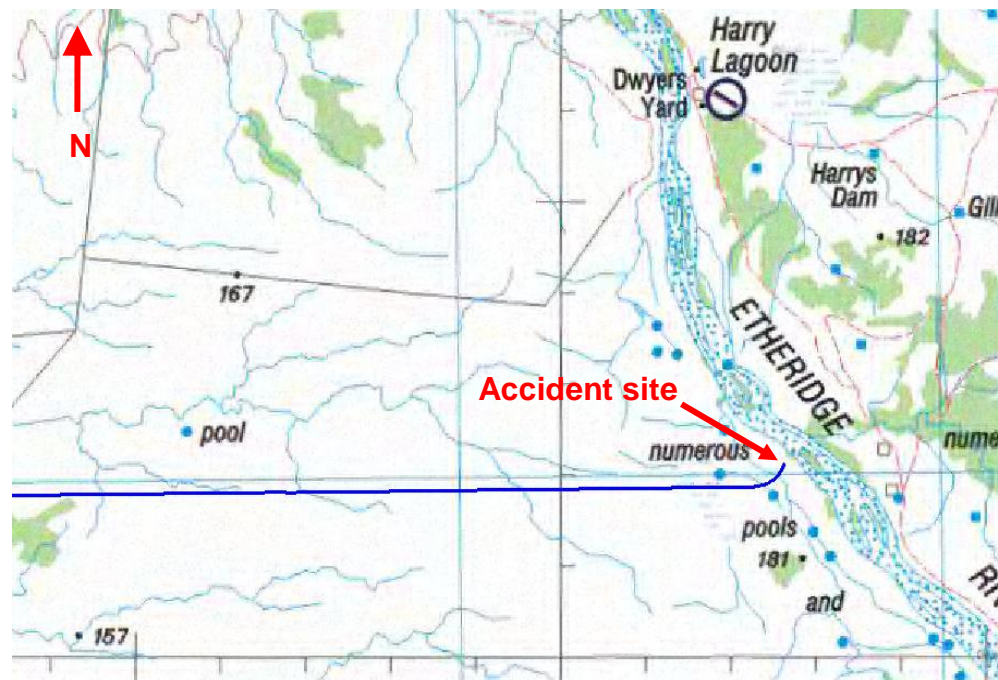
Figure 7: Aircraft track recorded by the survey equipment

The onboard geophysical survey equipment recorded the aircraft's location and altitude at half-second intervals. The data was downloaded by the equipment manufacturer for the ATSB and indicated that the pilot had accurately completed the survey lines prior to the accident. Approximately 13 seconds prior to the last recorded survey data, the pilot had completed the most southerly planned survey line and commenced a left turn to the north (Figure 7). During the turn, at about 8 seconds prior to the last recorded data, the aircraft began to lose altitude (Figure 8). The last recorded data was captured a few metres prior to the impact with the substantial tree. The survey data recorded for a total of 3 hours 12 minutes and 4.5 seconds.

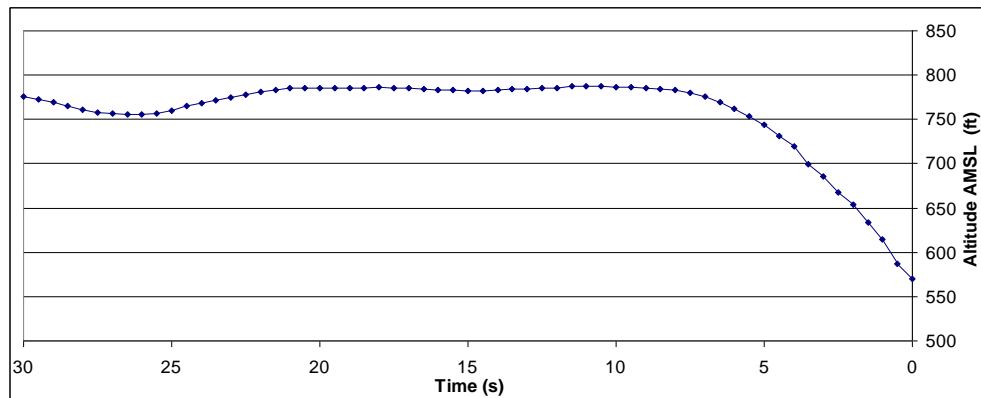
Figure 8: Recorded aircraft altitude over time

The ground level at the accident site was about 545 ft above mean sea level (AMSL).

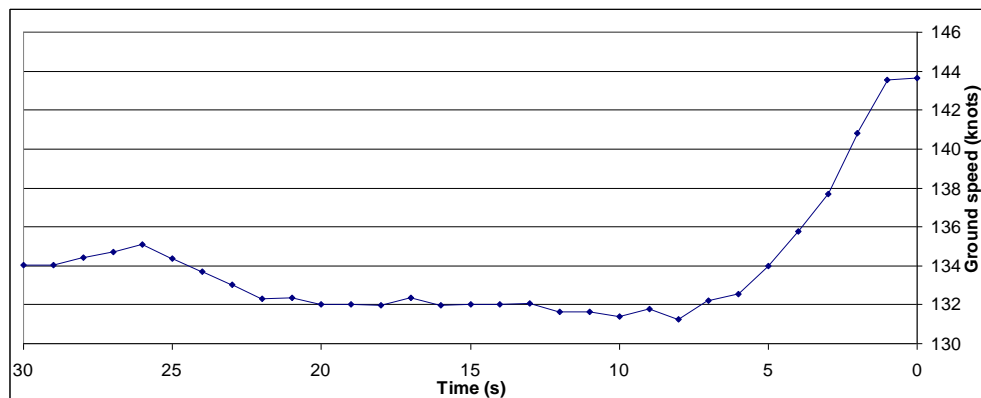
Figure 9: Derived aircraft groundspeed over time

The aircraft's groundspeed was derived from the recorded data. During the last survey line, the aircraft groundspeed averaged approximately 133 kts. During the turn and descent, the groundspeed increased to a maximum of 143 kts (Figure 9). The airspeed indicators from the aircraft's instrument panel were examined and one showed evidence that the aircraft had been travelling at about 145 kts at the time of the impact.

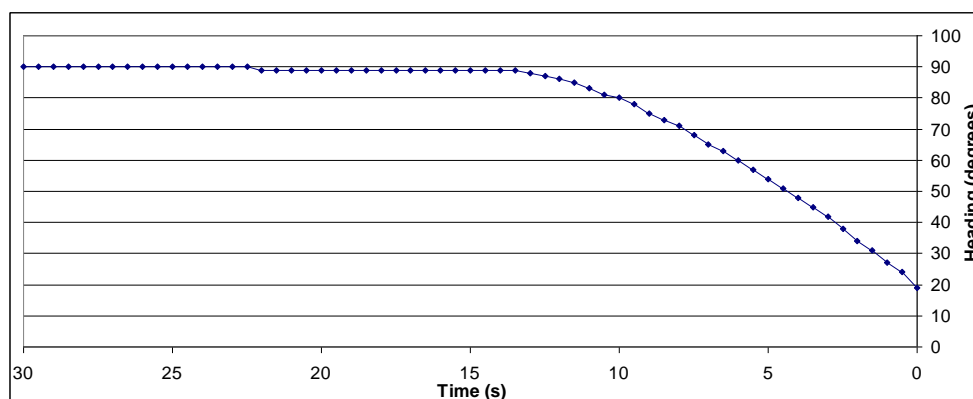
Figure 10: Recorded aircraft heading over time

The aircraft's bank angle was calculated from the recorded data, including the ground speed and aircraft heading (Figure 10). The bank angle was found to have increased during the turn to reach a maximum of approximately 50° left-wing low.
