ATSB TRANSPORT SAFETY REPORT
Aviation Occurrence Investigation AO-2008-039
Final

Airframe vibration
Wollongong Aerodrome, NSW
11 June 2008
VH-UAH, Bell Helicopter Co. 412

Airframe vibration
Wollongong Aerodrome, New South Wales
11 June 2008
VH-UAH, Bell Helicopter Co. 412

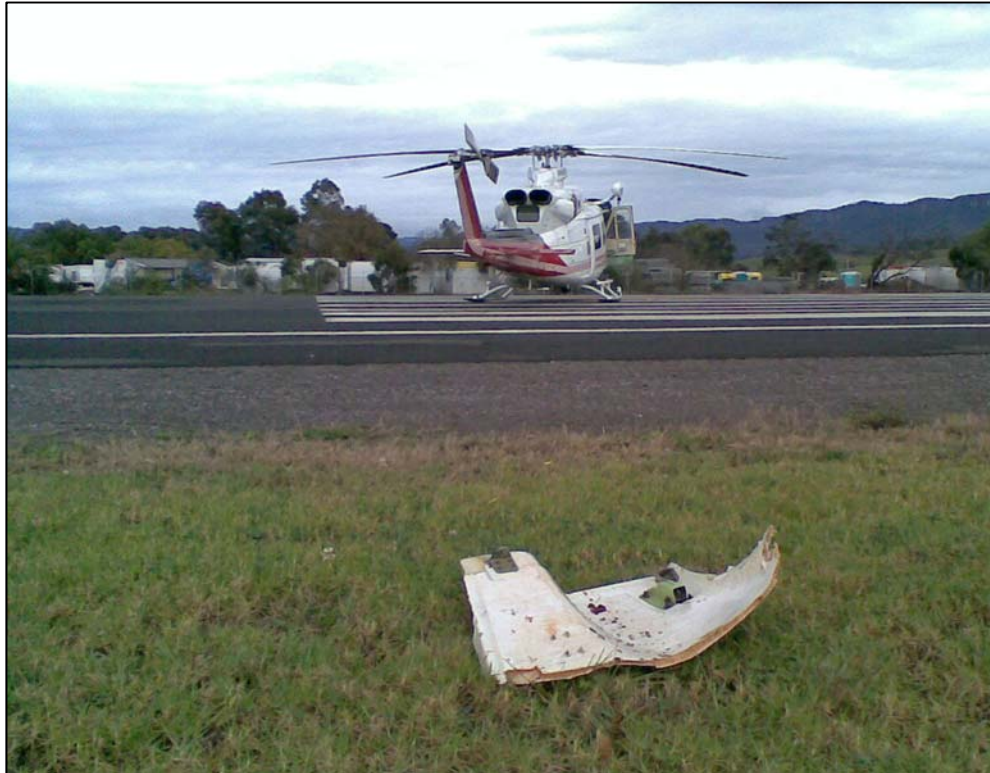
In response to the increasing vertical airframe vibrations, and suspecting that they were related to ground resonance⁴, the pilot in command announced that he was 'taking over' and raised the helicopter into a hover. As the helicopter broke ground contact, the vertical airframe vibrations and control difficulties increased in magnitude. Given the controllability issues, the pilot who had assumed control of the helicopter conducted an autorotation onto the runway. After the engines were shut down, both pilots exited the helicopter uninjured. The helicopter was substantially damaged (Figure 1).

Figure 1: VH-UAH on the runway after landing

Note: A section of pylon fairing that separated from the airframe during the occurrence is shown in the foreground.

The operator's inspection found that the rear section of both skids had been bent upward toward the fuselage and the rear crosstube that supported the skids had been flattened. Such damage was indicative that the helicopter had landed heavily in a tail-low attitude. No other damage to or anomaly associated with the skid landing gear was reported.

The tail rotor blades had sustained minor rotational impact damage from contact with the runway surface. The tail rotor drive coupling was found disengaged from the rest of the tail rotor drive components and some areas of the tail boom had buckled from the hard landing.

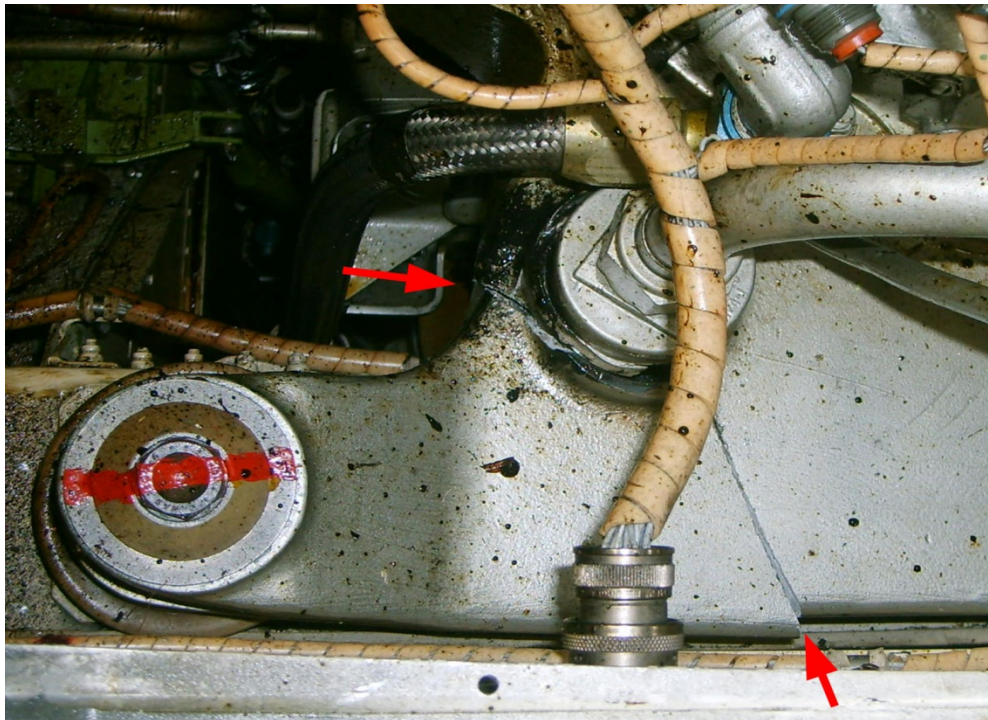
The operator's inspection of the main rotor transmission revealed that the right-rear and left-forward corners of the transmission support case had both fractured (Figure 2). The transmission had been attached to the airframe by a lift link and vibration isolation mounts at the support case corners. An internal inspection of the transmission was carried out by the operator and no internal mechanical defects were found. The transmission had no reported history of metal contamination, and pressure and temperature indications were reported to have been in the normal operating range prior to the occurrence.

Figure 2: One of the fractured mounts from the transmission support case (arrowed)

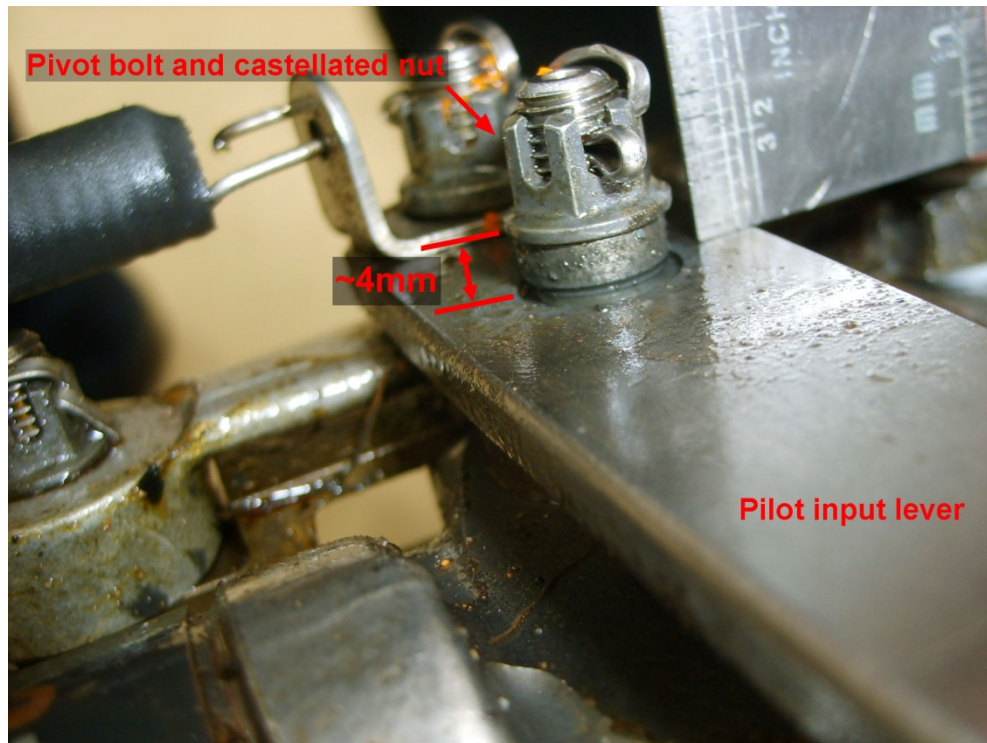
The collective actuator had operated for 513 hours since its last overhaul. The operator's inspection of the flight controls following the accident revealed excessive free play in the connection between the pilot's input lever (part of the collective control system) and the collective actuator assembly (Figures 3 and 4). In particular, it was noted that one of the pivot bolts on the input lever was loose, which had allowed excessive play to develop in the linkage.

The operator advised that it considered the pivot bolt free play in the collective actuator to have potentially affected the controllability of the helicopter. As a result,

Figure 3: Pivot bolt to the input linkage lever displaying excessive free play

On this basis, the manufacturer concluded that had running torque not been considered during the assembly process, the pivot bolt would have been inadequately tensioned, thereby allowing excessive clearance to exist between the fitted parts (as observed).

Excessive free play between the pivot bolt and the pilot input linkage was attributed to insufficient clamping at that joint – possibly originating from a failure to adhere to the actuator manufacturer's procedures for the tensioning of the assembly during the last actuator overhaul. If the running torque of the nut was not considered when the pivot bolt and castellated nut were installed, it is probable that the joint would not have received adequate initial tensioning, and as such, would have been predisposed to the development of excessive free play.

- After the occurrence, the operator performed an initial fleet-wide non-standard inspection of Bell 412 collective hydraulic actuator units for evidence of security or free play within the collective lever/pivot bolt joint. No defects were reported to have been found.
- The operator introduced a repetitive, non-standard inspection of the collective servo-hydraulic actuator units within their Bell 412 fleet.
- The operator released a flight staff instruction to their Bell 412 pilots, communicating that should they experience unusual or excessive vibrations during flight, that they land the helicopter and notify engineering personnel.

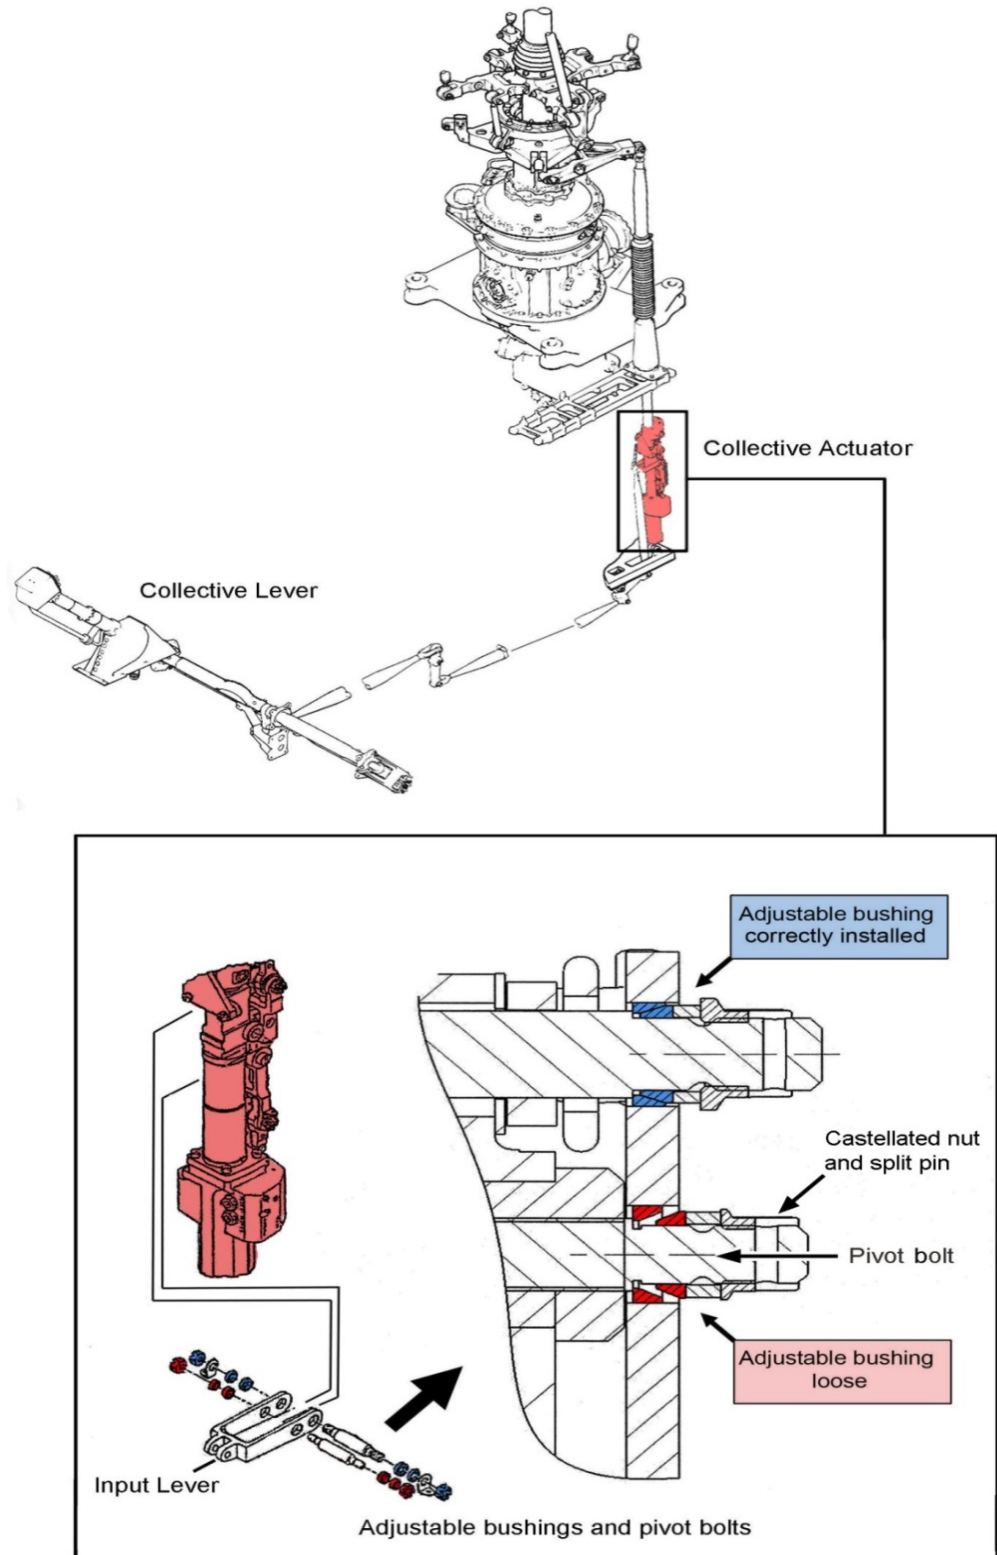
The component manufacturer noted that running torque values for new castellated nuts have been reported as high as 20 in-lbs, which is *above* the lower installation torque limit (15 in-lbs). While on the test stand, one of the two castellated nuts on the input lever was backed off and re-torqued to the minimum 15 in-lbs, while ignoring the 13 in-lbs of running torque. With the nut torqued to 15 in-lbs, it was further tightened to the minimum extent necessary for cotter pin installation. This left a 0.050 in gap between the spacer and the castellated nut. Manually twisting the pilot input lever resulted in observable free play at the pivot bolt joint.

Figure 4: Bell 412 collective system illustrating an incorrectly assembled adjustable pivot bolt and bushing assembly, as found during the actuator disassembly

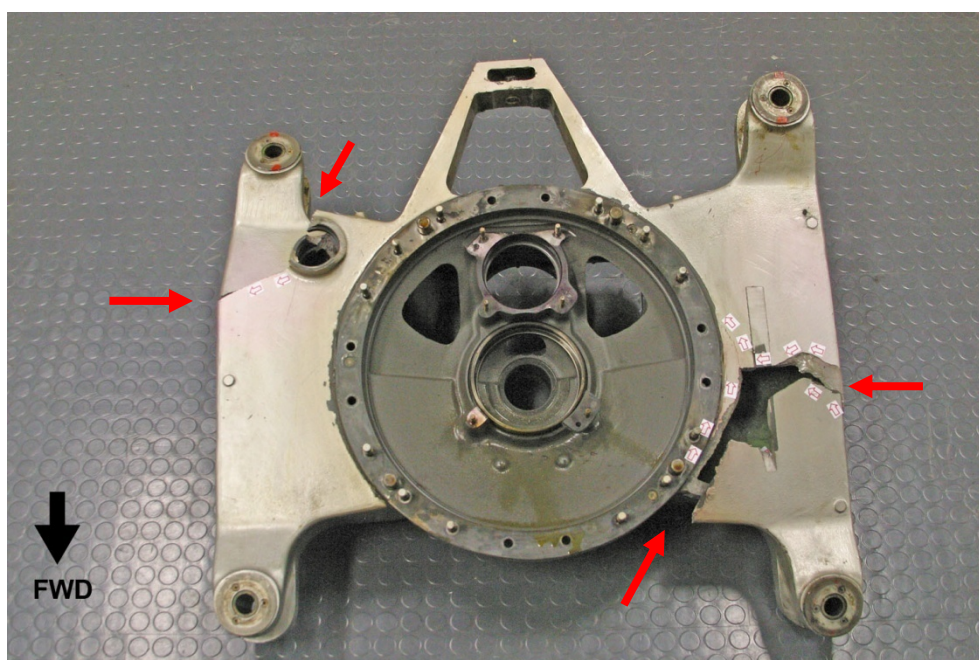
A detailed examination of the fractured transmission case was carried out in the ATSB laboratories to ascertain whether the failure may have contributed to the controllability difficulties reported by the pilots. No evidence of any pre-existing defects or progressive cracking was observed across any of the transmission case fracture surfaces, with all showing brittle fracture features, consistent with exposure to gross overstress conditions.

As noted in Figure 5, the lugs had fractured diagonally through each isolation mount, which was indicative that considerable out-of-balance forces from the main rotor system had developed during the latter stages of the occurrence flight. Other damage to the transmission case included the machining of a slot into the case surface from rotational contact with the main rotor disc brake.

Figure 5: Transmission support as received by the ATSB, showing diagonally opposing fractures (arrowed)
