ATSB TRANSPORT SAFETY REPORT
Aviation Occurrence Investigation A0-2008-042
Final

In-flight shutdown, VH-QOA 84 km N of Lockhart River Aerodrome, Queensland 20 June 2008

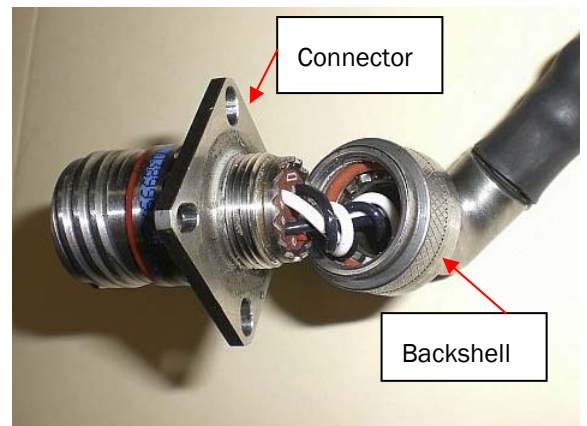
Figure 1: MPU-PEC wiring harness backshell and connector

An initial examination of the MPU by the operator's maintenance personnel identified an intermittent electrical fault in the MPU harness. The unit was forwarded to the component manufacturer in the United Kingdom (UK) for more detailed testing under the supervision of the UK Air Accident Investigation Branch.

The manufacturer's testing identified an insulation breakdown between the electrical connector pins and the No. 1 coil connector backshell⁴ in the MPU-to-PEC wiring harness (Figure 1). In addition, during disassembly, a previous reassembly anomaly was identified that was considered by the manufacturer's team to have been introduced during the operator's initial maintenance inspection. A number of manufacturing quality issues were also identified that the manufacturer stated would not have contributed to the occurrence.

The aircraft manufacturer has issued Service Letter DH8-400-SL-61-008A dated 7 May 2009, which outlined a software upgrade that will derive propeller RPM from the propeller gearbox when the magnetic pick-up unit signal is lost. This will negate the operation of the propeller at the overspeed governor setting of (1,068 RPM indicated) 104 % and should minimise the potential for nuisance overspeed triggers and subsequent in-flight shutdowns.

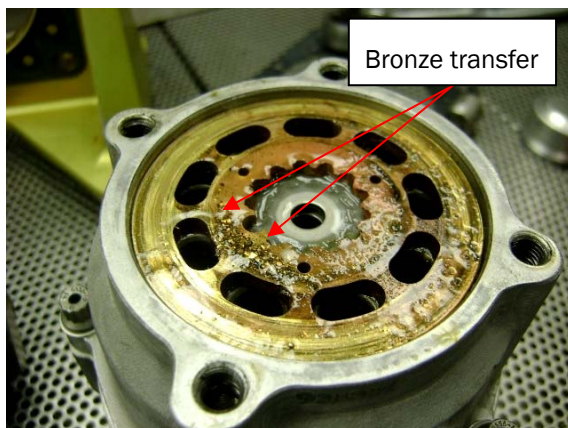
Figure 2: PTU with bronze transfer

- the hydraulic motor was in good condition with no signs of wear or damage
- there was damage to the hydraulic pump, including the failure of the pump:
 - barrel and port cap fluid bearing, with associated ‘bronze transfer’⁵ (Figure 2)
 - cam and piston subassembly (Figure 3), with resulting wear to the piston shoes and cam plate.

The manufacturer’s examination concluded that the PTU sustained an over-speed failure as a result of an air pocket forming at the pump inlet; a failure mode that had been observed previously on a number of other PTUs. The manufacturer indicated that a lack of No. 2 hydraulic system

reservoir pressure during PTU start up resulted in pump cavitations and an overspeed of the PTU.

The power transfer unit (PTU) manufacturer advised that the aircraft manufacturer was developing a modification to start the PTU before hydraulic reservoir pressure was lost. The revised autostart logic is planned to start the PTU upon failure of the right (No. 2) engine or of the respective engine-driven pump. The new PTU autostart logic was not available at the time of the occurrence.
