**ATSB TRANSPORT SAFETY REPORT**  
Occurrence Investigation Report AO-2008-043  
Final

**Collision with terrain  
10 km east of Cairns Aerodrome, Old  
Robinson Helicopter Company  
R44 Clipper II, VH-RYW**

**18 June 2008**

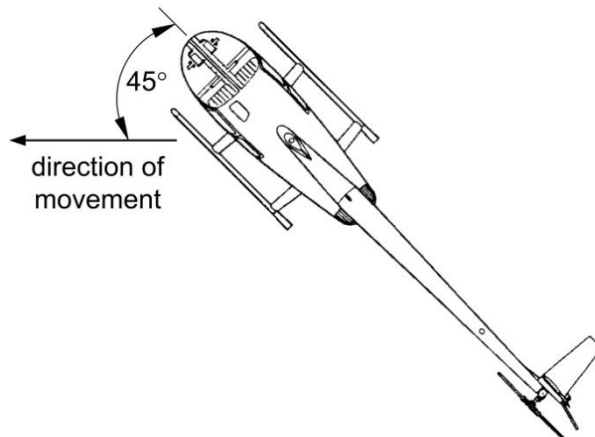
**Figure 3: Approximate movement of the helicopter during filming**

The passengers reported that, during the first period of filming, the helicopter began ‘wobbling’, ‘rocking’ and ‘swerving’, and that the pilot informed them that he needed to reposition the helicopter. The pilot advised the investigation that the helicopter was repositioned to facilitate the filming, and not due to any concern with the performance of the helicopter.

The passengers stated that, during the second period of filming, the movement of the helicopter appeared to be affected in the same manner as experienced during the first period of filming. The passengers described that almost immediately after that movement, there was a sudden, violent movement of the nose of the helicopter to the right, which developed into a rapid rotation of the helicopter in that direction.

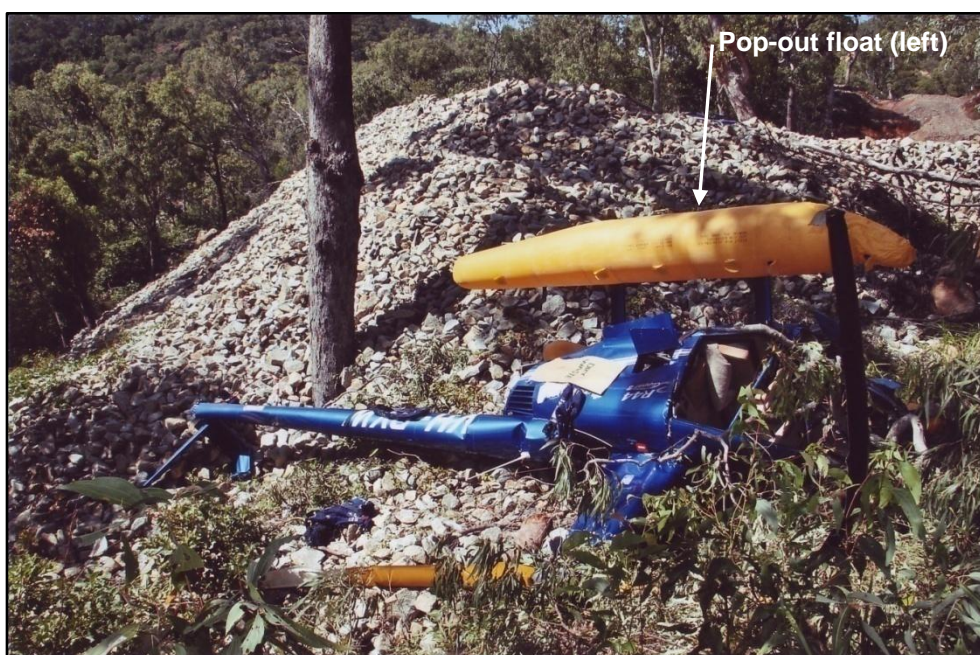
**Figure 4: Accident site and wreckage**

The helicopter collided with trees and came to rest on its right side and the helicopter's pop-out floats activated during the impact sequence (Figure 4). The two rear-seat passengers received minor injuries and were able to extricate themselves from the helicopter. They then assisted the pilot and front-seat passenger, both of whom were seriously injured, to exit the helicopter.

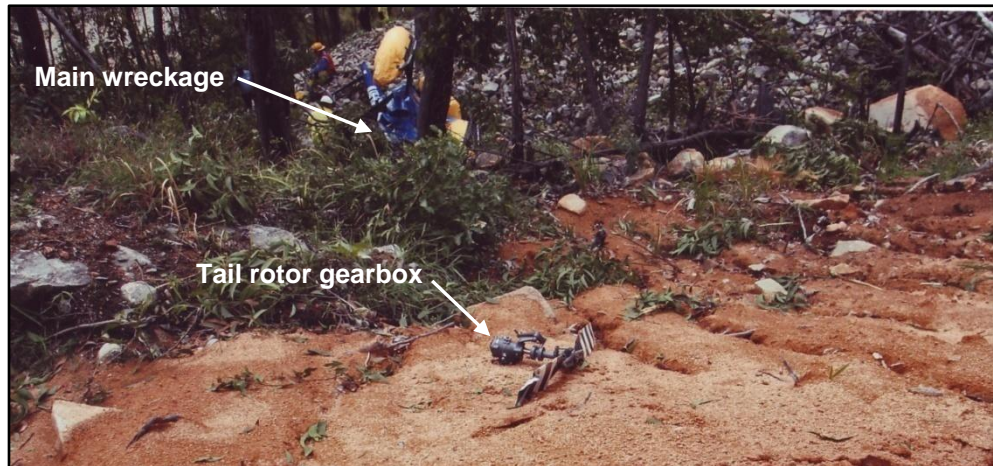
**Figure 5: Detached tail rotor and gearbox**

The accident occurred over sloping, timbered terrain adjacent to a road associated with the development site. The elevation of the accident site was about 180 ft. The helicopter initially contacted a number of trees while rotating to the right, before impacting the ground in a nose-low attitude and coming to rest on its right side with the engine still running. The tail rotor and associated gearbox were located a short distance away from the main wreckage (Figure 5).

The tail rotor blades and gearbox, and sections of the tail boom, tail rotor driveshaft and tail rotor pitch change rod were forwarded to the Australian Transport Safety Bureau (ATSB) for technical examination.

The damage to the tail rotor assembly was determined to have been associated with the contact with trees and the subsequent ground impact. No pre-existing mechanical damage or pre-impact defects to any of the components examined were identified that could have contributed to the accident.
