ATSB TRANSPORT SAFETY REPORT
Occurrence Investigation Report AO-2008-062
Final

Collision with terrain
6 km NE Purnululu ALA, Western Australia
14 September 2008
VH-RIO
Robinson Helicopter Company R44 Raven

Aviation Occurrence Investigation
AO-2008-062
Final

**Collision with terrain
6 km NE of Purnululu ALA, Western
Australia
14 September 2008
VH-RIO
Robinson Helicopter Company R44 Raven**

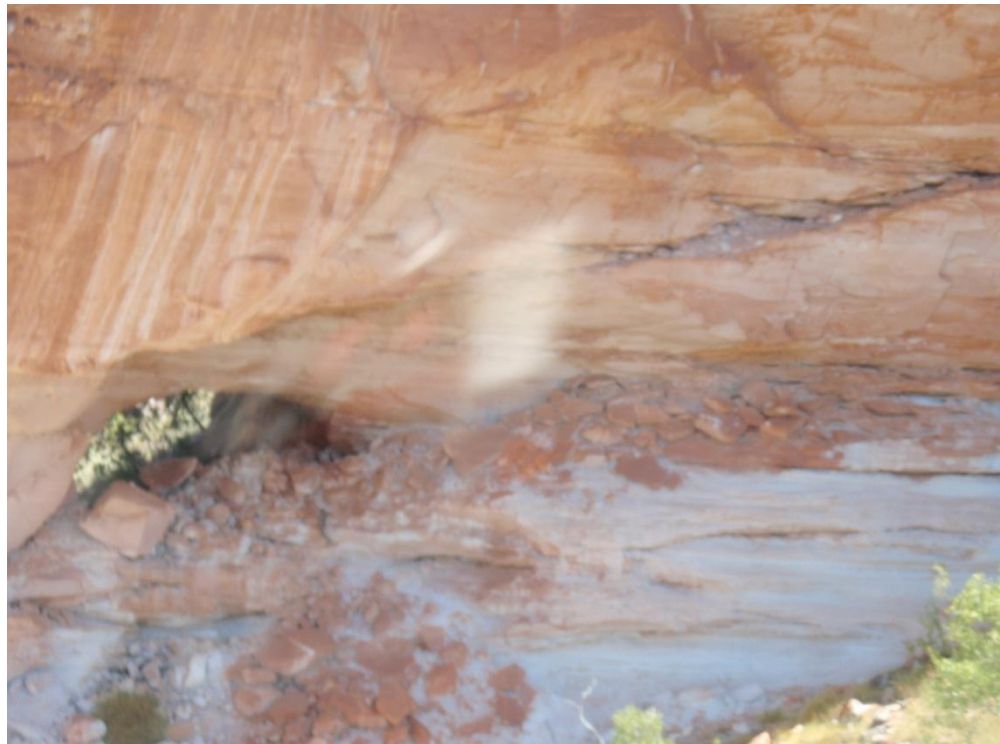
Figure 5: Last image recovered from camera

The last image recovered was taken close to overhead the accident site (Figure 5). Based on the recorded focal length of 16 mm, and the camera's image sensor size, it was estimated that the helicopter was about 80 m from the rock face when the image was taken. At that position, the helicopter would have been about 100 ft above the level of the accident site.

The position and height of the helicopter as derived from the last on board photographic image, in conjunction with the lack of forward speed evident at the accident site, was consistent with the helicopter being at or approaching a hover prior to the accident. The degree of impact damage to the helicopter was consistent with a high rate of descent as a consequence of low main rotor RPM. This analysis will examine how that condition could have developed during hovering flight, and highlights some operational safety considerations.

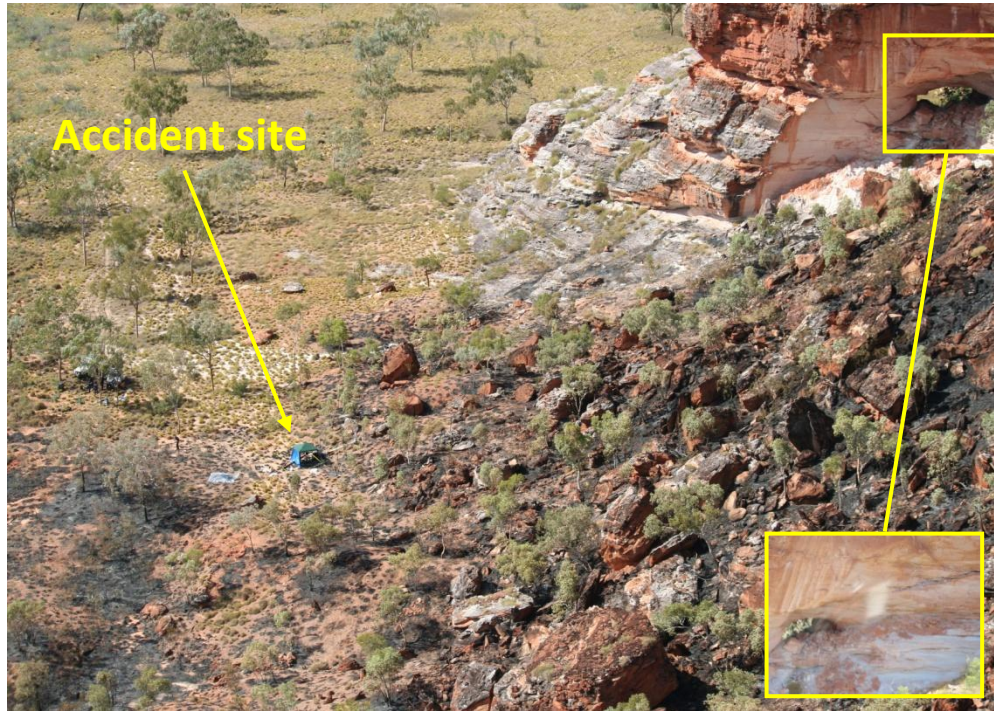
Figure 6: Accident site looking south (the inset is Figure 5)¹²

The wreckage of the helicopter was located on a relatively flat, stony and sandy site at the base of a rocky area that sloped upwards towards high, steep terrain (Figure 6). The helicopter was seriously damaged by the impact with the ground and post-impact fire that spread in a north-easterly direction from the accident site,

suggesting a locally south-westerly wind at that time. All of the critical helicopter components were accounted for at the site.

Damage to the engine firewall and skids showed that the helicopter impacted the ground generally upright, in a right skid-low attitude and with high vertical velocity. The absence of surface or vegetation disturbance in the vicinity of the wreckage indicated little or no forward speed at impact. Fire damage allowed the helicopter to subside onto its right side.

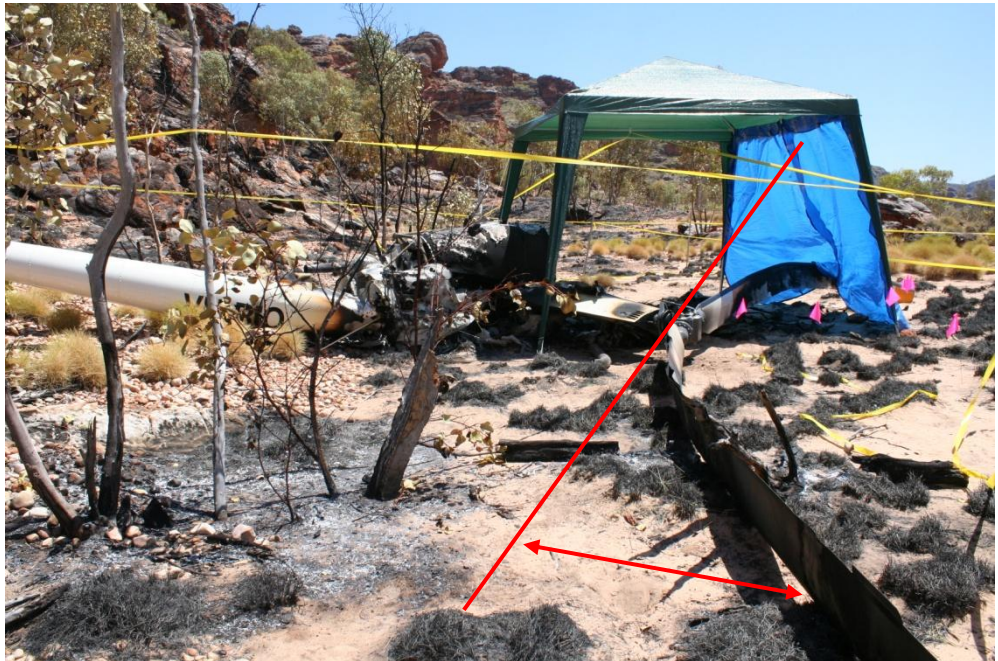
Figure 7: Main rotor blade coning (reference lines in red added)

The main rotor blades were securely attached to the hub, which remained connected to the mast. One of the main rotor blades had in-plane rearward bending at the tip, but otherwise there was little impact damage to either blade. There was also no sign of pre-impact delamination of either blade's surface. Both main rotor blades were curved upwards consistent with coning¹³ (Figure 7). The main rotor blades had not contacted the helicopter's tail boom or cabin. Overall, the main rotor blades displayed low rotational energy at ground impact.
