**ATSB TRANSPORT SAFETY REPORT**  
Aviation Occurrence Investigation  
AO-2008-064  
Final

**Stickshaker activation**  
**Boeing 717-200, VH-NXE**  
**Alice Springs, NT**  
**18 September 2008**

Stickshaker activation – Boeing 717-200, VH-NXE, Alice Springs, NT, 18 September 2008

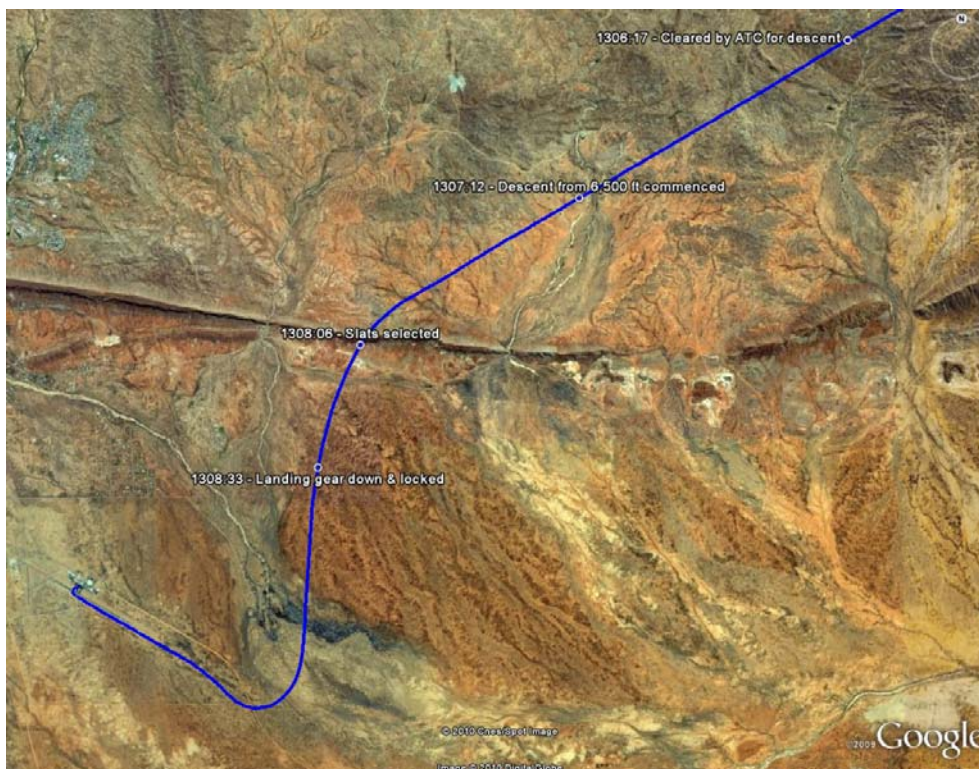
**Figure 1: Initial approach track**

The PIC recounted that due to being high on profile, he disconnected the autothrottle<sup>7</sup> and reduced engine thrust. The recorded N1<sup>8</sup> correspondingly reduced from 66% to 28% and the aircraft's spoilers<sup>9</sup> were deployed for 45 seconds. The PIC's recollection was that at some point, PROF<sup>10</sup> was selected on the FCP, which should have reengaged the autothrottle.

At 1307:50, when the aircraft was approaching 7 DME (13 km), ATC cleared the flight crew to track direct to a right base position for runway 30. The recorded data showed that at about that time, the aircraft was passing 4,500 ft (2,700 ft AAL) and the aircraft's speed was 272 kts computed airspeed<sup>11</sup> (CAS) and 292 kts groundspeed.

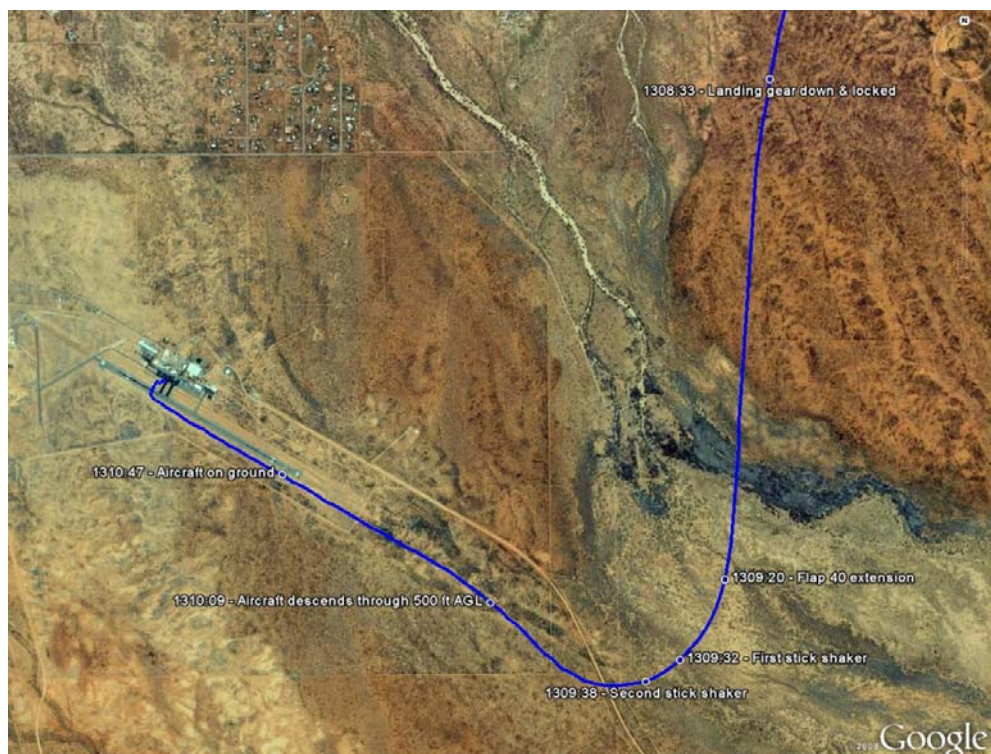
**Figure 2: Final approach track**

By 1309:04, the aircraft was established on the direct track to the final intercept position at 183 kts CAS, 210 kts groundspeed and passing 3,000 ft (1,200 ft AAL). The copilot set up the runway track on the FMS to assist the PIC's orientation.

At 1309:20, FLAP 40 (full flap) had finished extending and the PIC initiated a right turn to intercept the final approach track. The aircraft was passing 2,800 ft and the speed was 157 kts CAS and 180 kts groundspeed. The recorded bank angle varied between 26° and 29°. During the turn, the PIC was looking outside to maintain visual contact with the runway and the copilot was performing some of the pre-landing checklist actions.

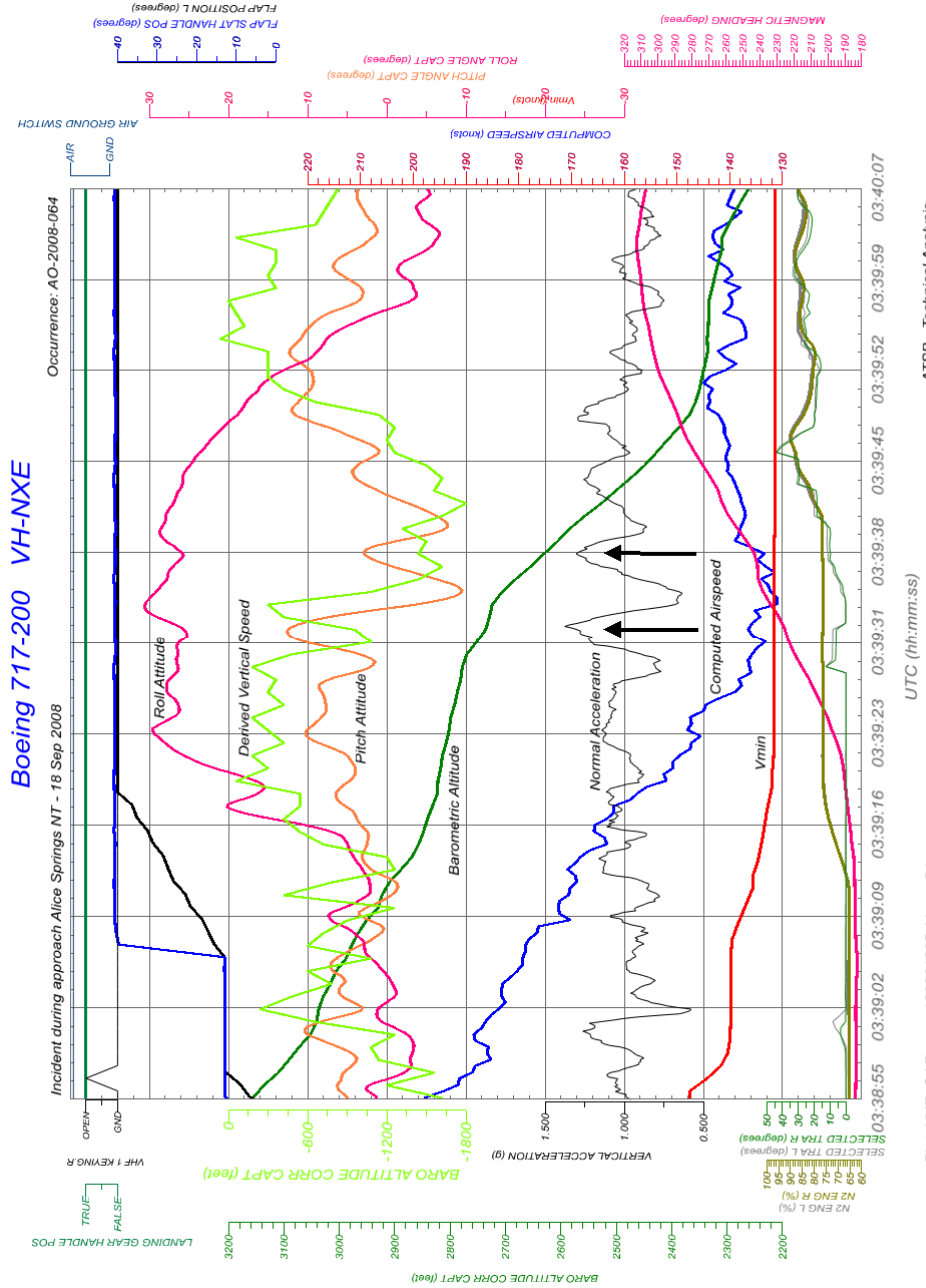
# APPENDIX A: DATA PLOT

Analysis of the recorded data showed that at 1309:32, the stickshaker activated as the aircraft was passing 950 ft AAL on a heading of 223° magnetic (M) with a recorded bank angle of 28° and airspeed of 135 kts. Following the stickshaker activation, the recorded pitch angle decreased from an average 6° to -4° with no immediate recorded throttle movement and no increase in the N1 value, which was then about 36%. At 1309:35, the airspeed had reduced to a recorded value of 131 kts with a bank angle of 30°.

The flight crew reported that shortly after the first stickshaker activation, the stickshaker momentarily activated again. Correspondingly, the data showed that at 1309:38, the stickshaker activated again as the aircraft was passing 850 ft AAL with a recorded bank angle of 27° and airspeed of 134 kts. The recorded pitch angle was 0° and the rate of descent was 1,800 ft/min. The nose was lowered again and the recorded airspeed increased to vary between 140 and 145 kts. Shortly after, the recorded throttle position increased and N1 reached a high of about 76%.
