ATSB TRANSPORT SAFETY REPORT
Aviation Occurrence Investigation
AO-2008-065
Final

Collision with terrain
Luddenham, New South Wales
24 September 2008
VH-CZX
Liberty Aerospace Incorporated XL2

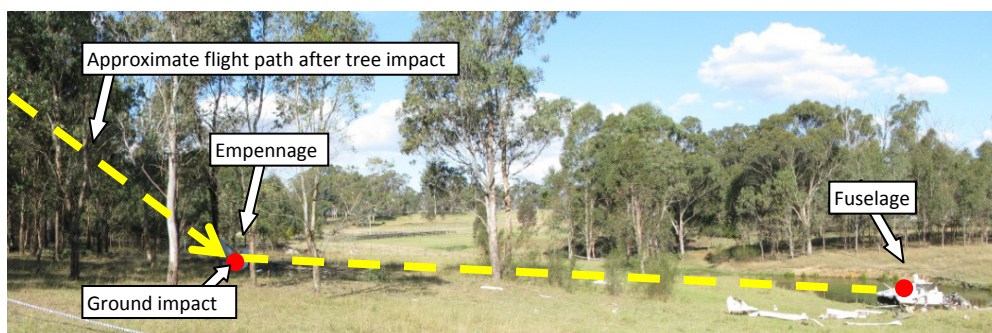
Figure 2: Accident site

The evidence at the accident site was consistent with a descent at low forward speed, in a direction of about 190° magnetic. The aircraft initially struck four small trees, separating the outer section of the right wing. The aircraft then descended steeply and struck a larger tree immediately before impacting the ground in a right wing-low attitude. The empennage and wings separated from the fuselage and the aircraft came to rest next to a small dam, 52 m from the first tree strike (Figure 2).

All major parts of the aircraft were accounted for at the accident site and the continuity of all flight controls was established. There was no evidence of a bird or wirestrike, or in-flight fire.

The left wing sustained crush damage consistent with tree impacts at an angle of bank of about 30° right wing low. There was no evidence of excess G-loading⁸ on the aircraft.
