Collision with terrain

VH-CZX Liberty Aerospace XL2

Luddenham, NSW

24 September 2008

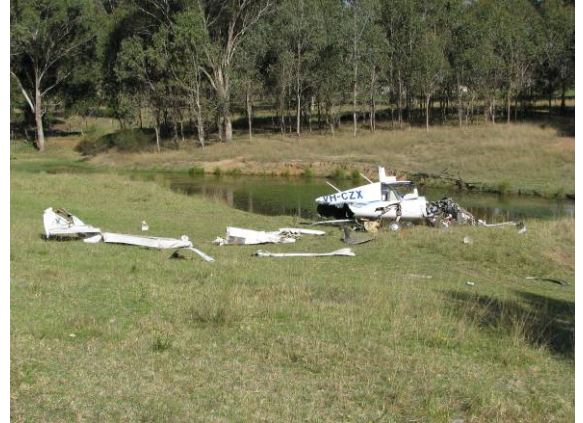
Figure 2: Accident site

The aircraft descended at about 40 degrees from the horizontal, in a direction of about 190 degrees (magnetic). It struck four small trees, travelled for about 18 metres and struck a larger tree, before impacting the ground about 5 metres from the base of that tree.

The empennage and wings separated from the fuselage and the aircraft came to rest next to a small dam, 52 metres from the first tree strike (Figure 2). The outer section of the right wing separated from the aircraft at an early stage in the impact sequence and was found 17 metres away from the fuselage. The left wing and inner section of the right wing came to rest about 7 metres from the fuselage. The inner section of the right wing sustained significant leading edge crush damage. The left wing sustained crush damage to the outer section consistent with tree impact. The nose section and cockpit were substantially damaged and the engine had partially separated from the fuselage.

Evidence of propeller strikes was found on fallen tree branches, and a large section of one propeller blade was found in a tree 40 metres to the right of the direction of aircraft travel, abeam the location of the ground impact.
