ATSB TRANSPORT SAFETY REPORT
Aviation Occurrence Investigation AO-2008-067
Final

Total power loss
Talbot Bay, Western Australia
25 September 2008
VH-NSH
Bell Helicopter Co 407

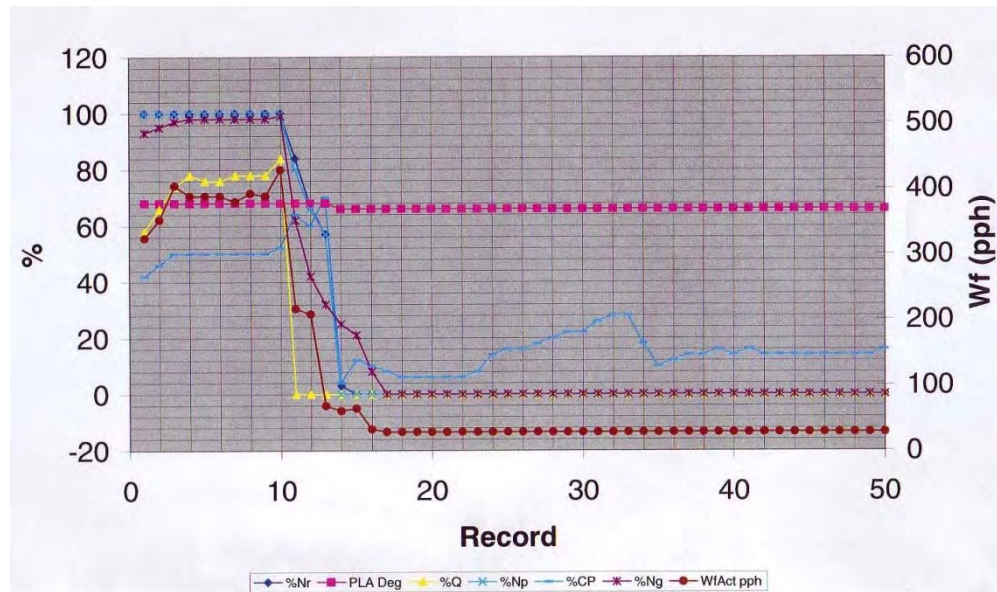
The ECU was recovered and forwarded to the component manufacturer for possible download. Although water damaged, an automatically-recorded 'snapshot' of the last few seconds of engine operation was recovered.

Figure 3: Graphical representation of the recorded ECU data

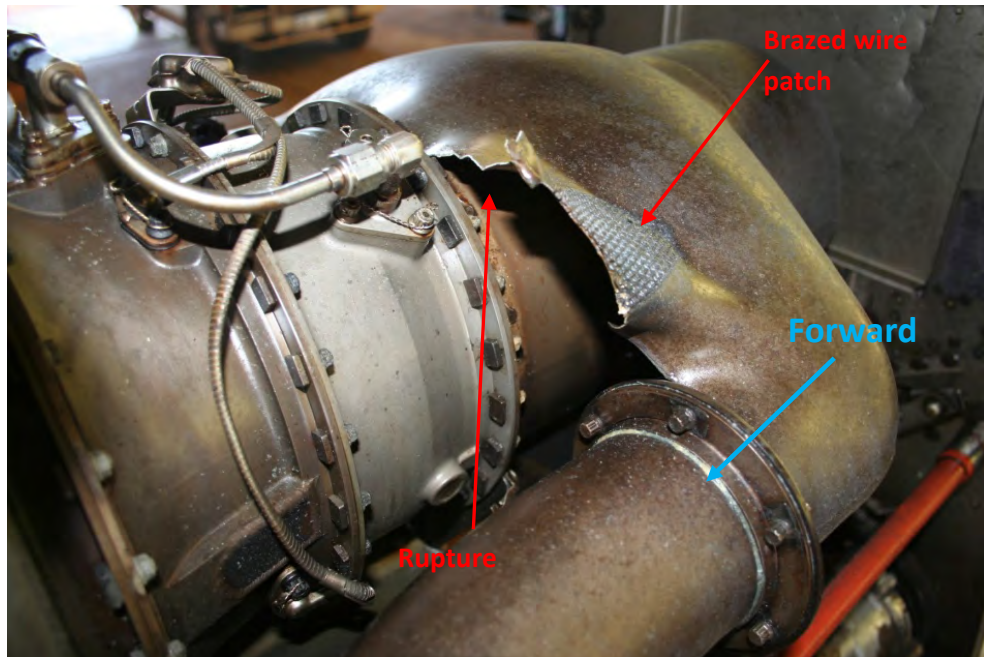
During the workshop examination, the engine was found to be intact; however, it was extensively corroded throughout from the salt water immersion. That corrosion had seized the engine's rotating parts. In addition, there was a significant 'rupture' failure of the combustion case in the area of the horizontal weld in the left 'armpit' region of the casing (Figure 4). The rupture passed through the approximate centre of a brazed wire patch on the left armpit, and a crack was located in a similar location in the right armpit region.

Figure 4: Ruptured combustion case in-situ

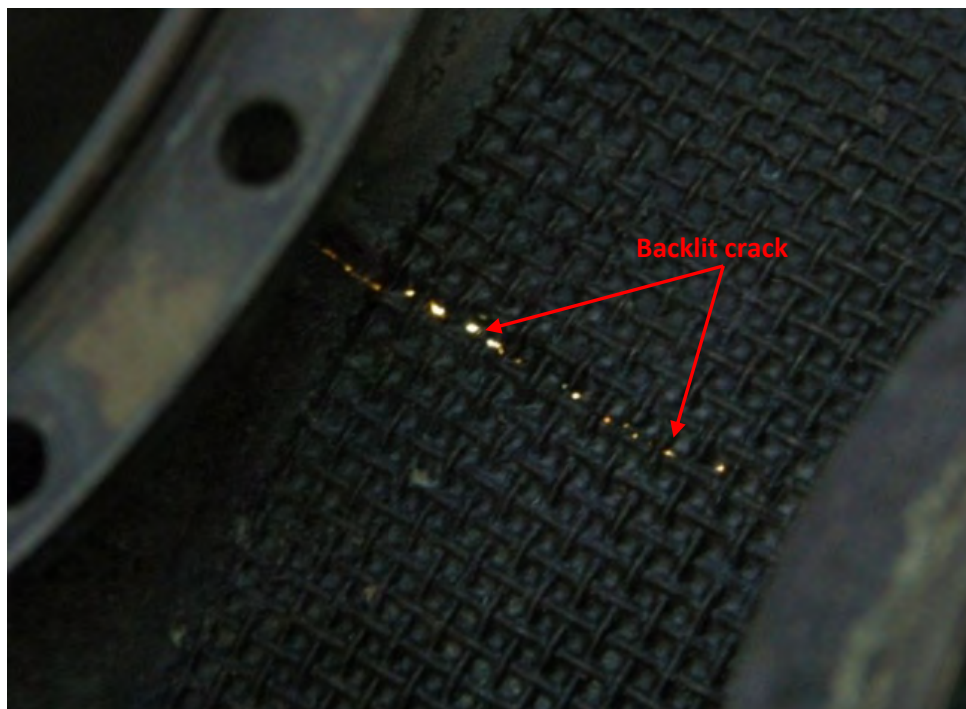
A similar fatigue crack, of 51 mm in length, extended through the brazed wire patch on the right armpit (Figure 5). The manufacturer estimated a power loss as a result of such a crack of about 1%, which the manufacturer considered would probably not be detected during the daily power assurance checks¹¹.

Figure 5: Crack through the brazed wire patch on the right armpit (backlit to indicate extent)

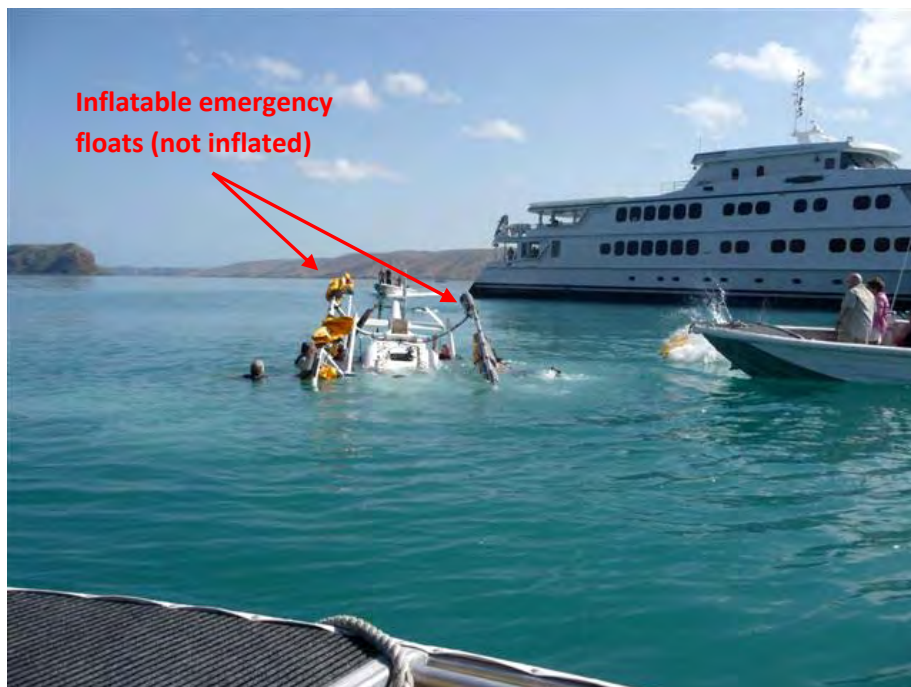
The pilot indicated that he armed the helicopter's emergency floatation system prior to the power loss. The pilot stated that, in this case, the rapidity of the ditching following the power loss did not allow sufficient time for their activation prior to the helicopter making contact with the water. Once out of the helicopter, he considered re-entering the helicopter to inflate the floats; however, he was discouraged from this course of action by one of the ship's crew.

Figure 6: Underside of the helicopter, floats not inflated

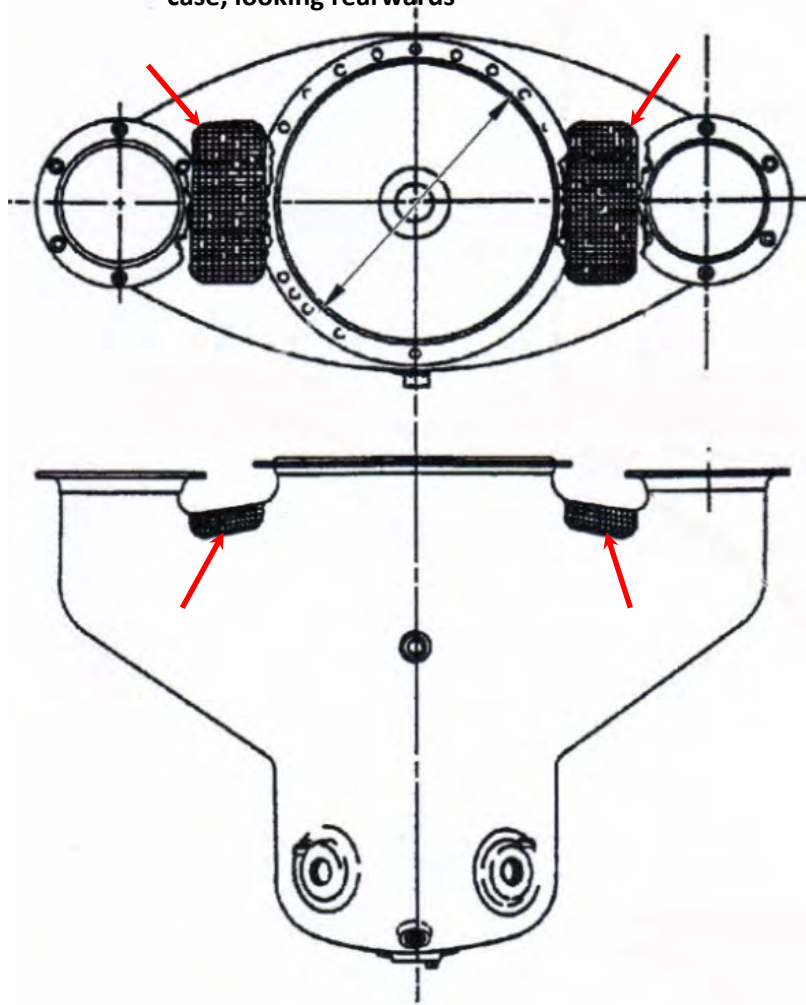
During their investigation of this occurrence, the manufacturer carried out computerised finite element analysis¹⁷ on the combustion case design with the brazed wire patches installed. That analysis found that the existing patches did not satisfactorily cover the peak stress areas in the combustion case armpits, due to the size of the patch and the relative location of the peak stresses in the armpit.

The reinforcing wire patches were attached onto the outer surface of the left and right armpit areas of the combustion case, reinforcing that area and preventing further cracking (Figure 8). Those patches have been an integral part of the RR 250 series engine combustion case since that time.

Figure 8: Manufacturer's drawing showing the brazed wire patches in the armpit areas of the combustion case (arrowed in red)

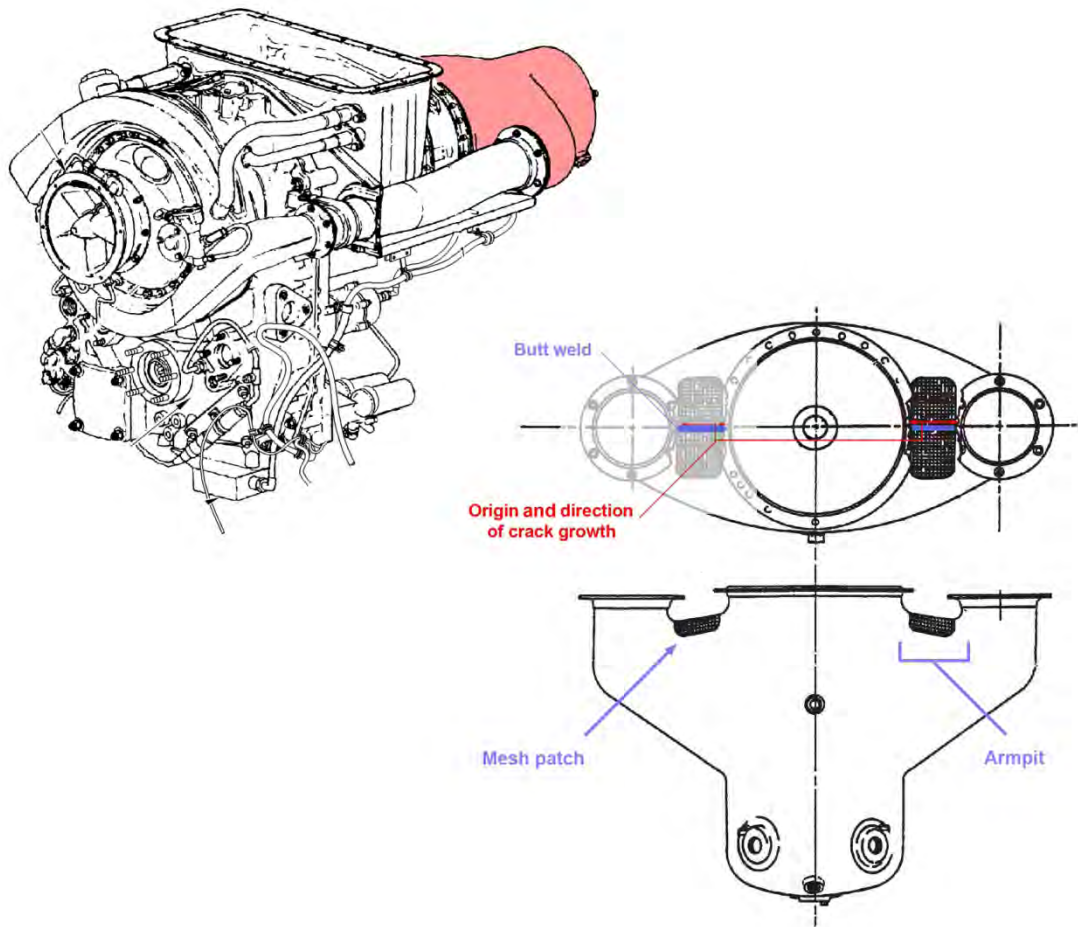
Figure A5: Diagram of the 250-47B engine and the outer combustion case depicting the region of crack growth in relation to the butt weld and brazed mesh patch

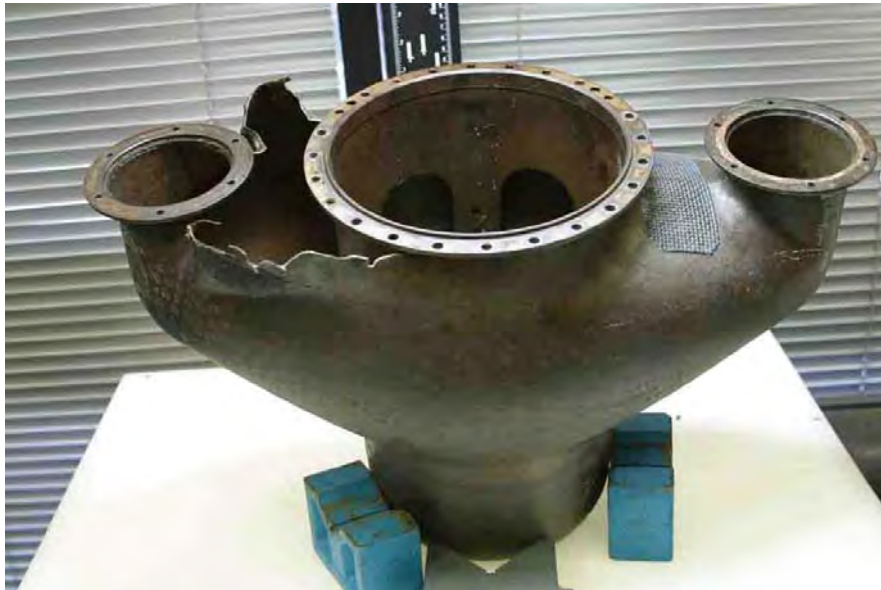
Figure A6: The ruptured outer combustion case (part number 23030911, serial number 33701) as removed from the Rolls-Royce 250-47B engine

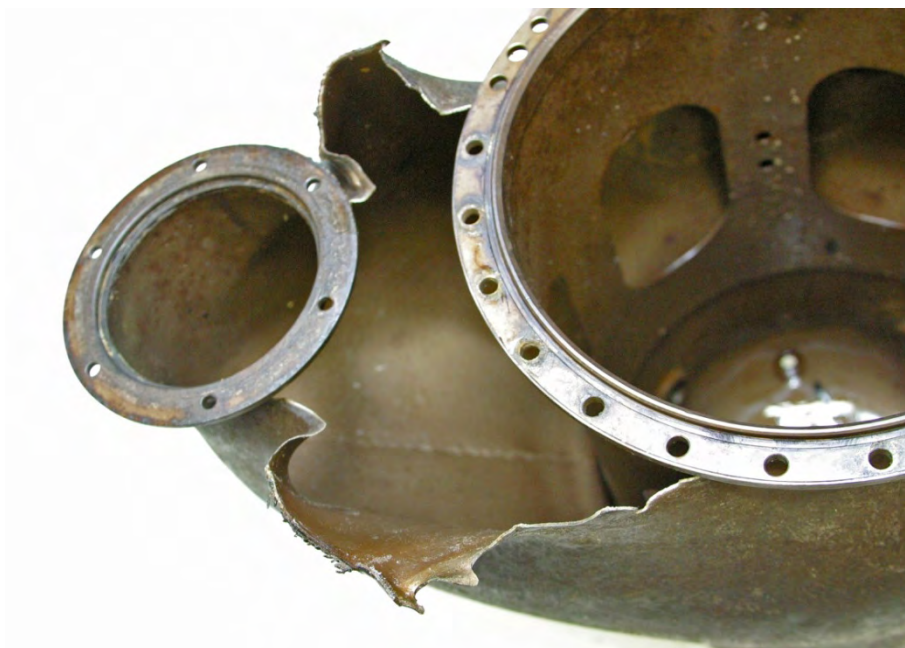
The primary point of failure was located on the left-side of the component between the flange of the air discharge tube and the gas producer. Known colloquially as the ‘armpit’ region, the thin-wall stainless steel skin at that location had cracked and then ruptured in an outward manner. A mesh patch that had been brazed onto the horizontally welded surface of the combustion case had also fractured along with the case material. The crack path was observed to follow the horizontal weld between the air discharge tube and the gas producer.

Figure A7: The primary point of failure in the left-side 'armpit' region

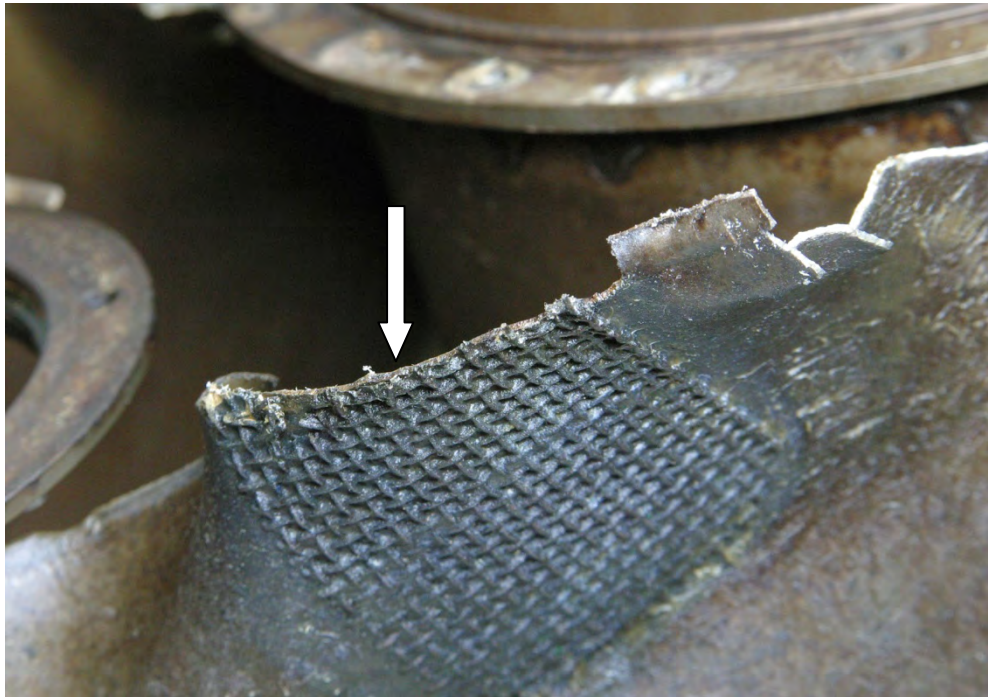
Figure A8: Close view of the primary fracture in relation to the mesh patch

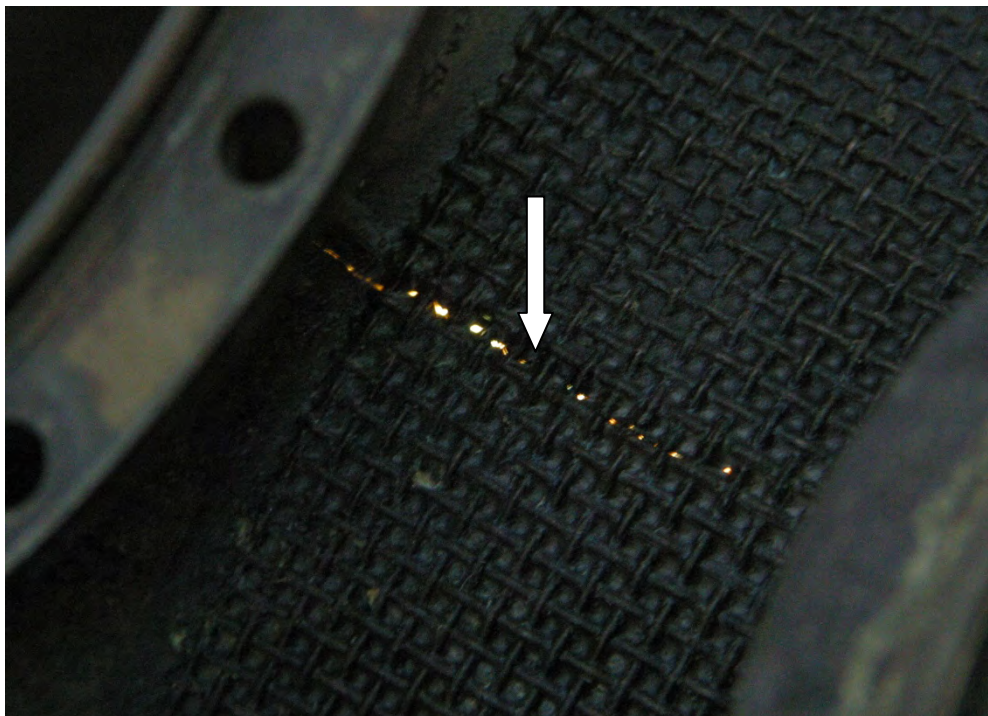
Figure A9: View of cracking through the mesh region in the right-side 'armpit' (arrowed)

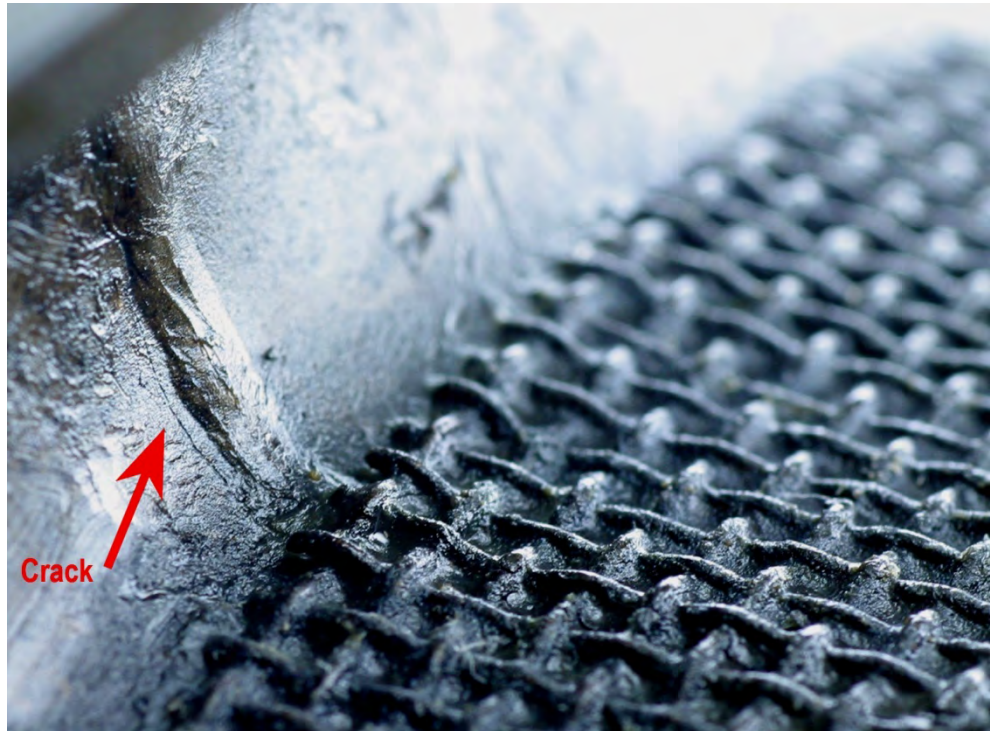
Figure A10: Close view of the right-side ‘armpit’ crack, as shown in Figure A5

through the mesh and along the horizontal weld in the same manner as the left-side rupture. Measurements indicated a total fatigue crack length of 51 mm.

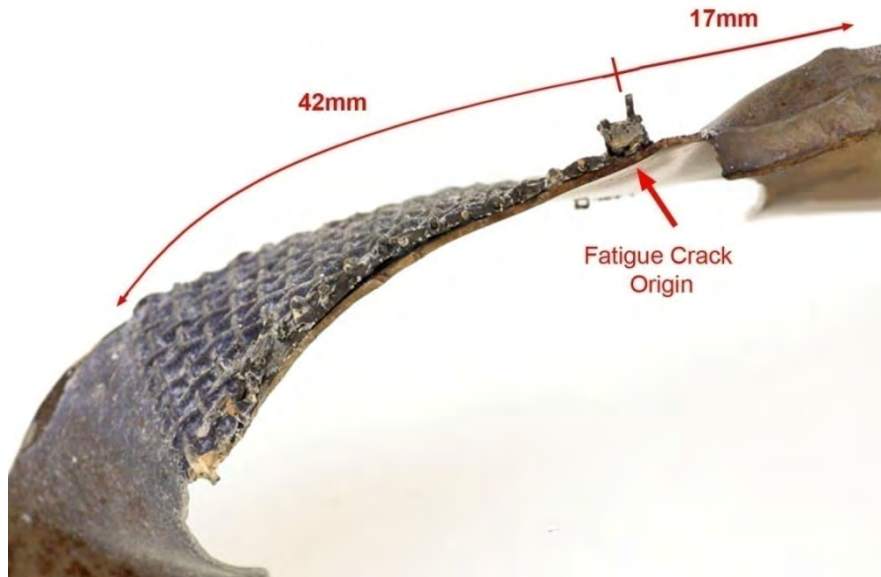
Figure A11: The primary fracture noting the fatigue crack origin (labelled)

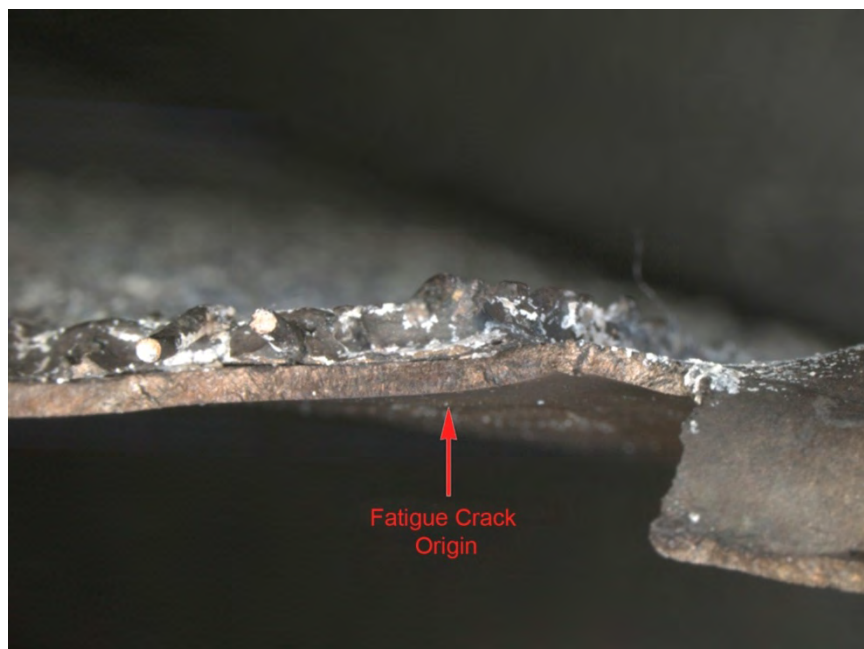
Figure A12: Close-up of the primary fracture surface showing the fatigue crack origin

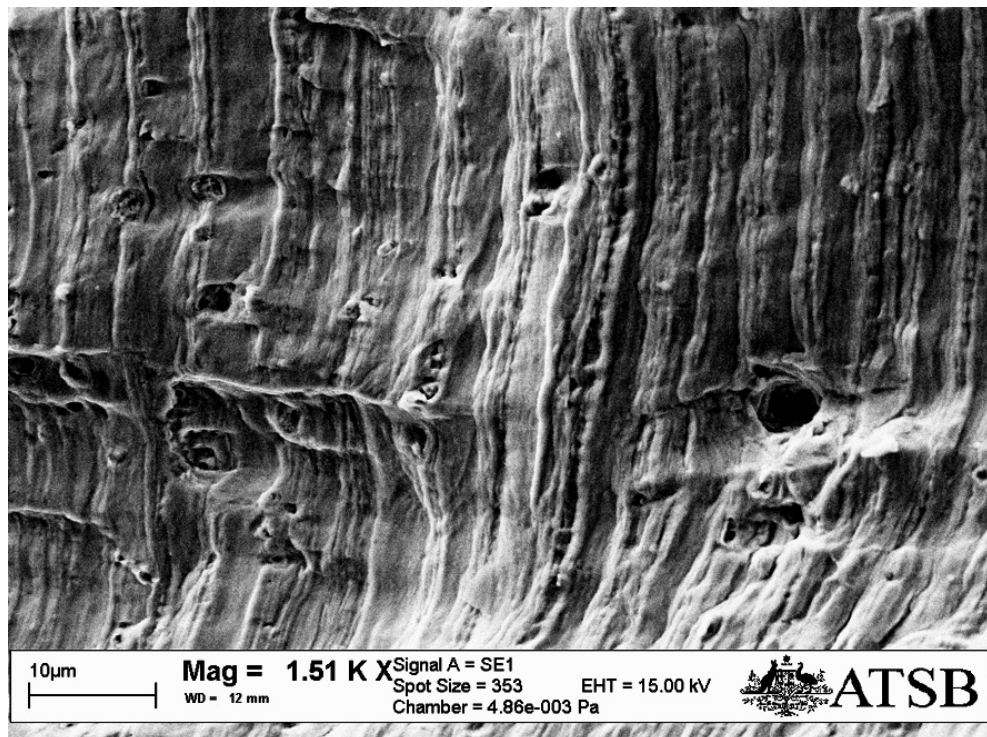
Figure A13: High magnification SEM image showing closely spaced progression markings on the rupture fracture surface

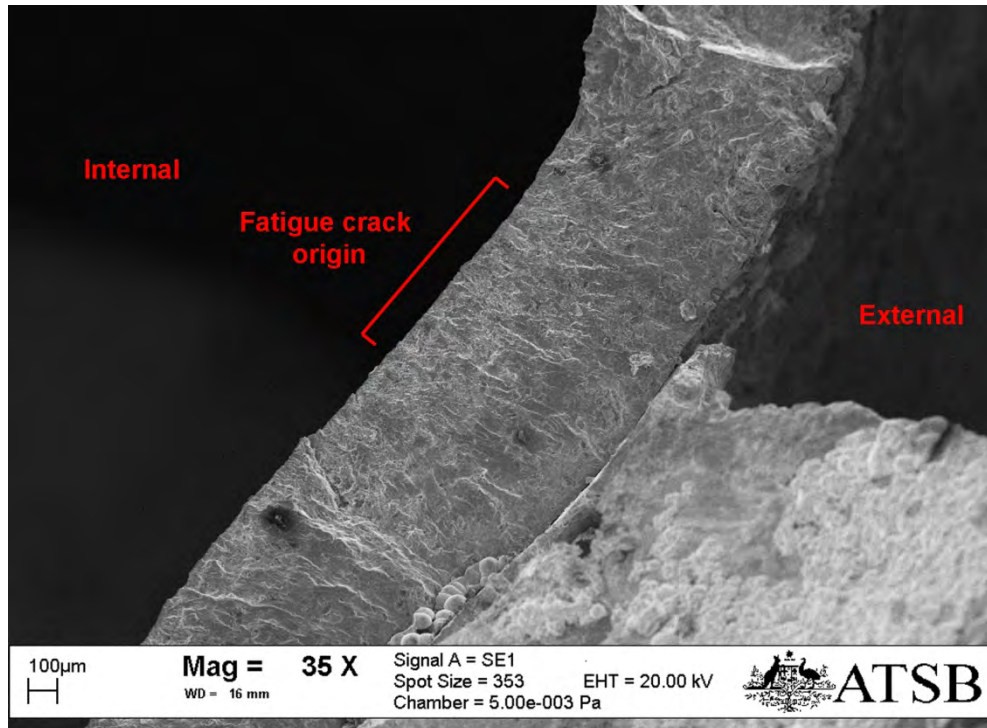
Figure A14: Low magnification SEM image of the fatigue origin (labelled)

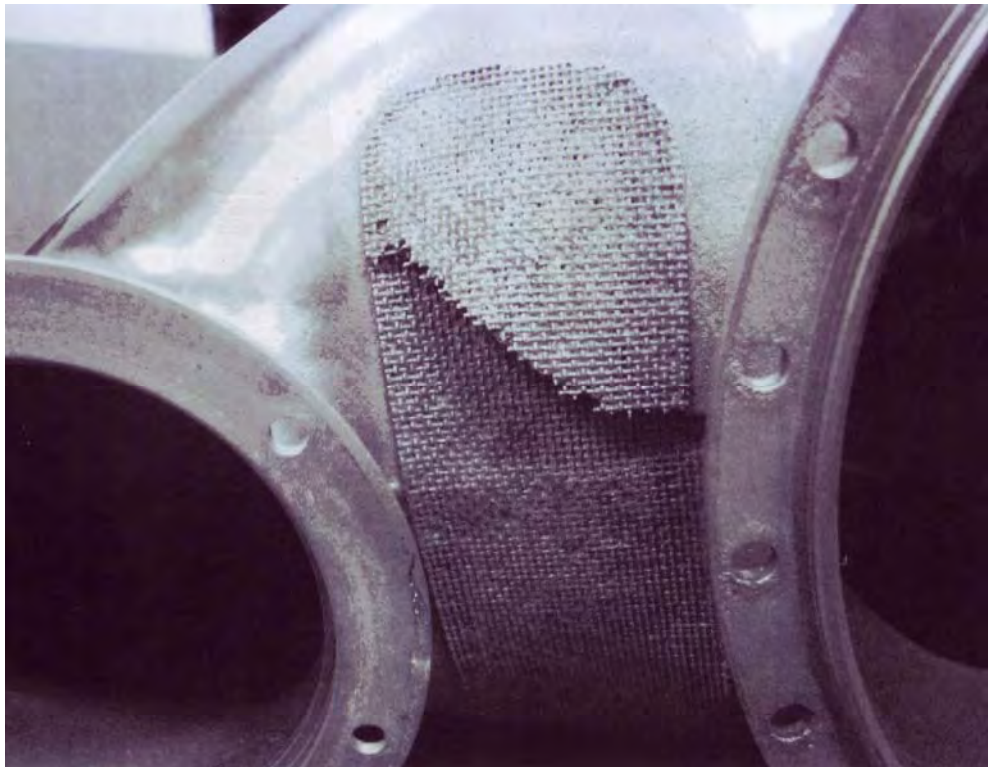
Figure A15: The ruptured outer combustion case from the Bell 206L4 helicopter

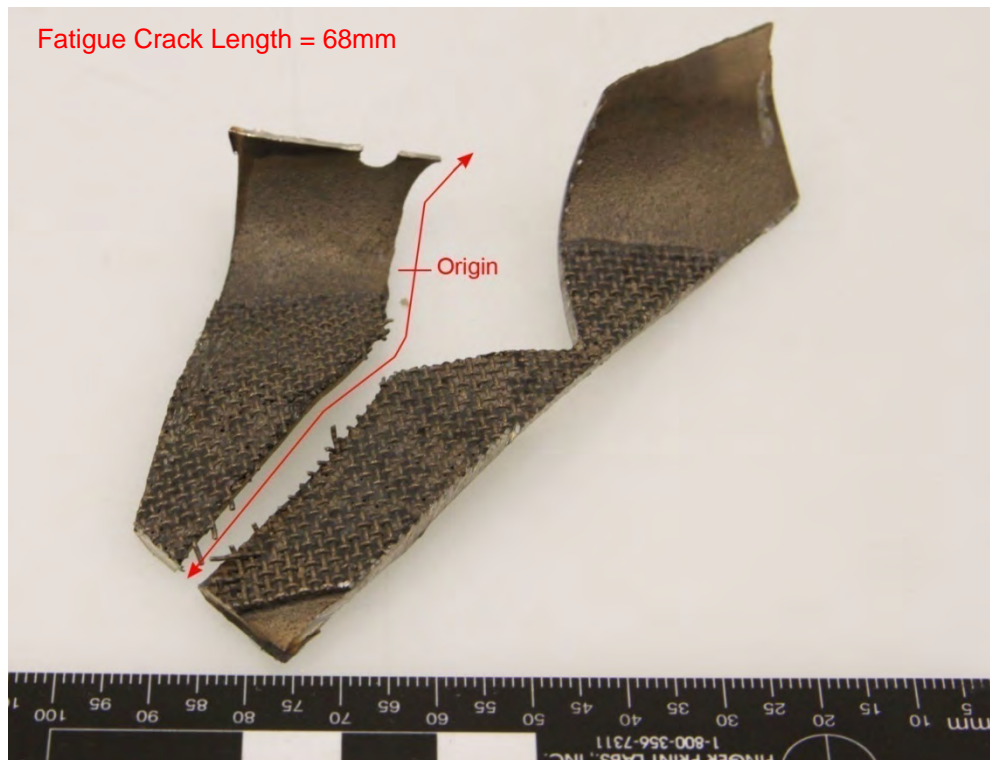
Figure A16: Section from the ruptured left-side 'armpit', as received

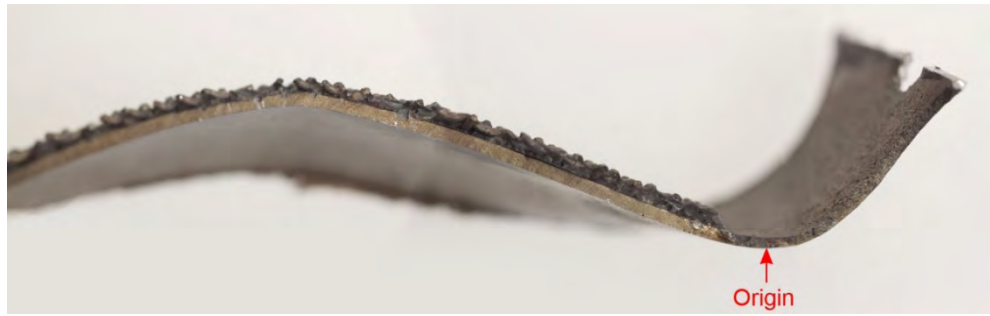
Figure A17: Fracture surface from the ruptured left-side 'armpit' region showing the origin of fatigue crack growth

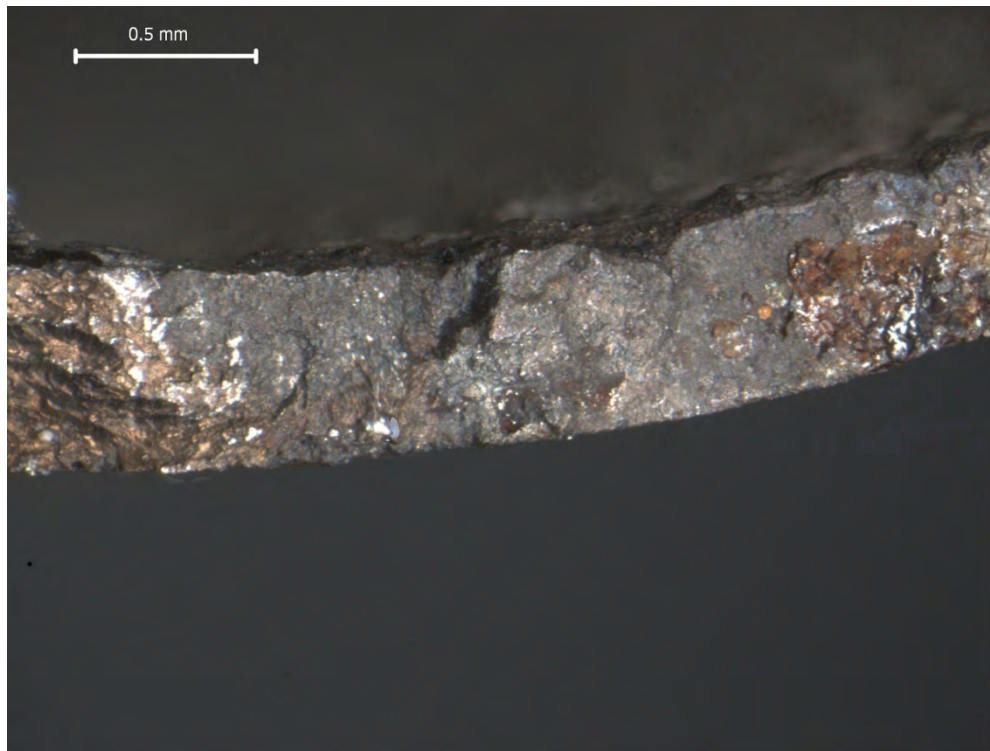
Figure A18: Heavily corroded and oxidised fatigue crack origin from the left-side 'armpit'

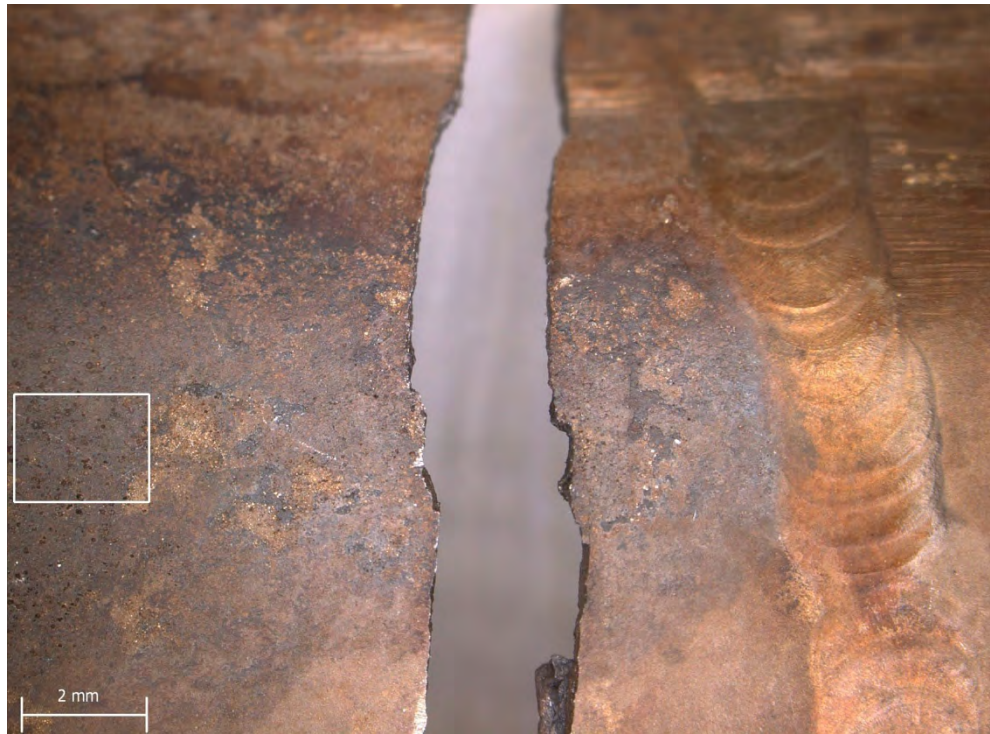
- Fatigue crack initiation in both 'armpits' may have been related to either internal surface corrosion damage that had developed during service, or from the shot-peening process that had been employed prior to brazing of the mesh patches. Due to the level of surface oxidation on the fracture surfaces, it could not be specifically established whether the external peening or the internal corrosion damage had contributed to the initiation of cyclic fatigue cracking in the component.

Figure A19: The internal surfaces of each 'armpit' contained similar levels of corrosion damage close to the fatigue crack origins

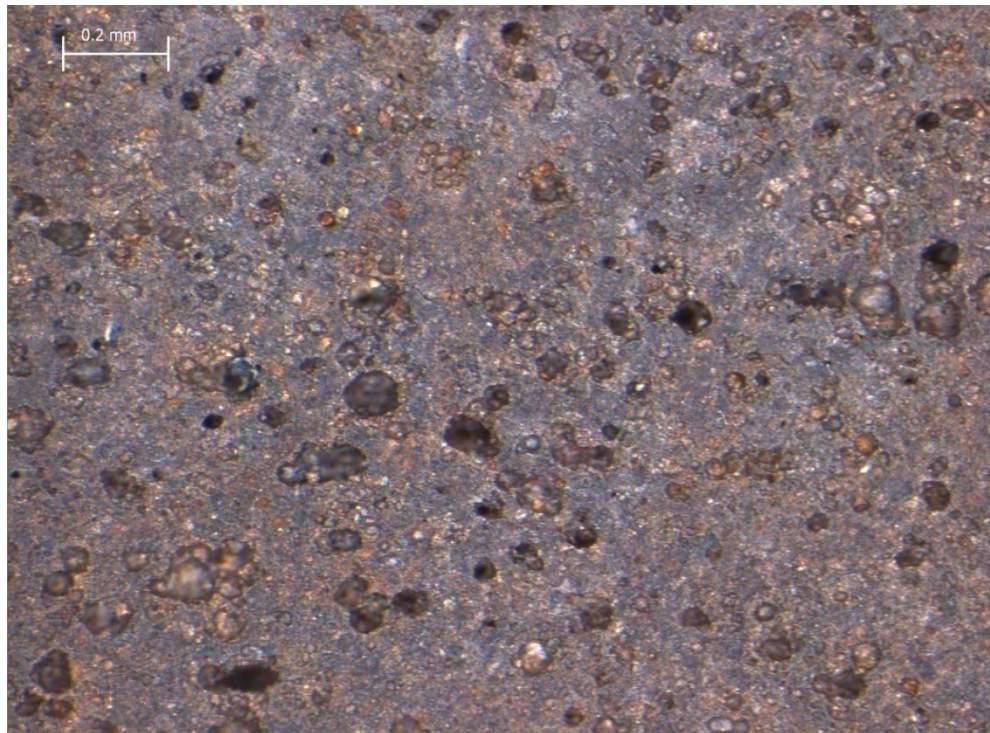
Figure A20: Close-up of the pitted surface, as highlighted in Figure A15

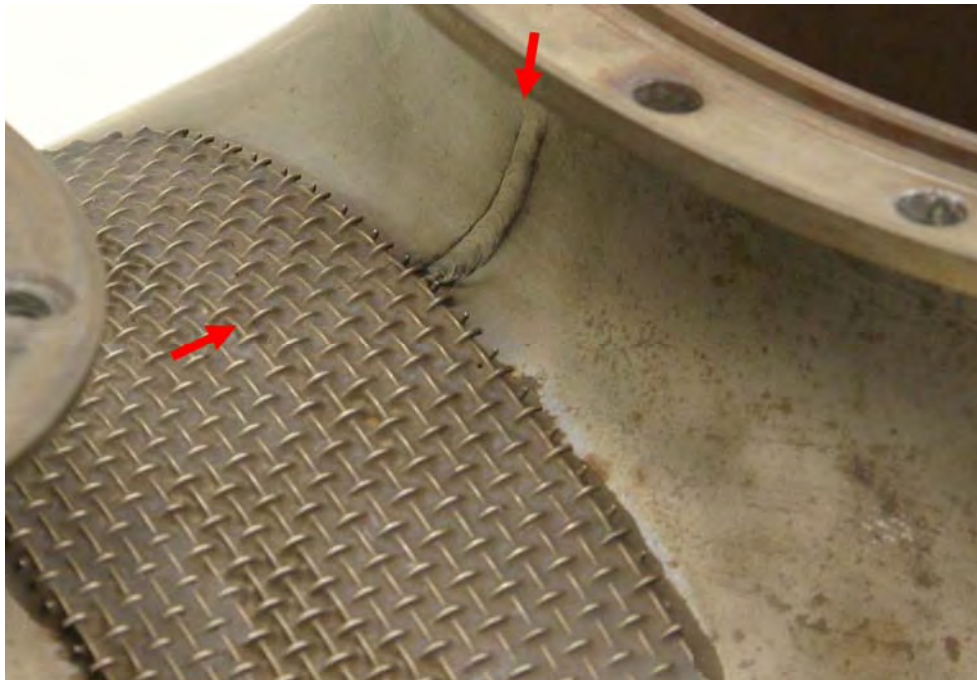
During the course of the VH-NSH investigation, the ATSB was notified that a twin-engine Sikorsky S-76A helicopter, registered VH-XHS, had also been found with a crack in the outer combustion chamber of one of its Rolls Royce 250-C30 engines. The defect was found by the operator's maintenance personnel shortly after the publication of a Civil Aviation Safety Authority (CASA) Airworthiness Bulletin (AWB)²¹ that advised operators and maintainers of Rolls Royce 250-series engines to urgently inspect the combustion case 'armpit' region for cracking. The AWB was published by CASA as a safety response to the Talbot Bay in-flight engine failure involving VH-NSH. At the time of the inspection, the Sikorsky helicopter was on a vessel being transported by sea to Antarctica. It was reported by the Sikorsky operator that the 'armpit' crack had been visually identified using a torch to aid illumination.

The defective combustion chamber (part number 23030910, serial number 29462) was removed from the engine and submitted to the ATSB. Non-destructive, visual examination confirmed that a crack had developed in the 'armpit' region along the centre-line weld at a location identical to the cracks found on both the Bell 407 (VH-NSH) and the Bell 206L4 (P2-PBF) helicopters. Measurements indicated that the crack extended for approximately 28 mm along the weld and into the reinforcement brazed mesh patch. No corrosion or other such external surface damage was evident that might have otherwise contributed to the development of cracking in the component.

Figure A21: 'Armpit' cracking as observed in the combustion case from the Sikorsky S-76A (VH-XHS)

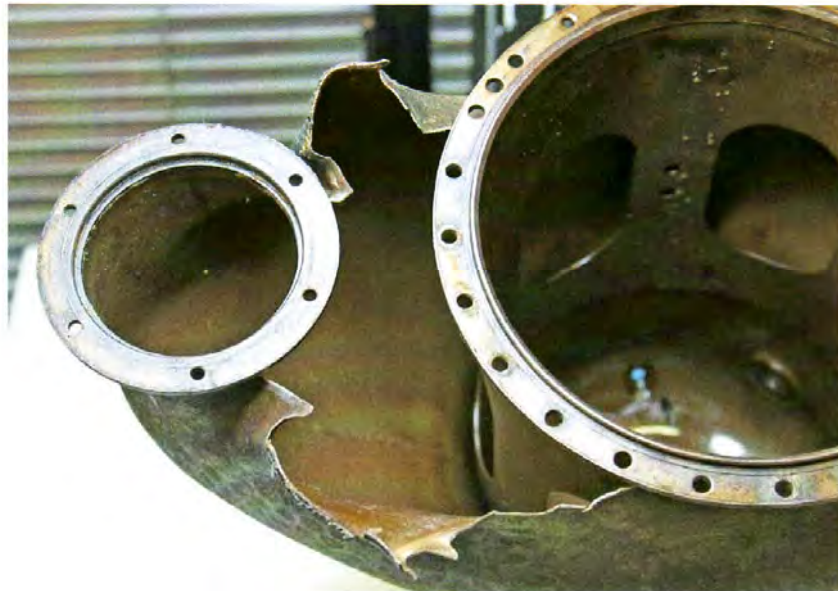
Figure 1.

The ATSB is currently conducting an investigation into the burst rupture of an OCC. See Figure 1, below. The rupture occurred immediately after take-off, resulting in the complete engine power loss. This resulted in the helicopter, a Bell 407, ditching.

RR 250 C47B OCC Rupture failure (RH Side).

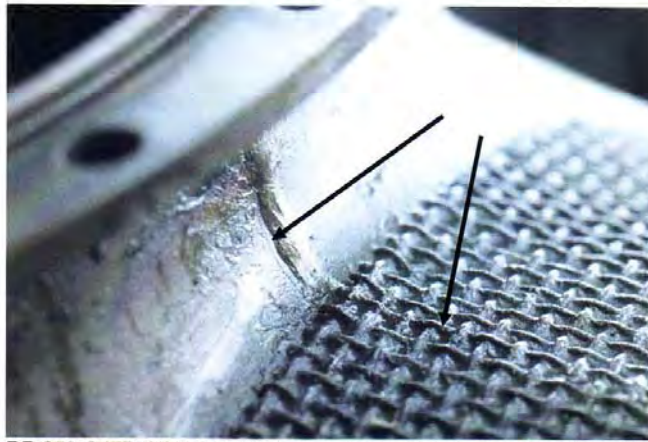
Figure 2.

RR 250 C47B OCC (LH side). Area of cracking, but on the other side of the duct shown in Figure 1.

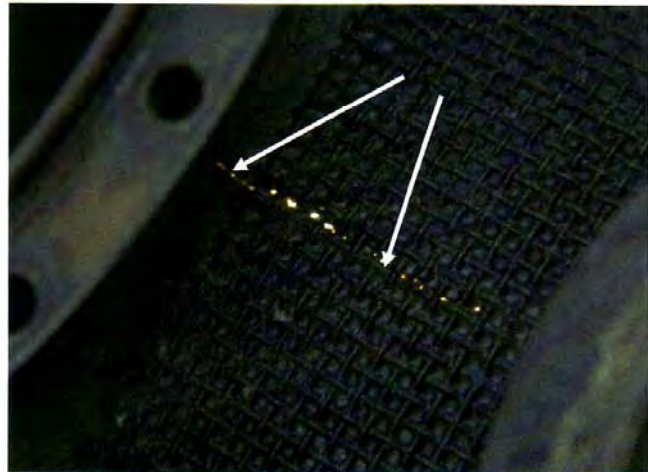
Figure 3.

RR 250 C47B OCC (LH side). Same area as in Figure 2, with a strong light placed inside the OCC, beneath the suspect area described in this AWB.
