**ATSB TRANSPORT SAFETY REPORT**  
Occurrence Investigation Report AO-2008-068  
Final

**Tail rotor pitch link failure  
near Hoxton Park Aerodrome, NSW  
19 September 2008  
VH-BUK  
Eurocopter AS350 BA**

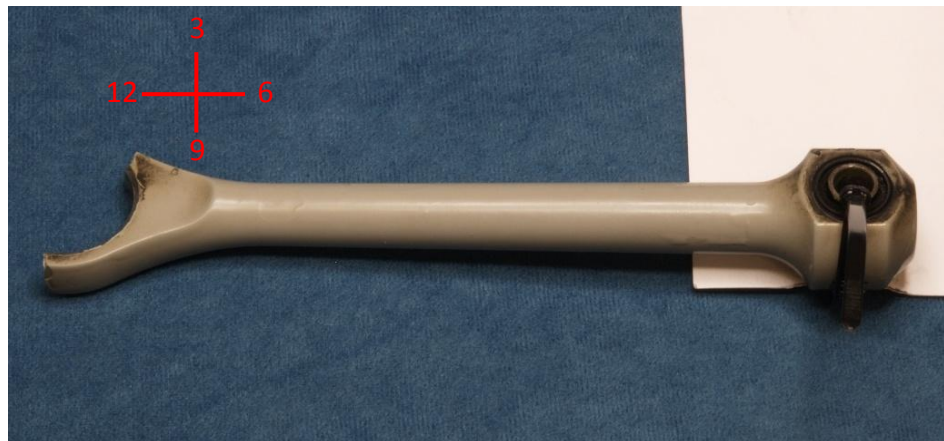
**Figure 3: Fractured pitch change link**

Figure 3 shows the failed pitch change link, with two clear fractures at approximately the 4 and 10 o'clock positions through the rod end.

The most likely reason for the failure of the pitch change link was as a result of progressive wear of the spherical bearing outside of the prescribed wear limits. Excessive play in the worn bearing resulted in a loading condition that originated a high cycle fatigue crack at one of the outside corners of the rod end and progressed through a majority of the section before failure. A second fatigue crack then originated on the interior surface of the rod end and progressed a short distance before the remaining material failed through overstress.

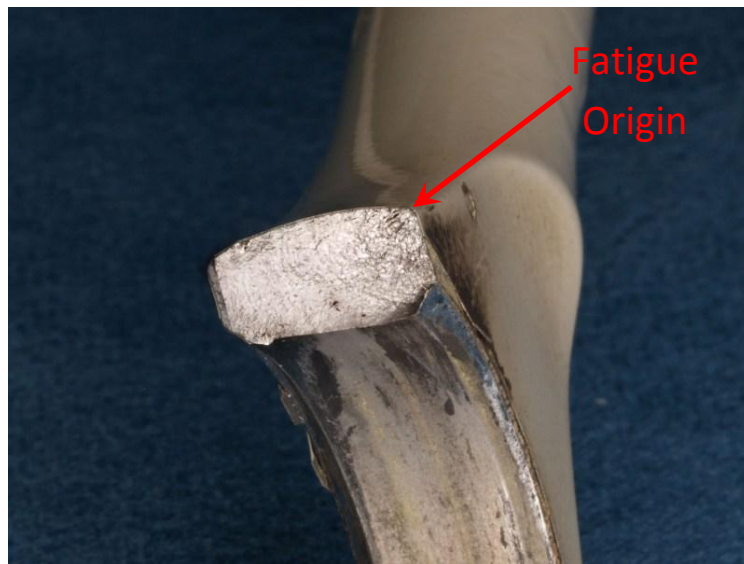
**Figure 4a: Fracture surface at 4 o'clock position, exhibiting beach marks**

The fracture surface at the 4 o'clock position (Figure 4a) exhibited clear beach marks, consistent with fatigue failure. The fatigue failure extended over a majority of the fracture surface and the origin was at the corner indicated. Examination of the fracture surface using a scanning electron microscope (SEM) revealed fatigue striations indicative of high cycle fatigue (Figure 5). There was no indication of inclusions or defects observed at the fatigue origin.

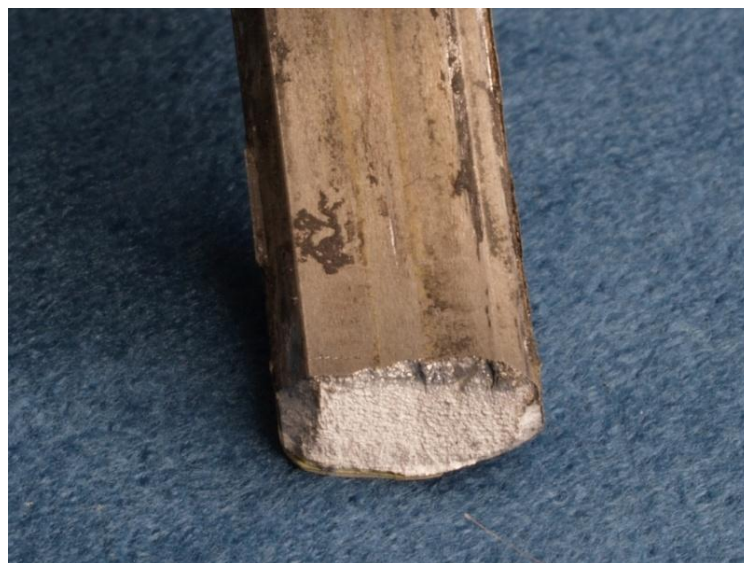
**Figure 4b: Fracture surface at 10 o'clock position**

The fracture surface at the 10 o'clock position (Figure 4b) exhibited two distinct fracture regions, consistent with a combination of a small amount of fatigue originating on the inside surface of the rod end, coupled with a large region of overstress.

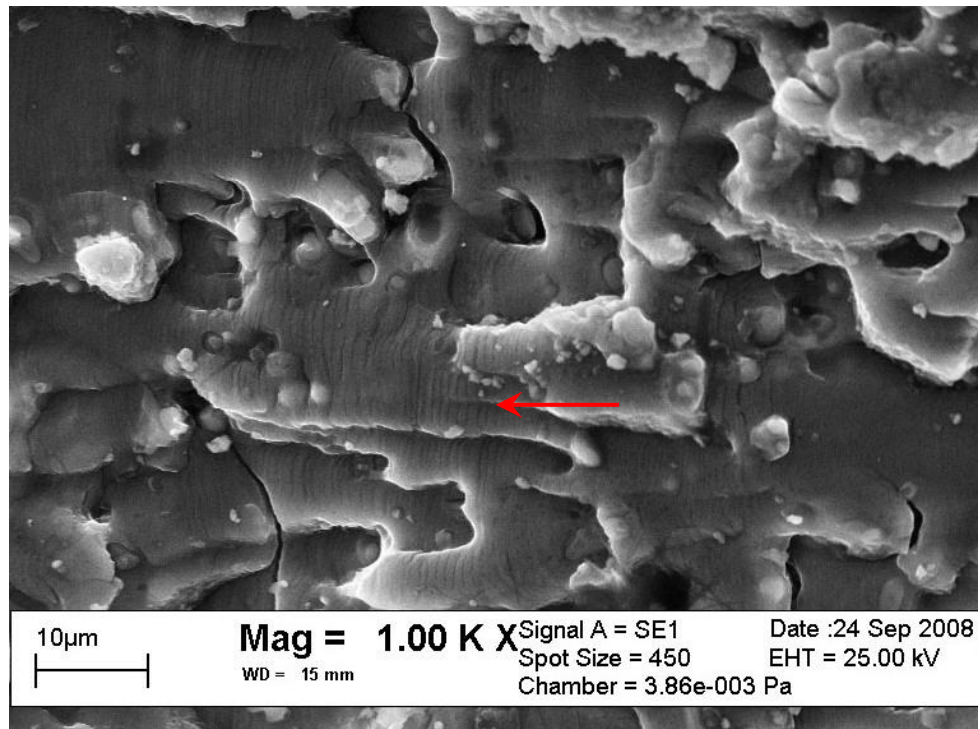
**Figure 5: SEM image of fracture surface in Figure 4A showing fatigue striations (arrowed)**

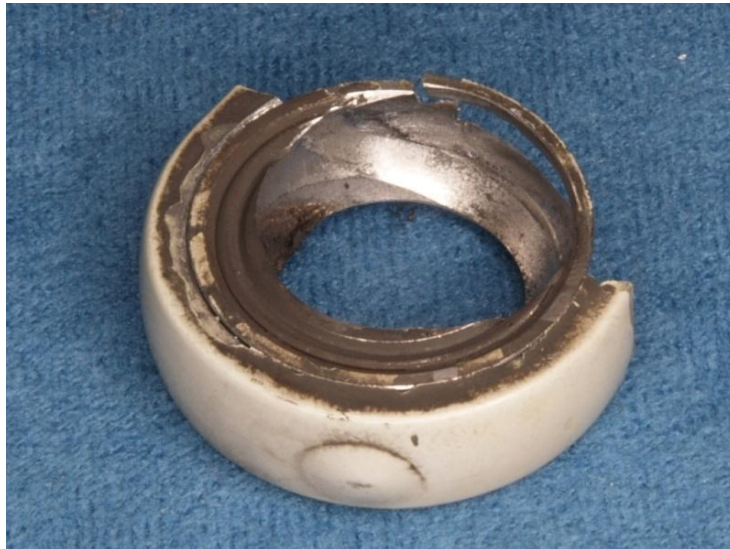
**Figure 6a: Fractured rod end exhibiting severe wear**

The bearing race from the fractured pitch link had severe wear as shown in Figure 6a. The Teflon liner was still present across the top of the rod end, but was completely worn from the base, which was the most heavily-loaded area of the bearing. Wear had progressed through the race, with the ball carving out several distinct grooves.

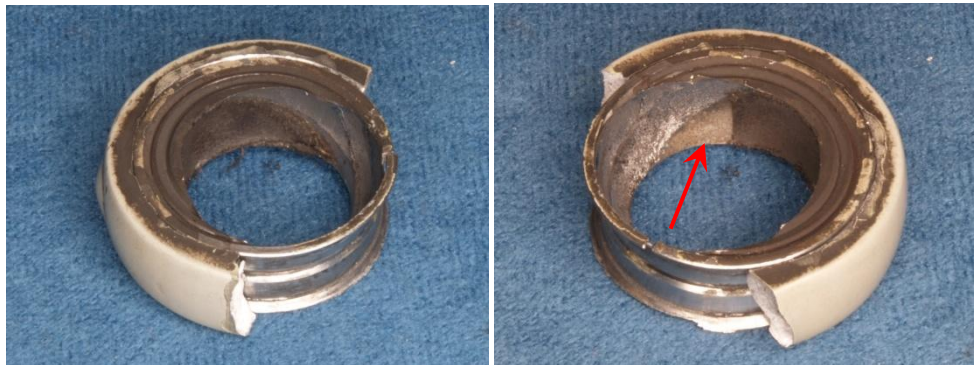
**Figure 6b: Fractured rod end showing Teflon liner**

The wear edge of the Teflon liner was consistent with the grooves on one side of the race, but finished in a straight edge, distinct from the grooves on the opposite side (Figure 6b). The liner gave the appearance of being disbonded from the substrate in the area immediately adjacent (arrowed).

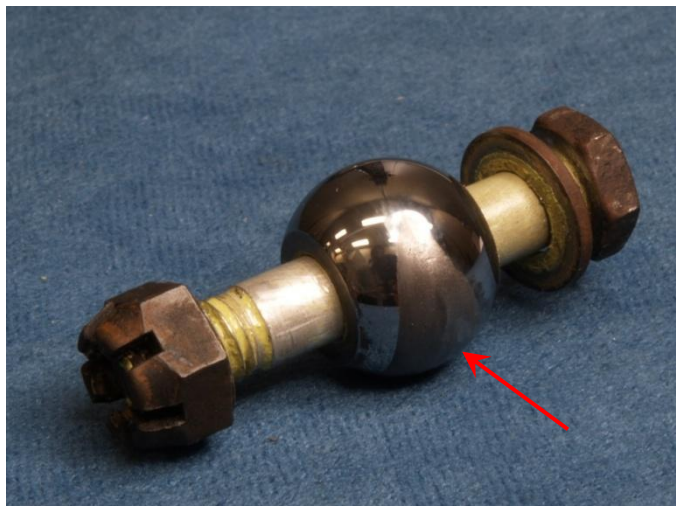
**Figure 7: Ball wear, fractured pitch link**

The ball also showed signs of heavy wear, concentrated on one side only and consistent with the wear on the race (Figure 7).

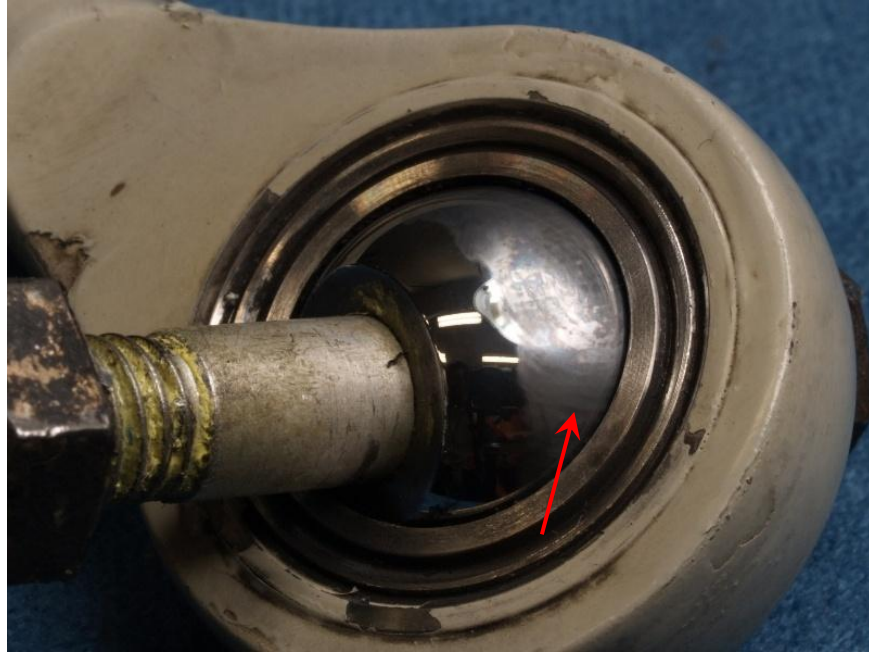
gauge and found to be close to, but within the prescribed limits. There was no evidence of extrusion of the Teflon liner. The ball was not scored, but did exhibit persistent discolouration that was indicative of early stages of wear (Figure 8).

**Figure 8: Persistent discolouration of the ball**

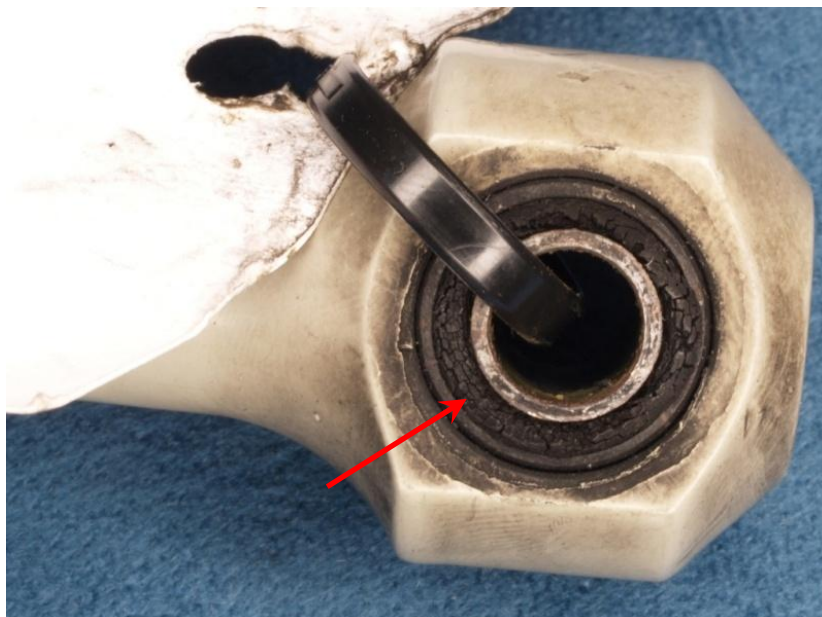
**Figure 9: Cracked elastomeric bearing**

The elastomer in both pitch links exhibited signs of deterioration in the form of extensive surface cracking (Figure 9). None of the cracks were found to exceed the 5mm AMM inspection requirement; however, examination did reveal some bonding separation between the elastomer and the inner sleeve. Based on this, the condition of the elastomer fell outside of AMM requirements.
