**ATSB TRANSPORT SAFETY REPORT**  
Aviation Occurrence Investigation AO-2008-076  
Final

**Collision with terrain**  
**VH-OPC**  
**Piper Aircraft Corp PA-31-350**  
**3 km N Bathurst Airport, NSW**  
**7 November 2008**

**Collision with terrain**  
**3 km N Bathurst Airport, NSW**  
**7 November 2008**  
**VH-OPC**  
**Piper Aircraft Corp. PA-31-350 Chieftain**

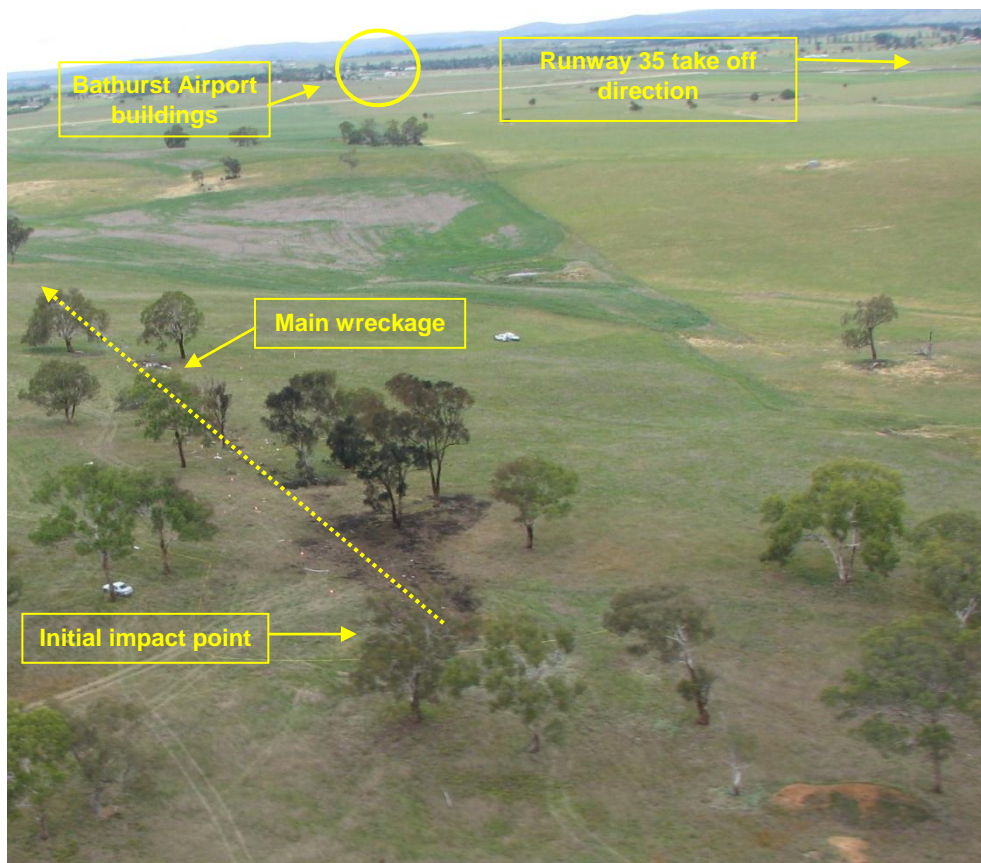
**Figure 6: Accident site (dotted line indicates wreckage trail orientation)**

The aircraft collided with terrain on a rural property that was located about 3 km to the north of Bathurst Airport, at about the same elevation as the airport (Figure 6). The initial impact point was on a grassy area that sloped upwards for about 50 m before slightly sloping down. The wreckage trail was generally linear, orientated on a bearing of 165° M and extended for about 300 m. The length of the wreckage trail and damage to the aircraft was consistent with a high speed collision with terrain. There was evidence of fire along the wreckage trail.

Below the likely aircraft flight path, between 20 and 35 m down-slope of the initial impact point, was a cluster of trees about 12 m high. There was no apparent gap for a Chieftain to fly through, and no apparent damage to, the trees, indicating that the aircraft passed over the trees at a descent angle greater than about 20°.

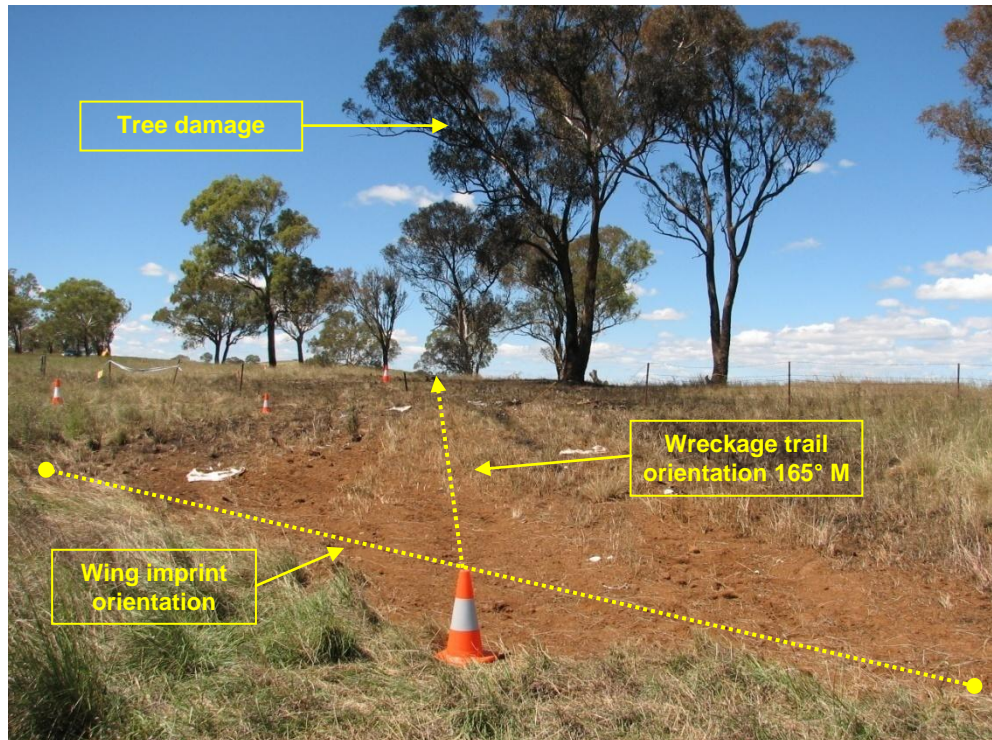
**Figure 7: Initial impact site (looking in direction of travel)**

The ground marks and debris at the initial impact site (Figure 7) indicated that the aircraft was generally upright at the point of impact. The first sign of aircraft contact was a blade tip from the right propeller that was embedded in the ground, closely followed by ground disturbance consistent with wing impact. The

orientation of the wing impact line was consistent with a slightly right wing-low attitude at impact. The ground marks and aircraft damage indicated that the aircraft attitude at impact was shallower than the minimum descent angle over the trees that was derived by the investigation.

Drag marks extended for about 50 m from the initial impact point, including through a fence. A tree located about 50 m into the wreckage trail sustained upper branch damage. Drag marks restarted about 110 m into the trail and continued up to the main wreckage. Aircraft wreckage was distributed along the accident site.

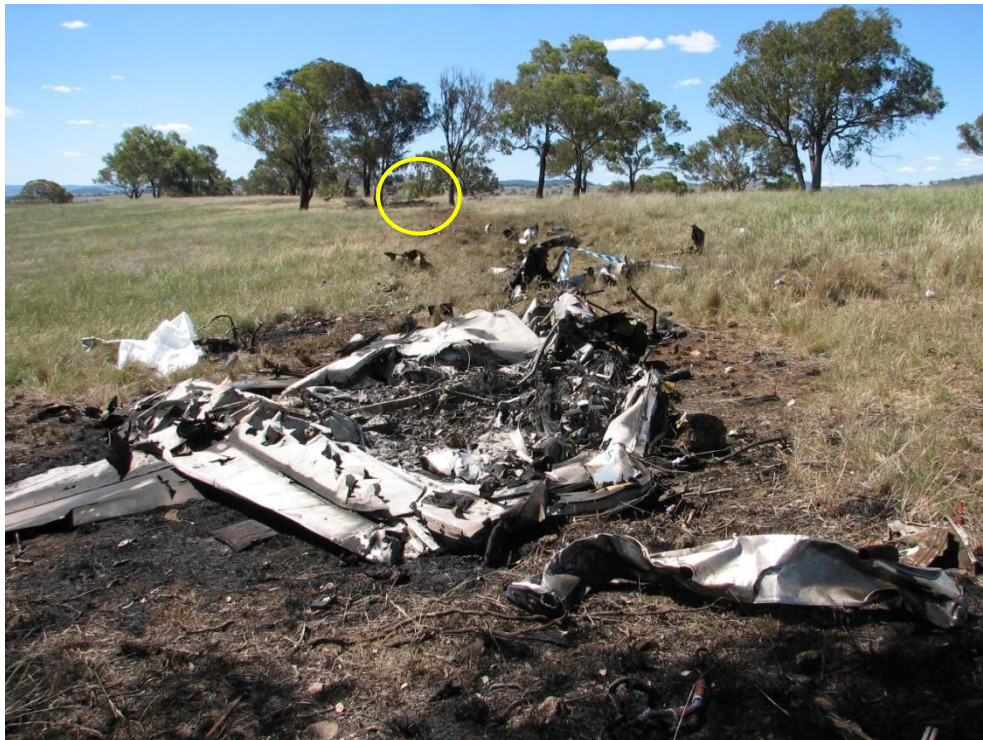
**Figure 8: Main wreckage (looking back along the direction of approach – initial impact site circled)**

The main wreckage, comprising the majority of the fuselage, tail and inboard section of the right wing, was located about 200 m along the wreckage trail (Figure 8). The left engine assembly was 13 m further on and the right engine core was 35 m further on from the main wreckage. The right engine turbocharger assembly, found at about 300 m from the initial impact point, was at the extremity of the wreckage trail.

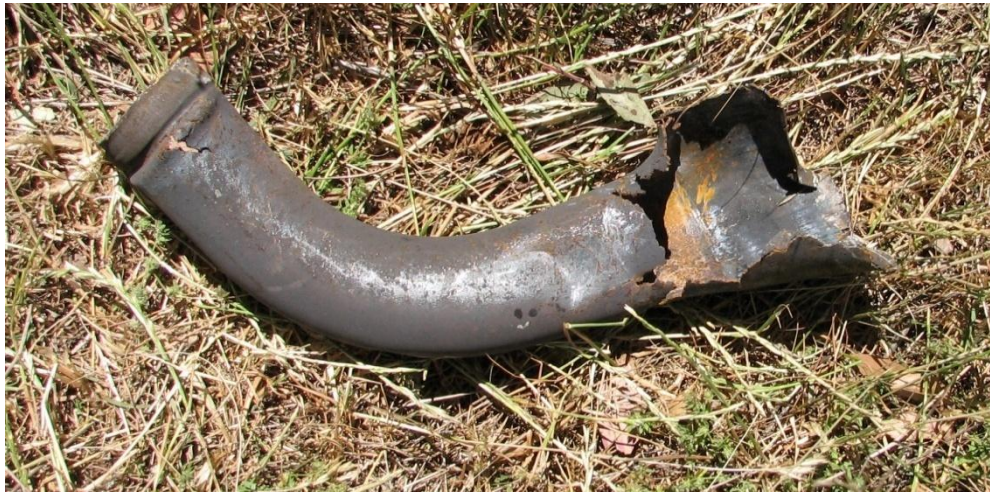
**Figure 9: Fractured exhaust pipe as found on site**

One of the left engine exhaust pipes was fractured at its sleeve joint end (Figure 9). Specialist examination showed that the pipe material, weakened during elevated-temperature service, was probably fractured during the impact sequence.

The investigation was unable to establish the service history of the fractured exhaust pipe.

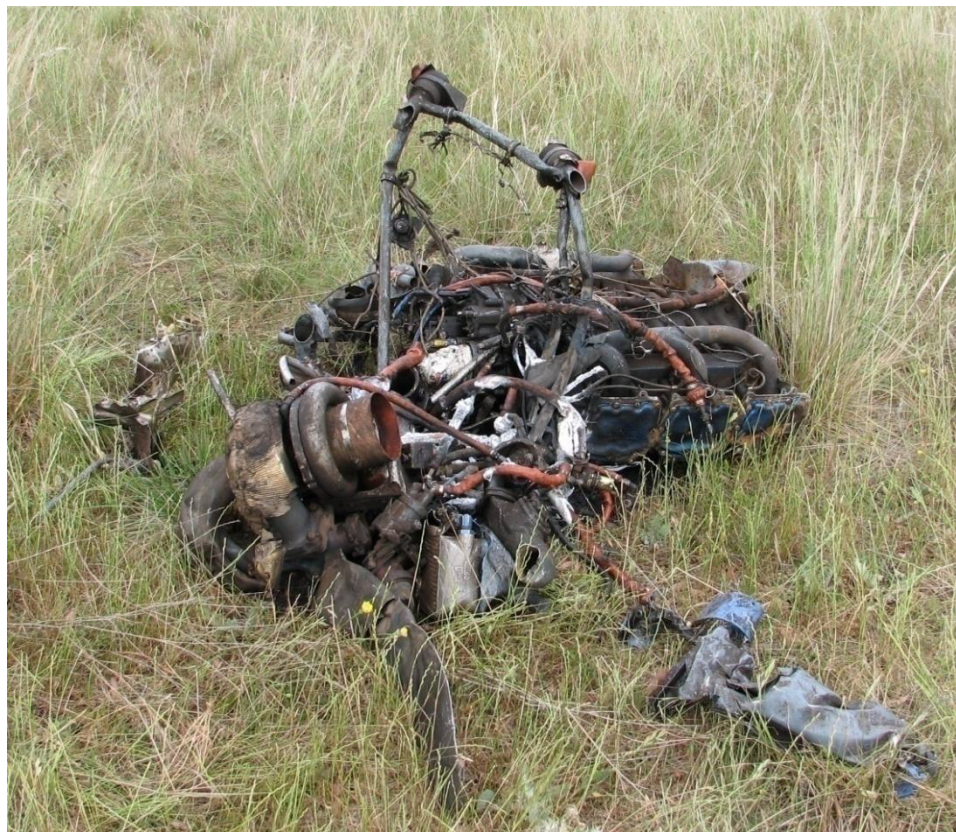
**Figure 10: Left engine assembly as found on site**

Some areas of the left engine assembly, between the rear of the engine core and the turbocharger, exhibited localised severe burning. There was no intense grass fire leading up to, and where the engine came to rest (Figure 10), that may have been the source of the localised severe burn damage (Figure 10). As such, the investigation used an exemplar aircraft to correlate those burnt areas with possible sources of intense heat, and found that the pattern of burning was not consistent with an in-flight fire.

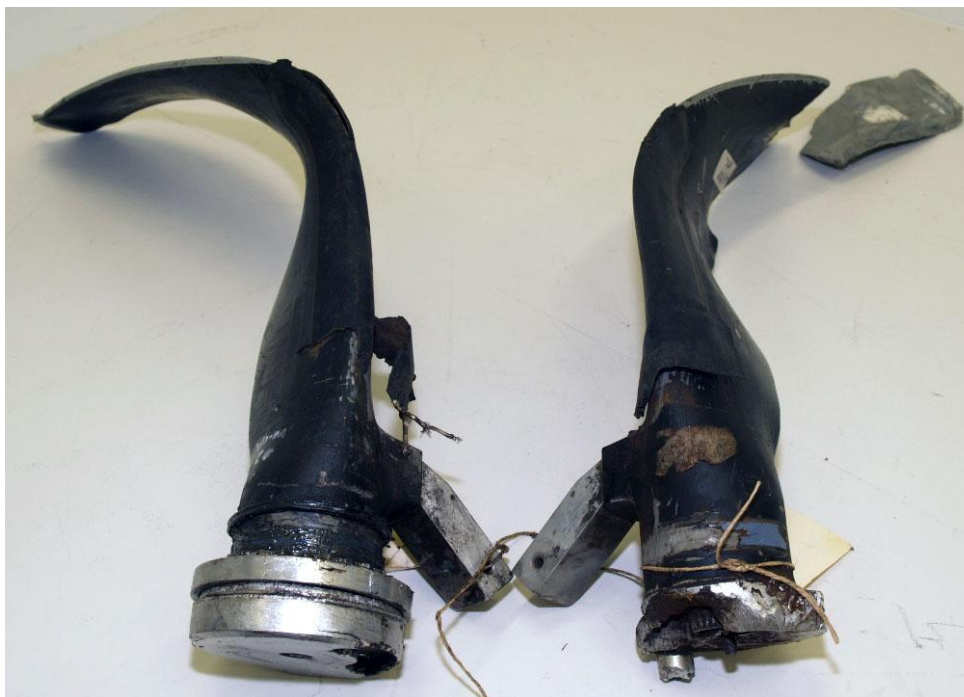
**Figure 11: A left propeller blade (on left) and a right propeller blade (on right) with corresponding damage**

Examination of the left and right propellers did not identify any pre-impact defects. The bending and twisting of the left and right propeller blades was comparable, and was consistent with a high level of rotational energy associated with significant engine power at the time of impact (Figure 11).

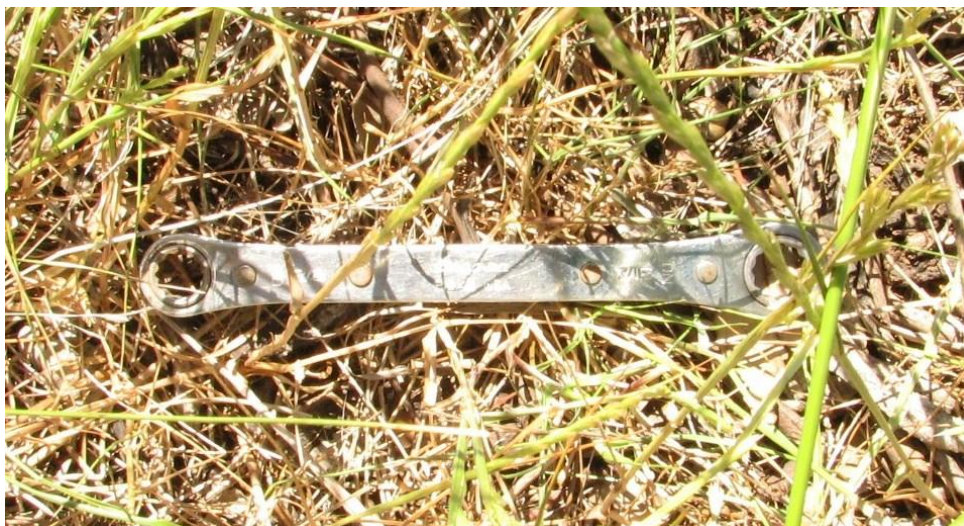
**Figure 12: Hand tool as found at accident site**

A hand tool was found about halfway along the wreckage trail (Figure 12). It was established that the tool was probably last used to tighten the engine cowl fasteners during the recent 50-hour inspection. However, it was not clear how the tool came to be in the aircraft, or what its location was in the aircraft, at the time of the accident. The ATSB examined the tool and found it in good condition except for some scrape marks with associated corrosion. The investigation was unable to determine how those marks were made.
