**ATSB TRANSPORT SAFETY REPORT**  
Aviation Occurrence Investigation  
AO-2008-080  
Final

**Operational event**  
**Darwin Aerodrome, NT**  
**17 December 2008**  
**PK-GZJ, Boeing B737-4MO**

Operational event - Darwin Aerodrome, Northern Territory - 17 December 2008 - PK-GZJ, Boeing Company B737-4MO

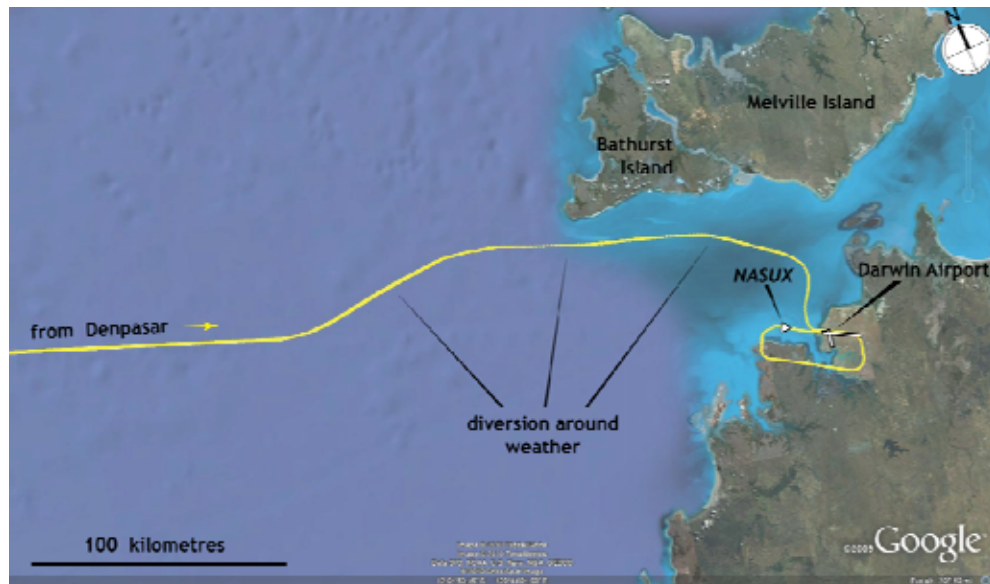
**Figure 1: Track to Darwin**

On 17 December 2008, a Boeing 737-4MO, registered PK-GZJ, was being operated on a scheduled passenger service from Denpasar, Indonesia to Darwin, Northern Territory with an arrival time in Darwin of about 0500 Central Standard Time<sup>1</sup>. The aircraft's planned track from Denpasar approached Darwin from the north-west but the flight crew were forced to divert up to 40 km left of track to avoid weather (Figure 1).

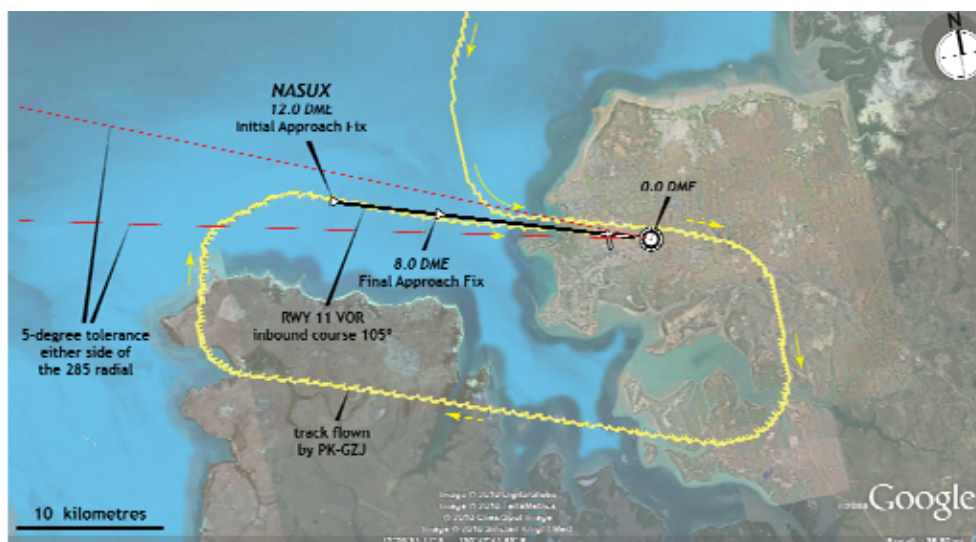
**Figure 2: Aircraft track superimposed on elements of the runway 11 VOR approach<sup>10</sup>**

threshold. It did not intercept the 105 radial inbound to the VOR.<sup>9</sup> Instead, the aircraft flew a track parallel to, and 600 m north of, the 105 radial (Figure 2) while continuing its descent towards the minimum descent altitude for the runway 11 VOR approach of 500 ft.

<sup>10</sup> Derived from latitude and longitude information that was supplied by the aircraft's inertial reference units (IRUs) and recorded at 1-second intervals by the aircraft's flight data recorder (FDR). The serrated appearance of the aircraft's track was a result of the limited resolution of the recorded latitude and longitude data.
