ATSB TRANSPORT SAFETY REPORT
Aviation Occurrence Investigation
AO-2008-081
Final

Midair collision
Cessna 152, VH-FMG and
Liberty Aerospace Inc. XL-2, VH-XLY
Casula, NSW,
18 December 2008

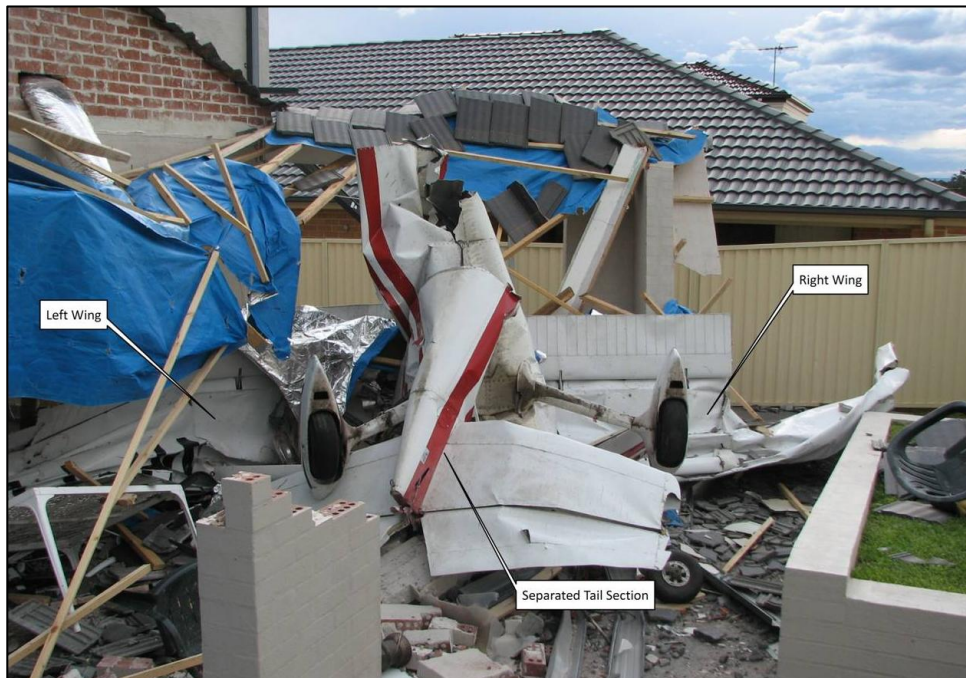
Figure 5: Cessna wreckage and crash site

The Cessna impacted a house and the ground in a vertical, nose-down attitude. The damaged tail section remained attached to the remainder of the aircraft by the flight control cables and was located on the bottom of the fuselage after the aircraft came to rest. There was significant compression damage to the leading edges of both wings, consistent with impact with the structure of the house and the ground (Figure 5).

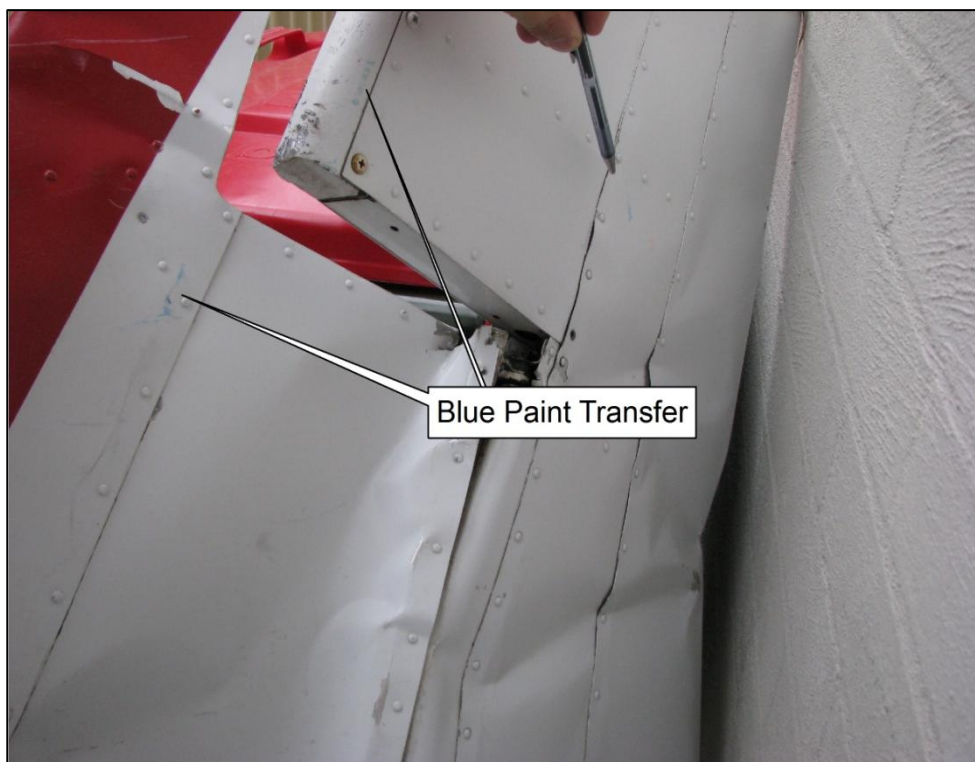
Figure 6: Paint transfer on the detached portion of the Cessna's vertical fin

A detached section of the Cessna's vertical fin came to rest between two houses in an upright position after impacting the roof of a house to the west of the main

wreckage. Examination of that piece of wreckage revealed blue paint transfer on the left side of the mass balance weight and upper section of the vertical fin (Figure 6).

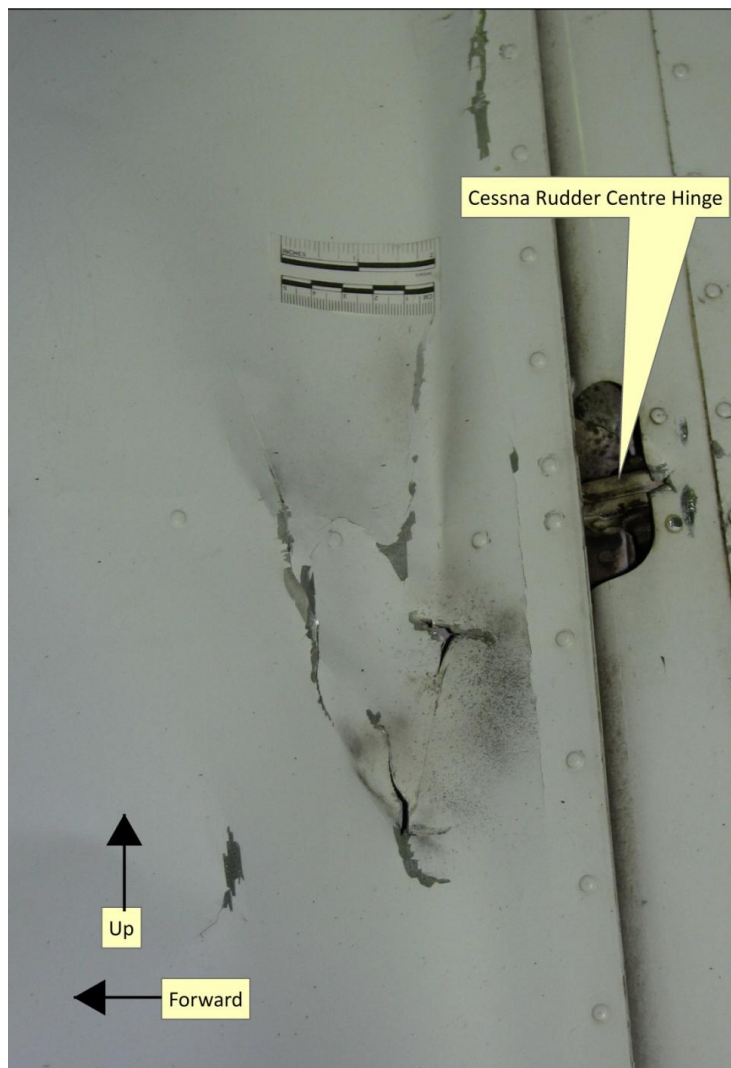
Figure 6: Witness mark on the Cessna's vertical fin

Examination of the portion of the vertical fin that remained attached to the Cessna revealed impact damage on the left side of the fin that was inconsistent with an impact with the ground or house. Later examination revealed that this damage was consistent with an impact with the Liberty's exhaust pipe (see the following wreckage description titled *Liberty*) (Figure 6).

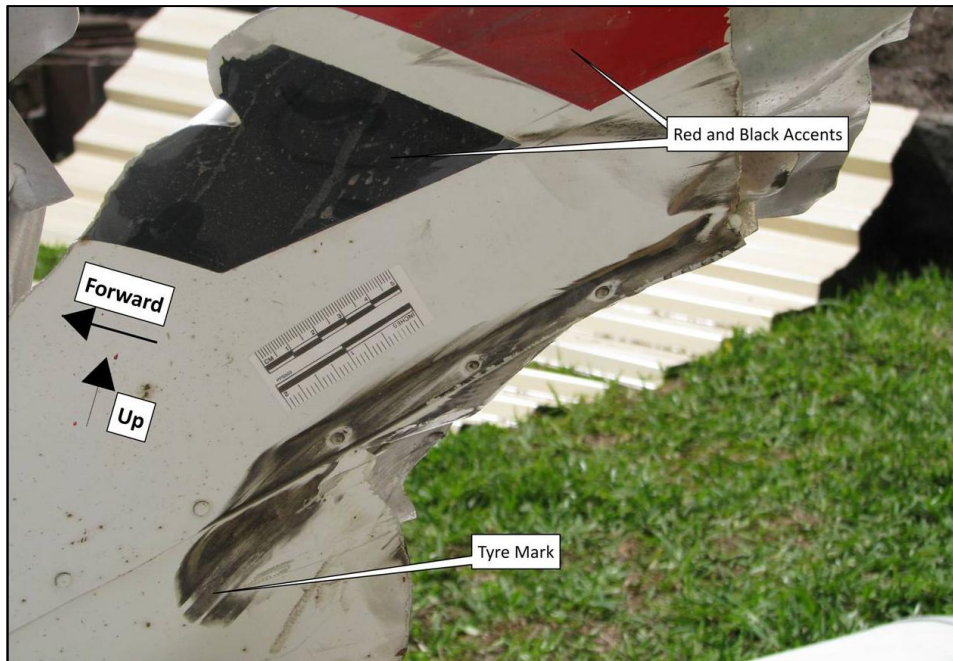
Figure 7: Tyre mark on the left side of the Cessna's vertical fin

A single tyre mark was located on the left side of part of the Cessna's vertical fin (Figure 7). In addition, debris that was consistent with contact with a tyre was located at the base of the vertical fin.

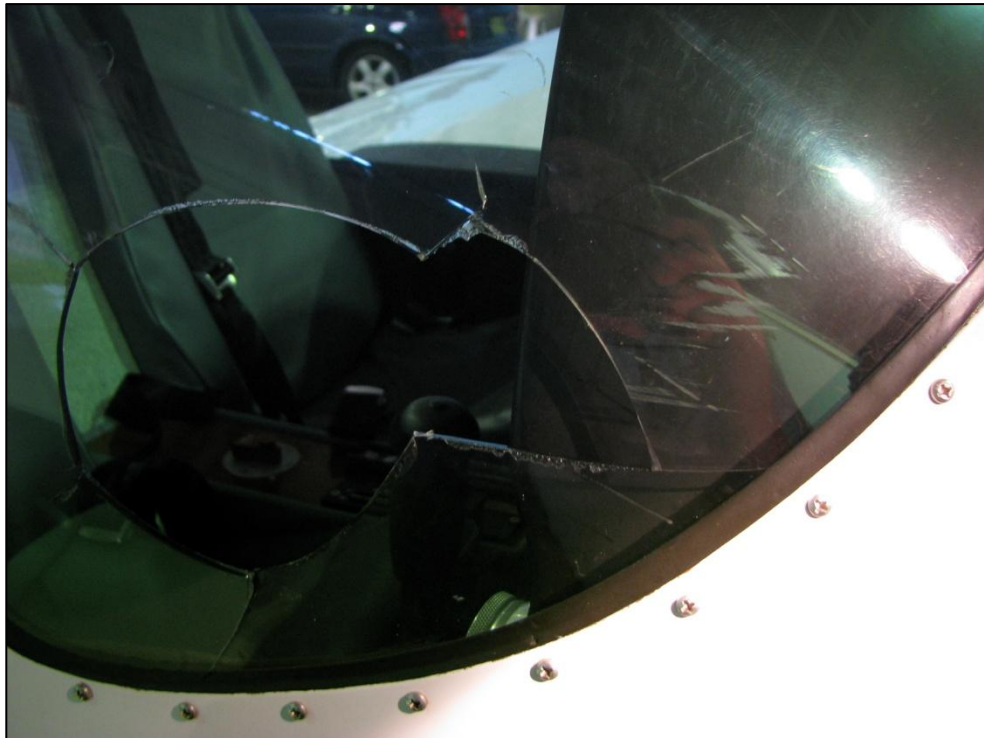
Figure 8: Broken right lower windscreen

After the collision, the Liberty remained in a controllable condition and landed at Bankstown Aerodrome where it was secured by the NSW Police Force until examined by the Australian Transport Safety Bureau (ATSB). Damage to the Liberty consisted of impact damage to the right side of the aircraft's nose cowling, with associated paint transfer and crush damage to the single exhaust pipe that was located on the lower-right side of the engine cowling. There was also damage to the right side of the nosewheel, paint transfer on the leading and trailing surfaces of the impact-damaged propeller and a break on the lower-right side of the cockpit windscreen (Figure 8).

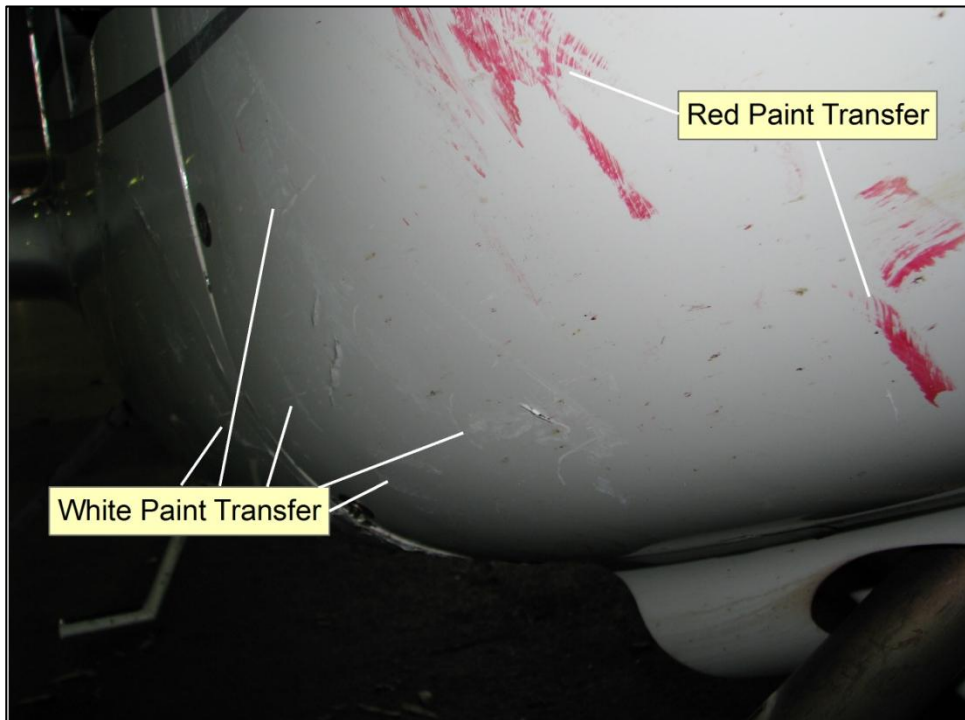
Figure 9: Impact damage to the right engine cowling

Examination of the damage to the right side of the nose cowling revealed red paint transfer at the front of the cowling, with additional crush damage and white paint transfer towards the rear of the cowling (Figure 9).

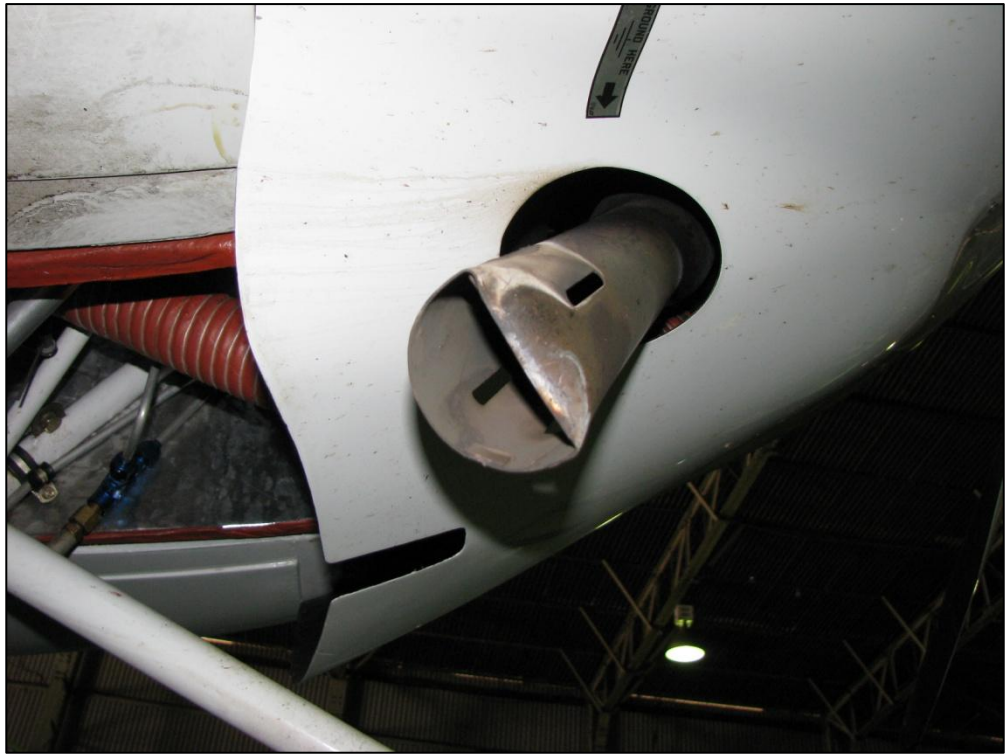
Figure 10: Exhaust pipe crush damage

Inspection of the single exhaust pipe on the right front of the Liberty revealed crush damage to the forward section and white paint transfer (Figure 10).

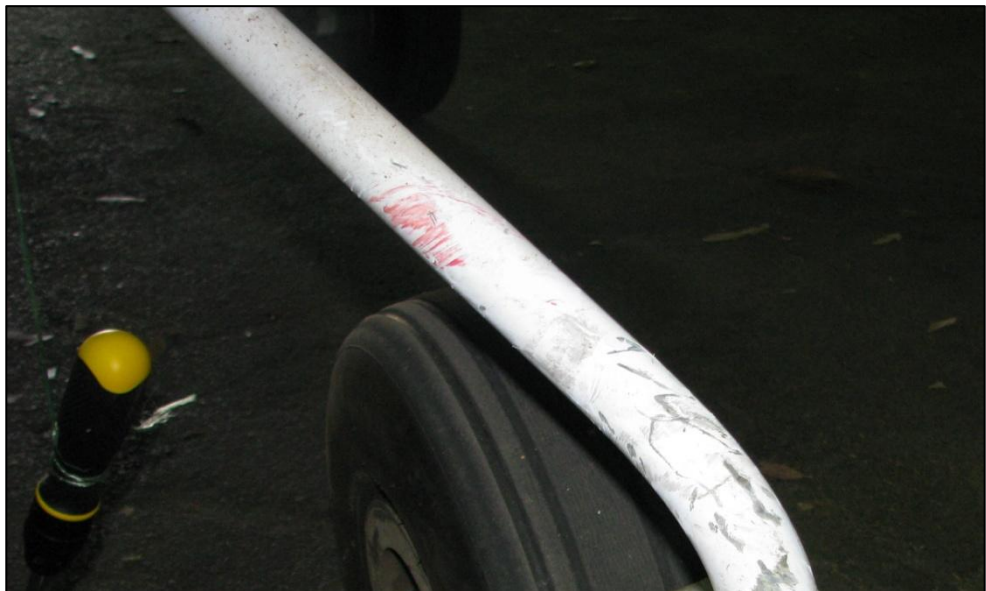
Figure 11: Red paint transfer on the right side of the nosewheel leg

The nosewheel had been displaced to the left of its normal position on the aircraft's centreline. There was red paint transfer on the right side of the nosewheel leg (Figure 11).

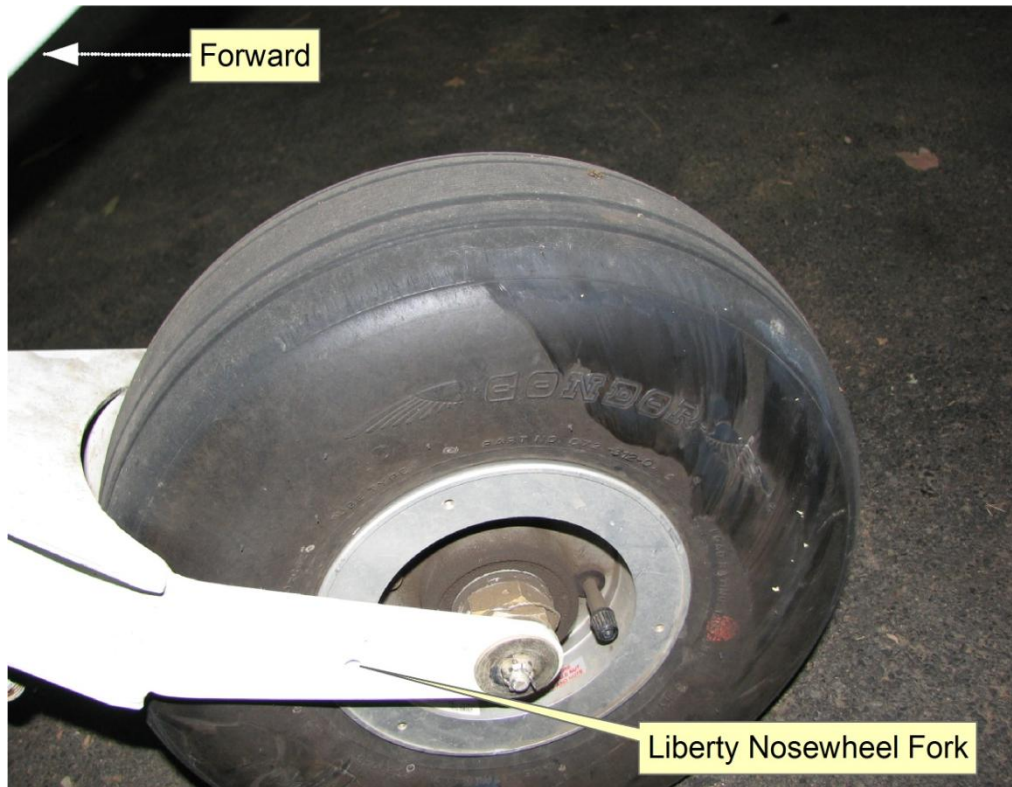
Figure 12: Liberty nosewheel tyre left side damage

Examination of the nosewheel tyre revealed rubbing damage to the left side, consistent with it coming into contact with the nosewheel fork structure (Figure 12).

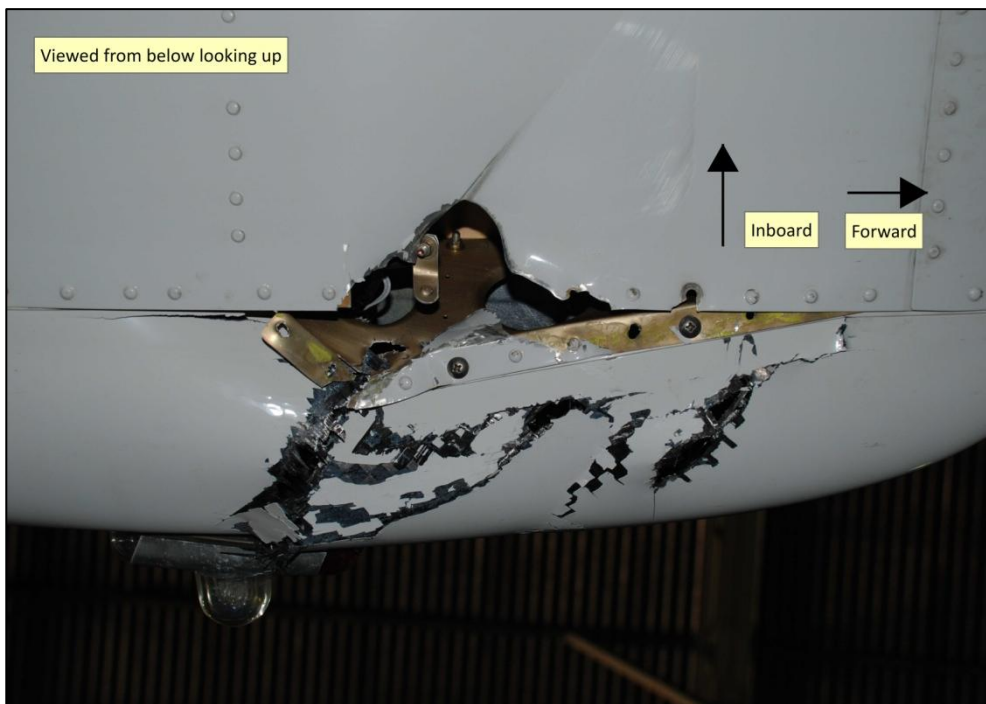
Figure 13: Damage to the underneath surface of the left wing

There was additional damage to the underneath surface of the left wingtip (Figure 13).

The damage to the lower surface of the left wing was consistent with a contact with a second structure with sufficient force that it pierced the Liberty's wing surface

and wingtip fairing. That damage was later found to be consistent with striking the Cessna's tail navigation light, which was recovered from a field to the west of the main wreckage.

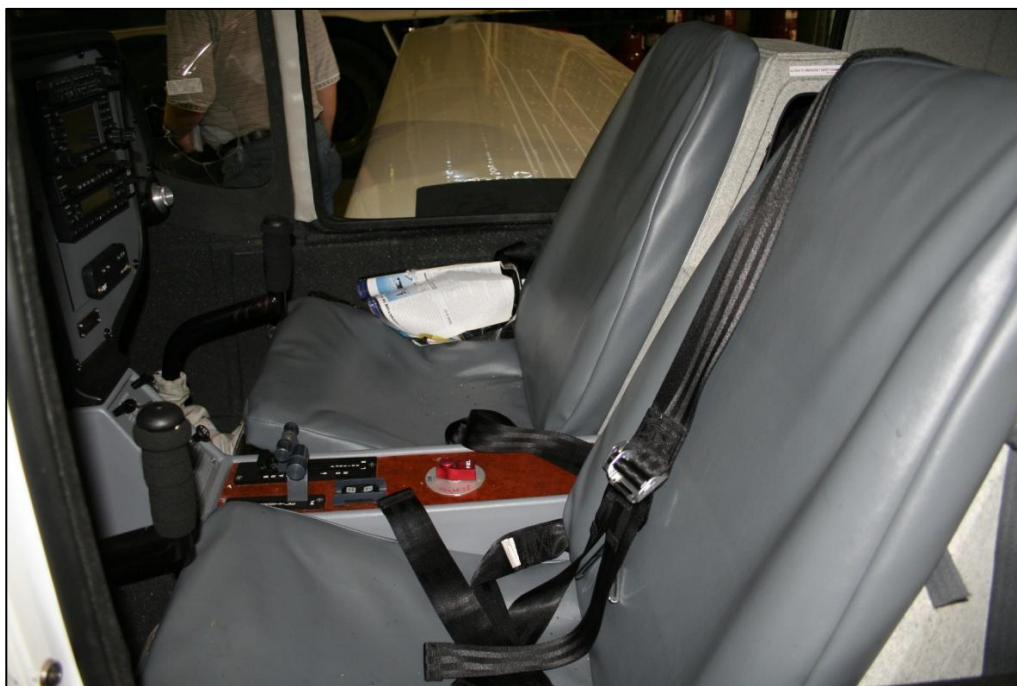
Figure 14: Location of the magazine at the right pilot seat

A reading magazine was found adjacent to the right pilot seat when the Liberty was inspected by the ATSB (Figure 14). The ATO reported reading the magazine earlier in the flight as a means to 'put the student pilot at ease' during the flight and that he put it away after he had finished with it.

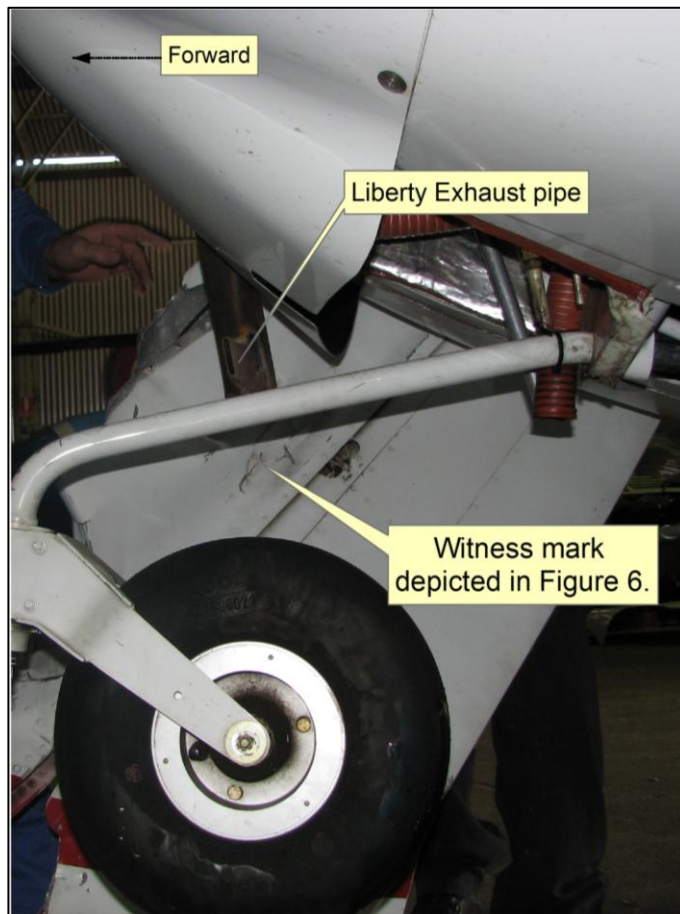
Figure 19: Alignment of witness marks – Cessna vertical fin and Liberty exhaust pipe and nosewheel

The collision occurred when the Liberty, which was travelling faster than the Cessna, impacted the left of the Cessna's tailplane. The position of the damaged single exhaust pipe on the right of the Liberty's engine cowling and corresponding impact mark on the left side of the tail of the Cessna, served as a point of reference on which to orientate both aircraft at the time of the collision. When coupled with the tyre mark on the left side of the Cessna's tail, the vertical and horizontal orientation of the Liberty at that time was able to be determined with a high degree of certainty. The location of the Cessna's vertical fin at that time was confirmed by the paint transfer between both aircraft. That location is depicted at Figure 19.
