Aviation Occurrence Investigation – AO-2009-012
Interim Factual Report

Tailstrike
Melbourne Airport, Vic.
20 March 2009
A6-ERG
Airbus A340-541

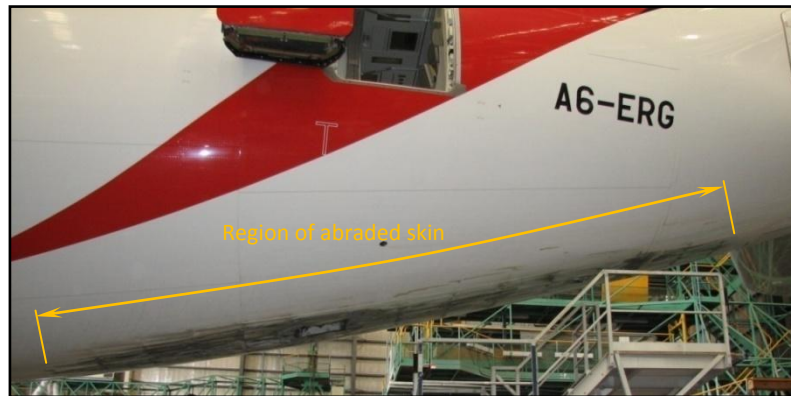
An initial inspection of the aircraft revealed that the rear of the fuselage was seriously damaged¹². The lower skin panels were abraded by contact with the runway surface (Figure 1), and in some areas the skin had worn through the full thickness (Figure 2). A service panel had been dislodged (Figure 2) and was found by airport personnel at the end of the runway, along with numerous pieces of metal

Figure 1: Skin abrasion

Temporary repairs were carried out in Melbourne by the aircraft manufacturer and the aircraft was flown to France for further engineering work to be carried out by the manufacturer.

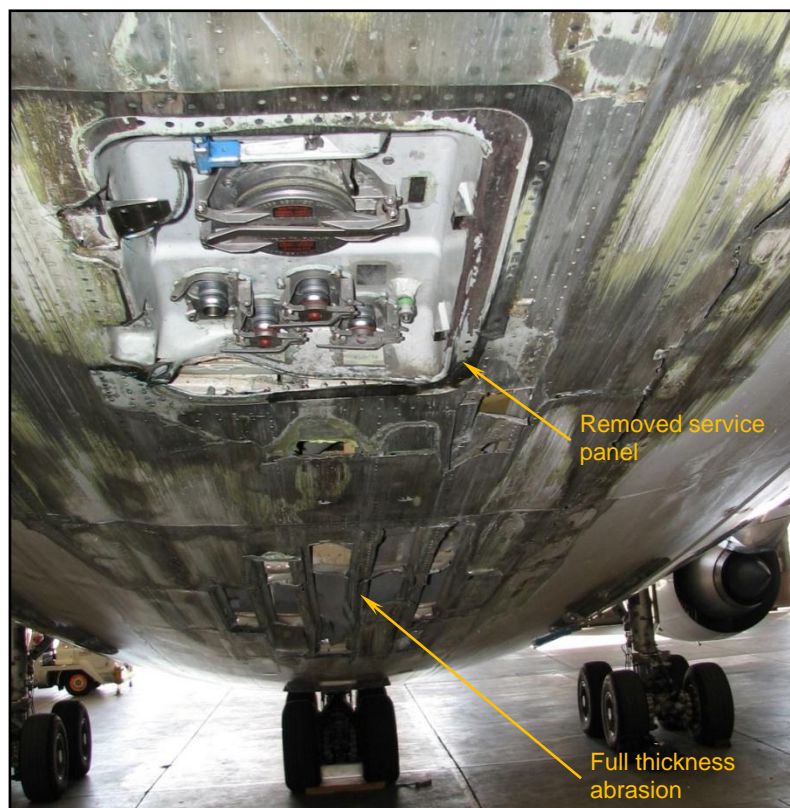
Figure 2: Skin abrasion detail

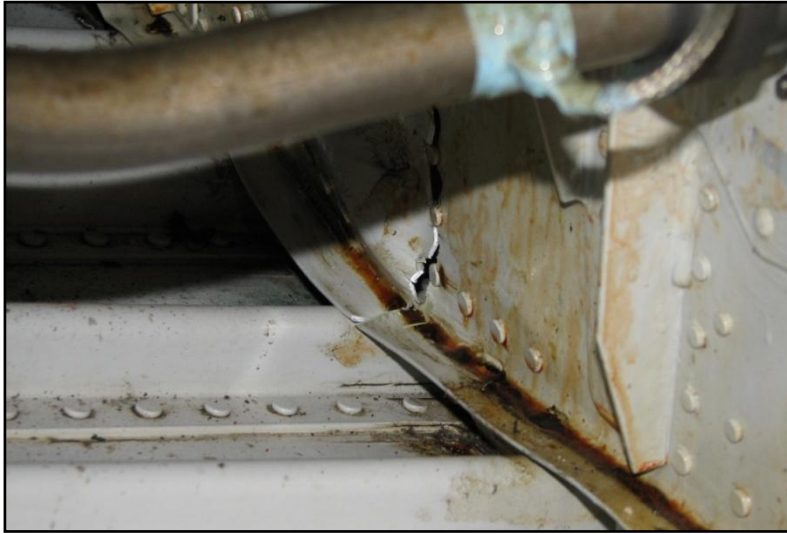
consistent with the abraded skin panels. Numerous fuselage frames and stringers in the region were deformed and several contained cracks (Figure 3). The rear pressure bulkhead¹³ contained cracks in the composite structure and deformation of the diaphragm support ring (Figure 4). There were also scrapes on the right side of the fuselage consistent with contact with external objects. One contact mark had an orange colouration and was located forward of the skin abrasion, immediately below the right-rear cargo door (Figure 5). The other contact mark was located adjacent to the skin abrasion and consisted of several, fine, divergent marks running rearwards and slightly upwards (Figure 6). There was also a contact mark on the left main landing gear, inboard-rear tyre (Figure 7).

Figure 3: Example of frame deformation and cracking

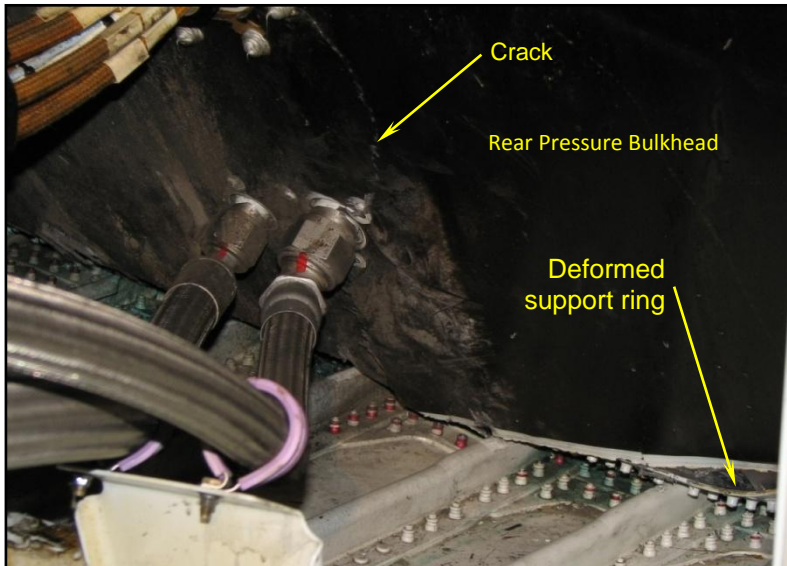
Figure 4: Example of rear pressure bulkhead damage

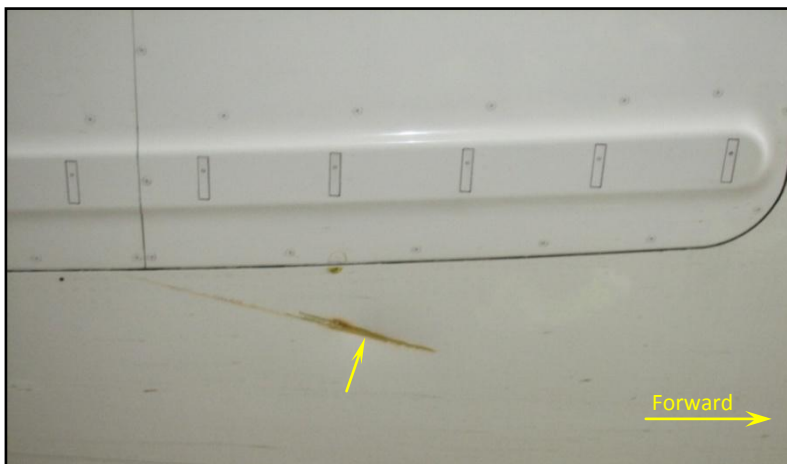
Figure 5: Contact mark below right, rear cargo door

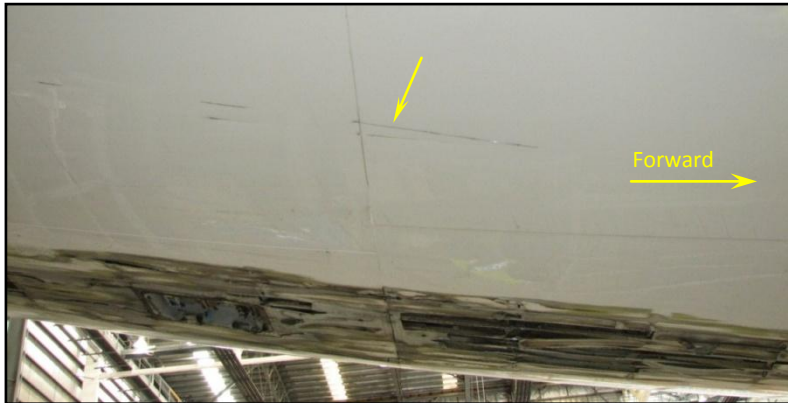
Figure 6: Contact marks adjacent to skin abrasion

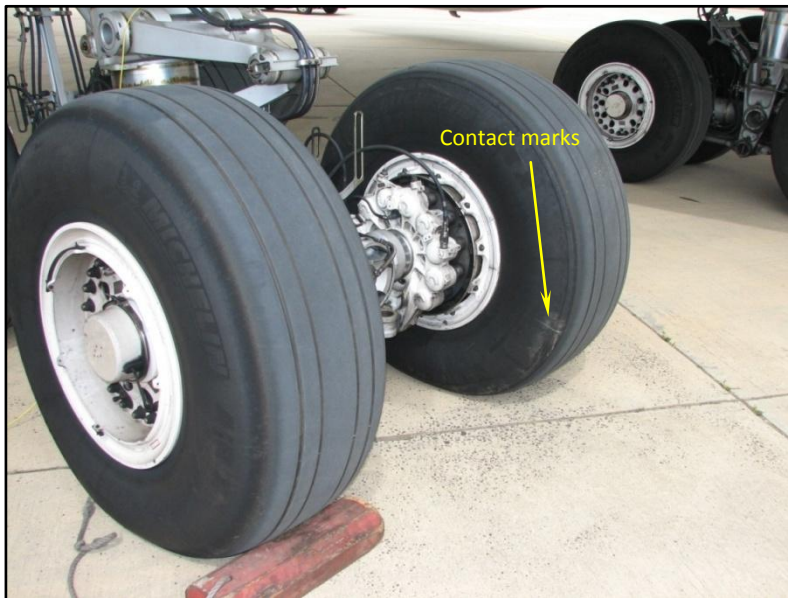
Figure 7: Contact mark on left main landing gear, inboard rear tyre

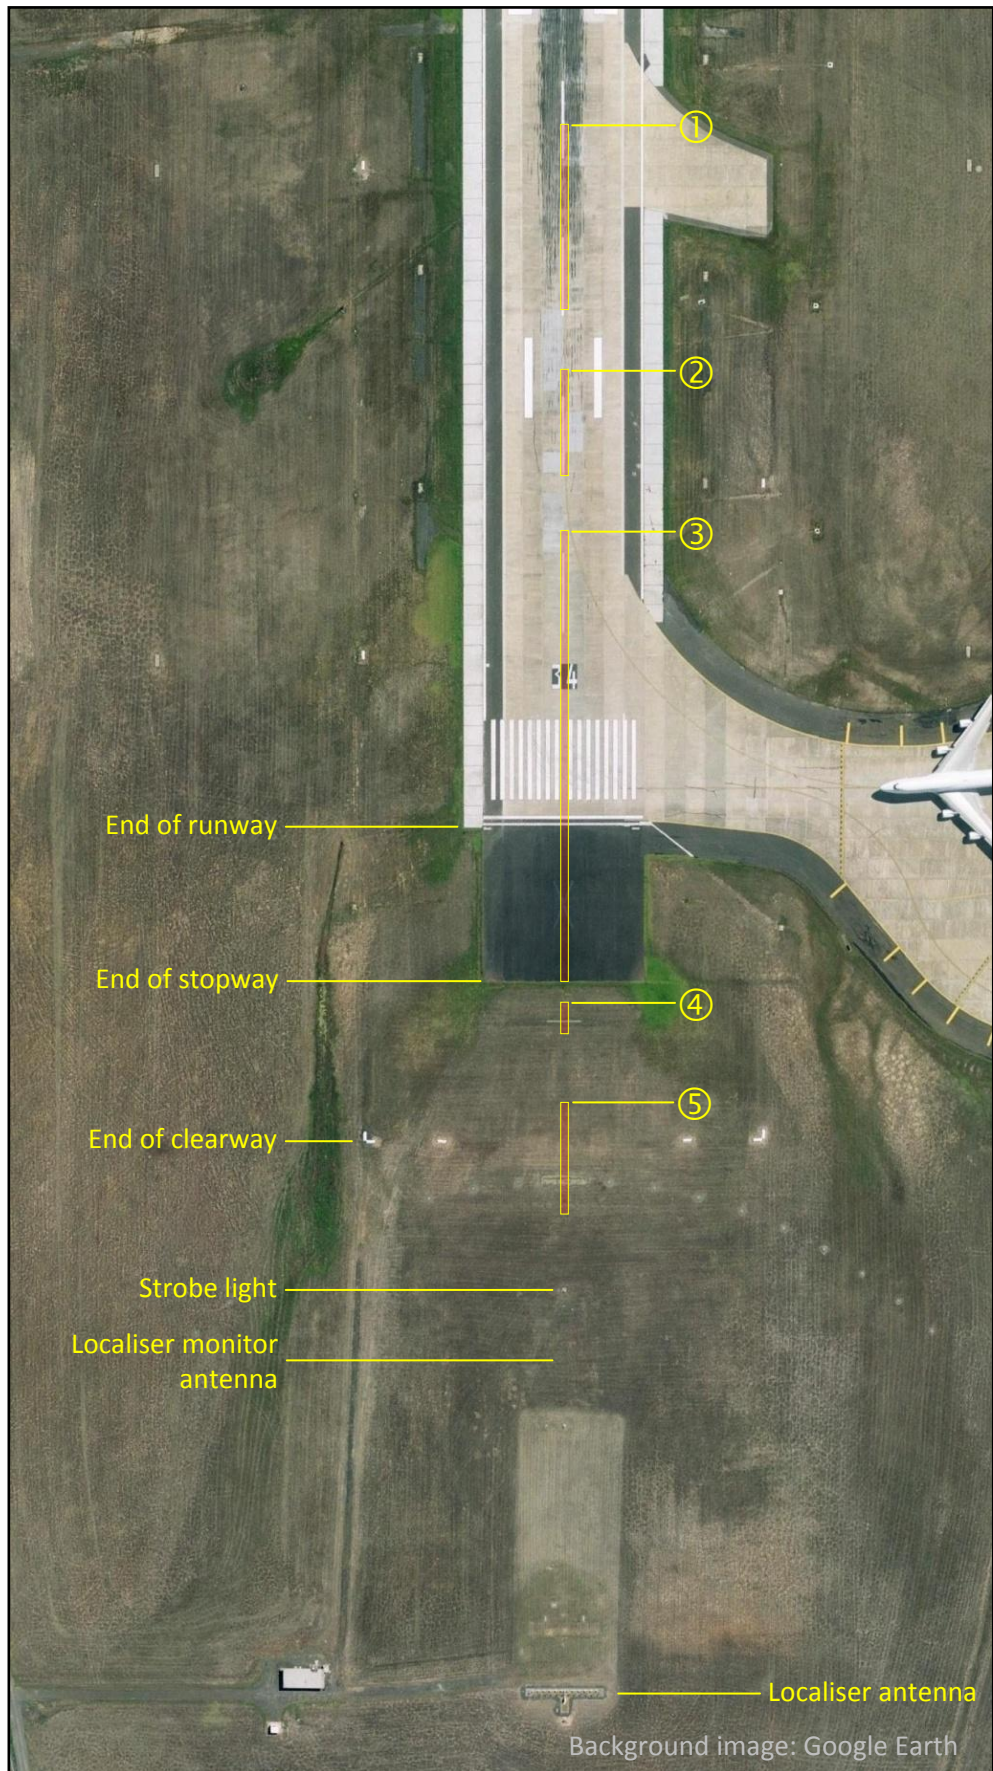
An inspection of the runway and overrun areas identified multiple contact marks (Figure 8). The tail of the aircraft made contact with the runway at three locations, each starting at the positions indicated by ① ② and ③ in Figure 8. After leaving the stopway, two contact marks were identified in the grassed area, indicated by ④ and ⑤ in Figure 8. Figure 9 shows typical ground contact marks. The aircraft also made contact with ground infrastructure; a runway 34 sequenced lead-in strobe light (Figure 10), and the runway 16 localiser monitor antenna (Figure 11). The damage to the runway 16 localiser antenna (Figure 12) was consistent with the contact mark on the left main landing gear inboard-rear tyre. The resulting damage to the antennas disabled the localiser function.

Figure 8: Ground contact marks

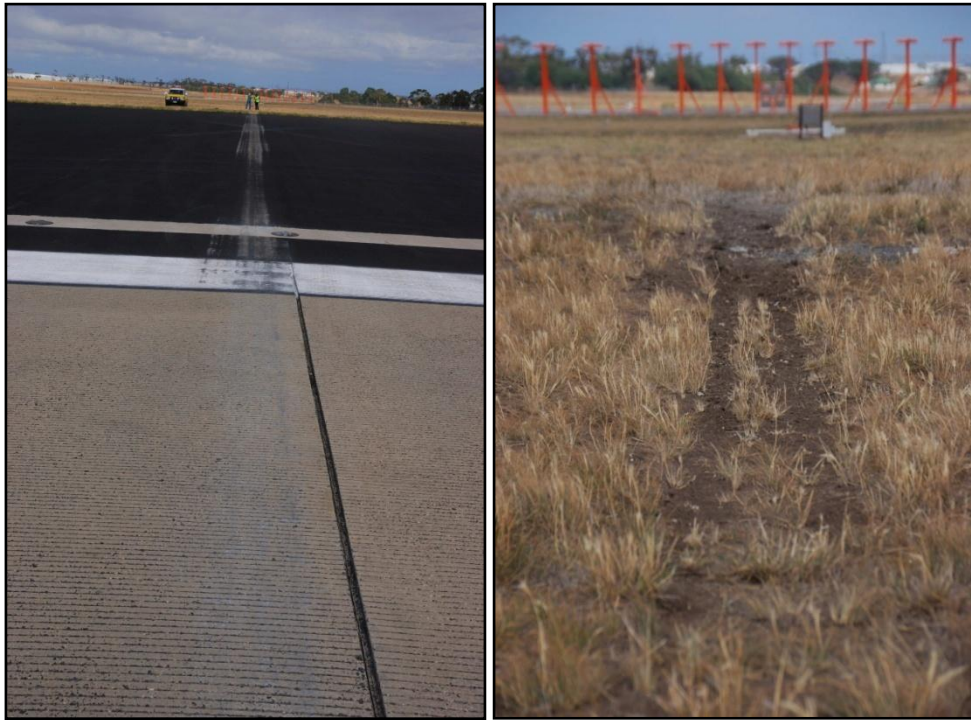
Figure 9: Typical contact marks on runway, stopway and grassed areas

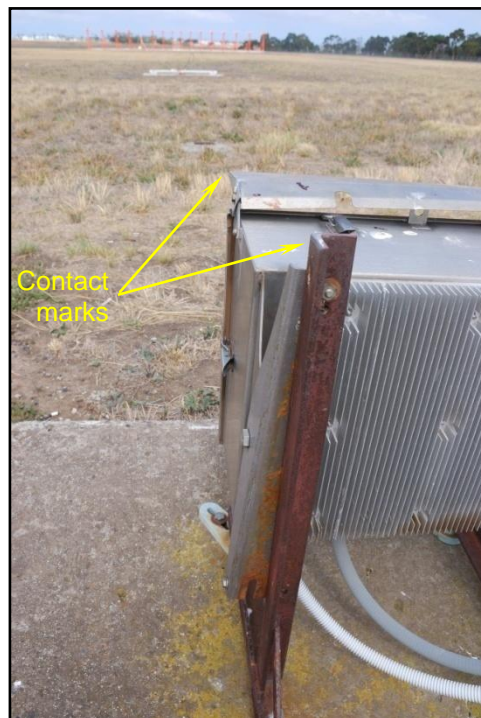
Figure 10: Sequenced lead-in strobe light

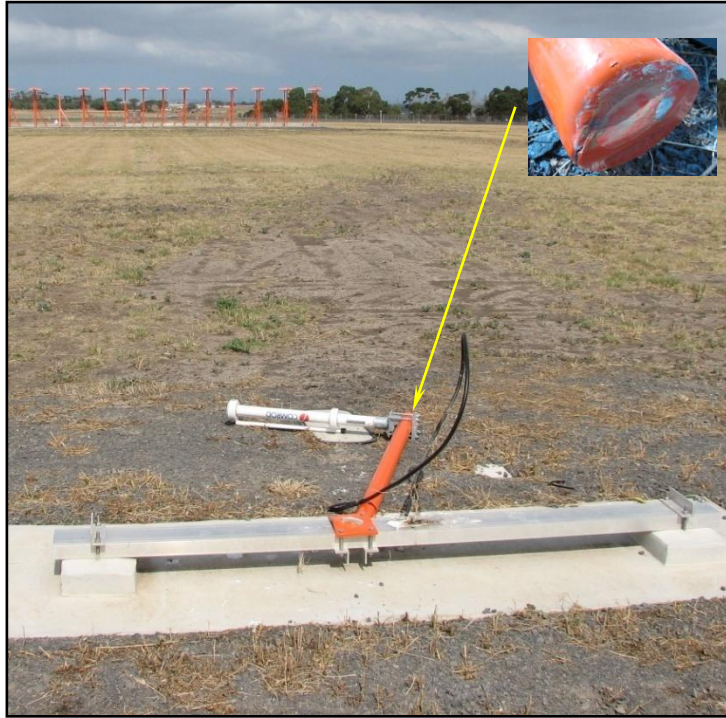
Figure 11: Localiser monitor antenna

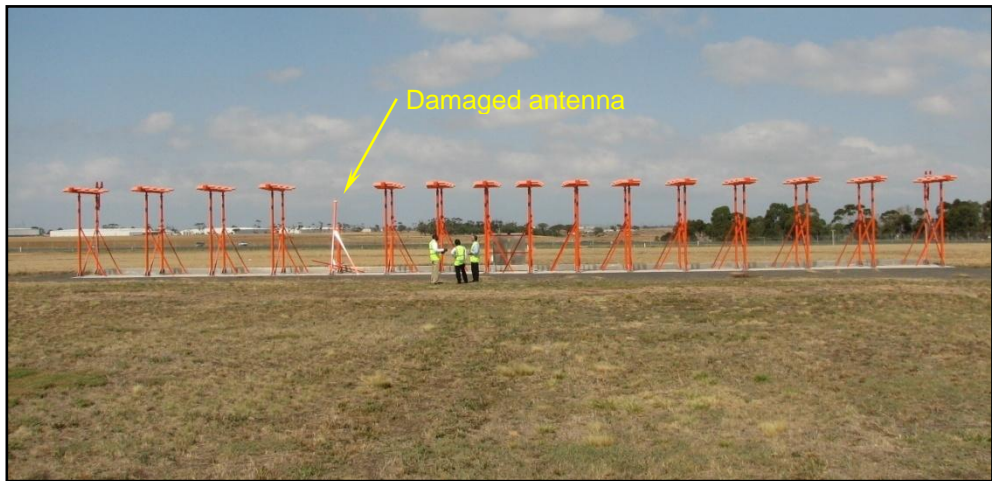
Figure 12: Localiser antenna array

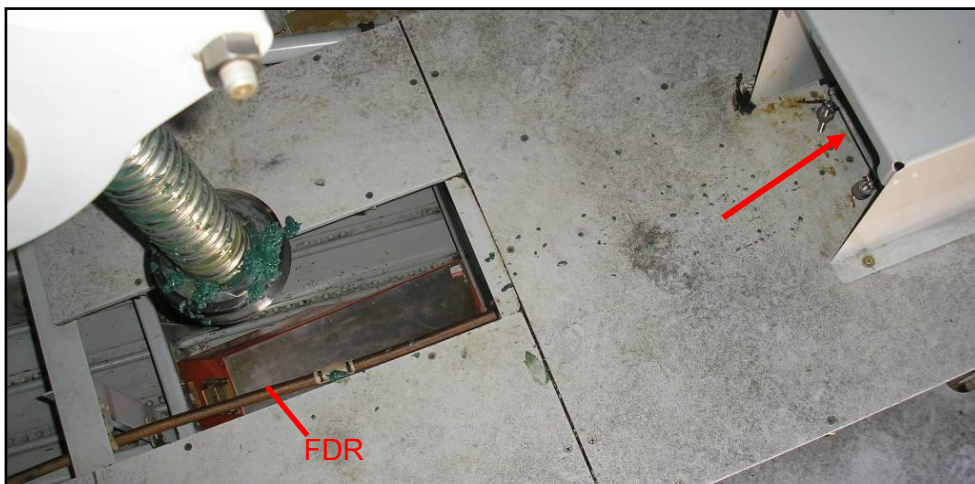
The examination and retrieval of the flight recorders was undertaken under Australian Transport Safety Bureau (ATSB) supervision on 21 March 2009. The FDR had separated from its mounting rack and was located in a small compartment directly to the rear of the mounting rack and adjacent to the tail lower skin (Figure 25).

Figure 25: Location of FDR as found with FDR mounting rack in view (arrowed)

The FDR mounting rack displayed evidence of deformation with part of one securing nut found to have separated from the rack. The CVR and DAR PC-card were in their correct locations and undamaged.

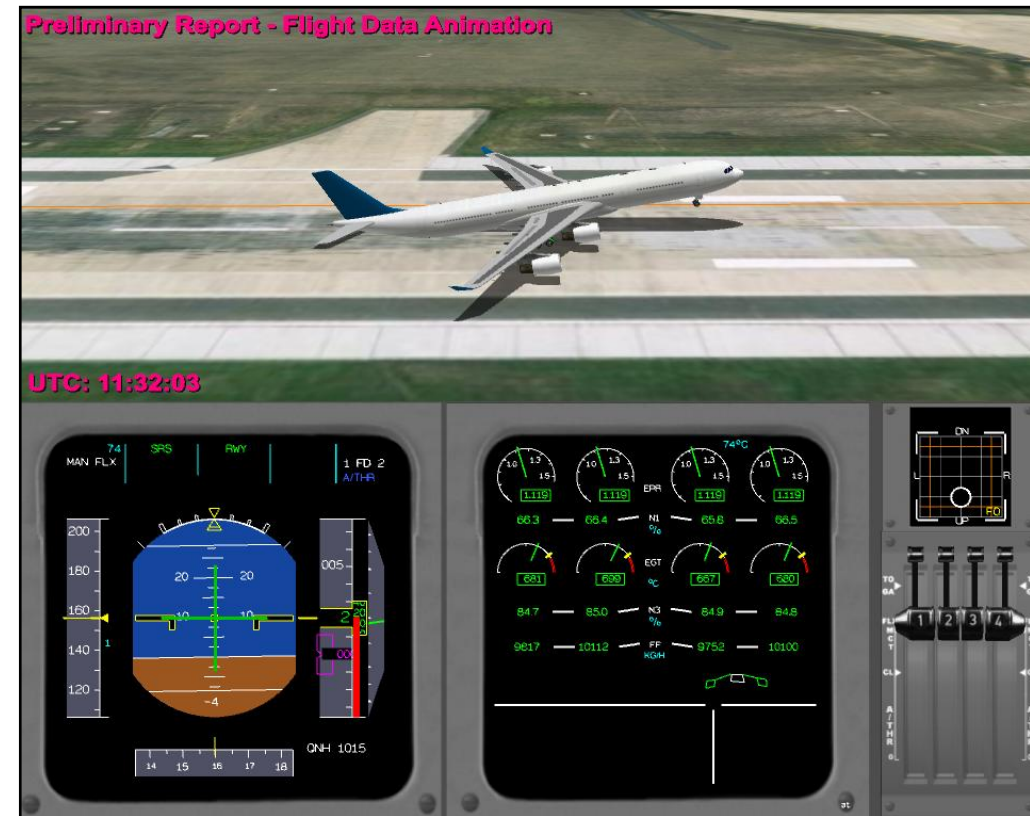
Figure B2: Initial tail contact with the runway

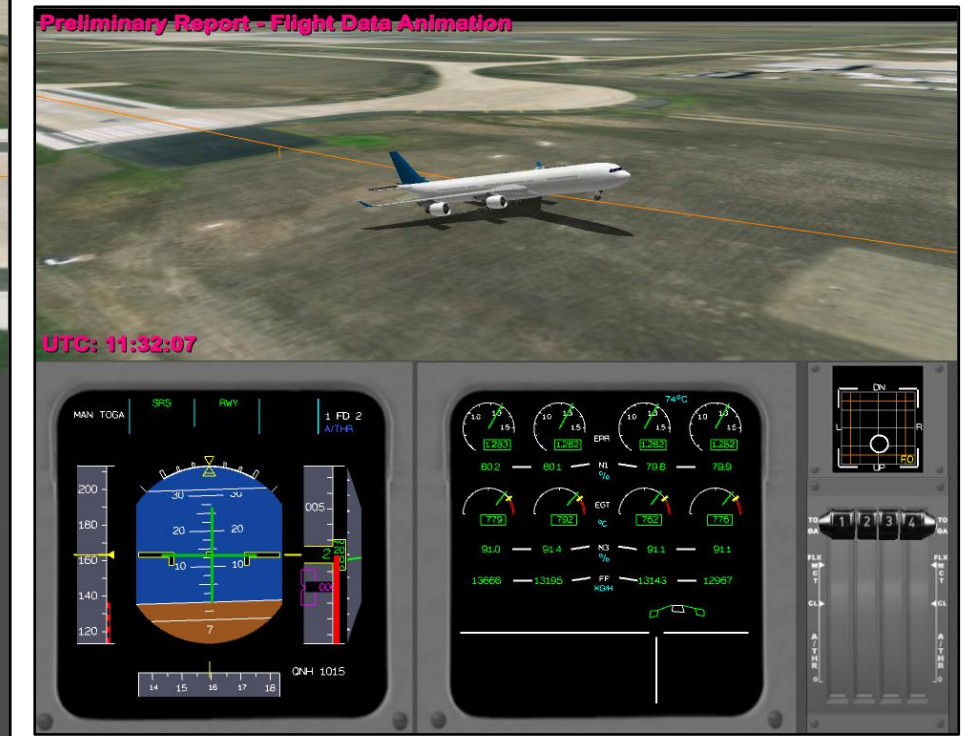
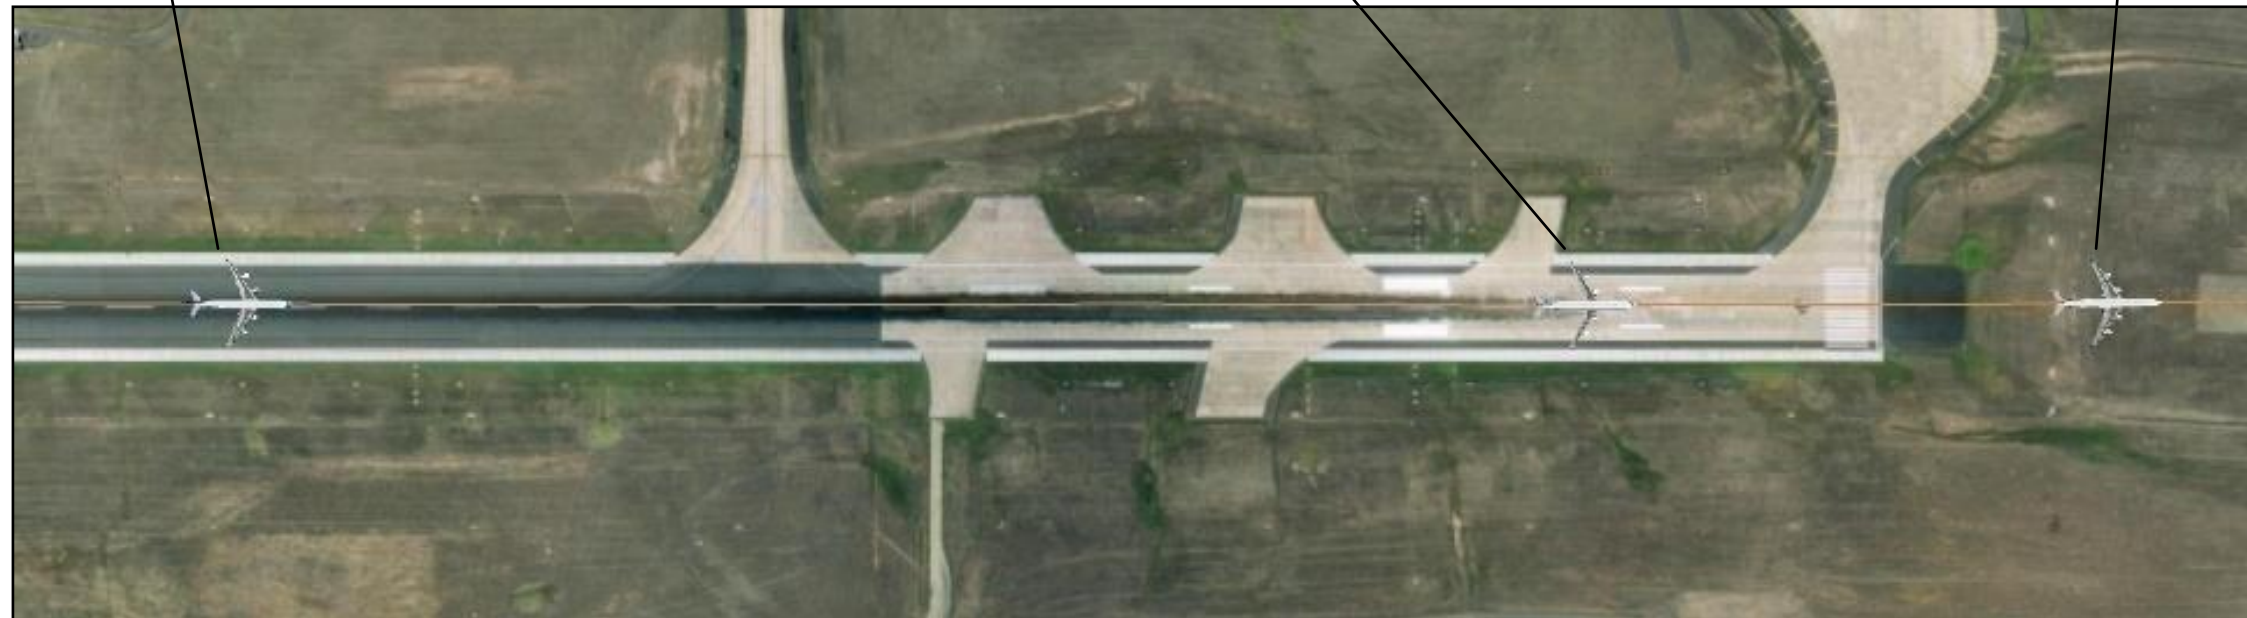
Figure B3: Final tail ground contact witness mark
