**ATSB TRANSPORT SAFETY REPORT**  
Aviation Occurrence Investigation – AO-2009-017  
Final

**Wirestrike**  
**Langkoop, Victoria**  
**20 April 2009**  
**VH-EZT**  
**Robinson Helicopter**  
**R44 Raven II**

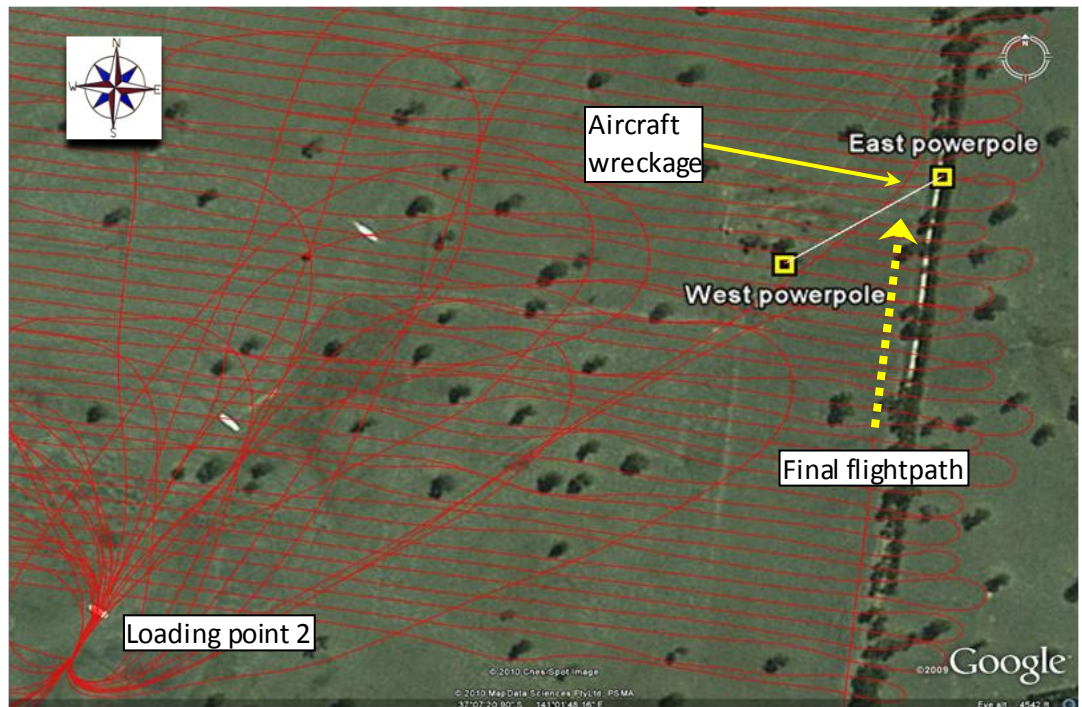
**Figure 2: EZT Satloc tracks and the position of the powerline in the northern half of paddock 2**

The spray runs for paddock 2 were divided between the two helicopters, with the pilot of EZT allocated the northern half of the paddock. The planned spray runs had been programmed into EZT's Satloc<sup>2</sup> global positioning system (GPS) tracking device in preparation for the task and while operating in this area, the pilot successfully negotiated a number of hazards that included large trees, a disused windmill, a power pole and the powerline that was ultimately struck. That powerline partially intersected the northern half of paddock 2, and was aligned in a north-east to south-west direction (Figure 2).

Recorded information showed that the pilot last flew in the vicinity of the powerline about 18 minutes prior to the wirestrike. There was no evidence that the pilot conducted a hazard identification check before commencing the cleanup run.

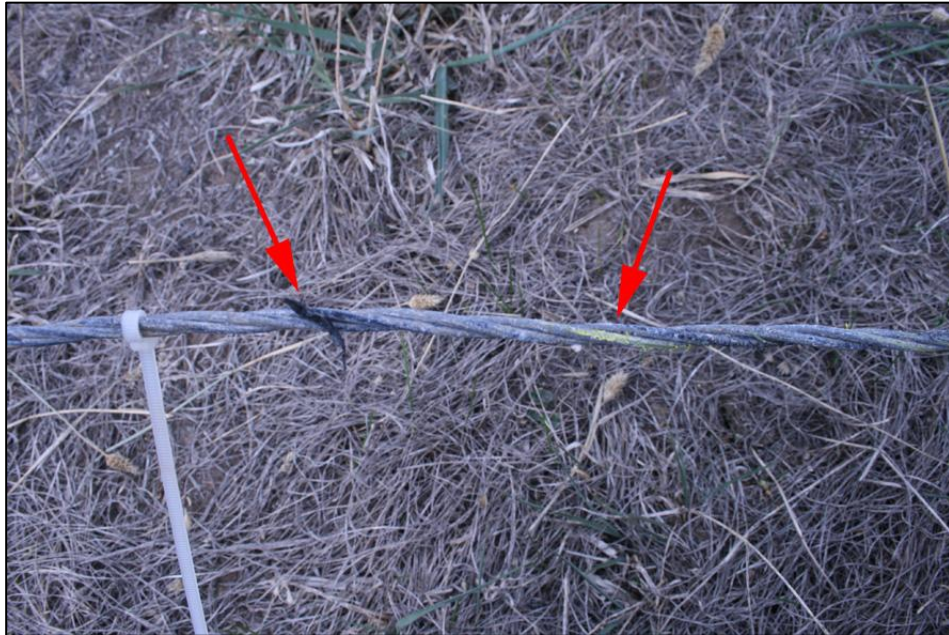
Yellow and black transfer markings were evident on the conductor in the area adjacent to the fracture in the conductor (Figure 3). Those markings corresponded with score marks that were identified on the black plastic connector and yellow hose that formed part of the helicopter's spray unit assembly.

**Figure 3: Black and yellow markings observed on the severed conductor, indicative of contact with the spray hoses and fittings**

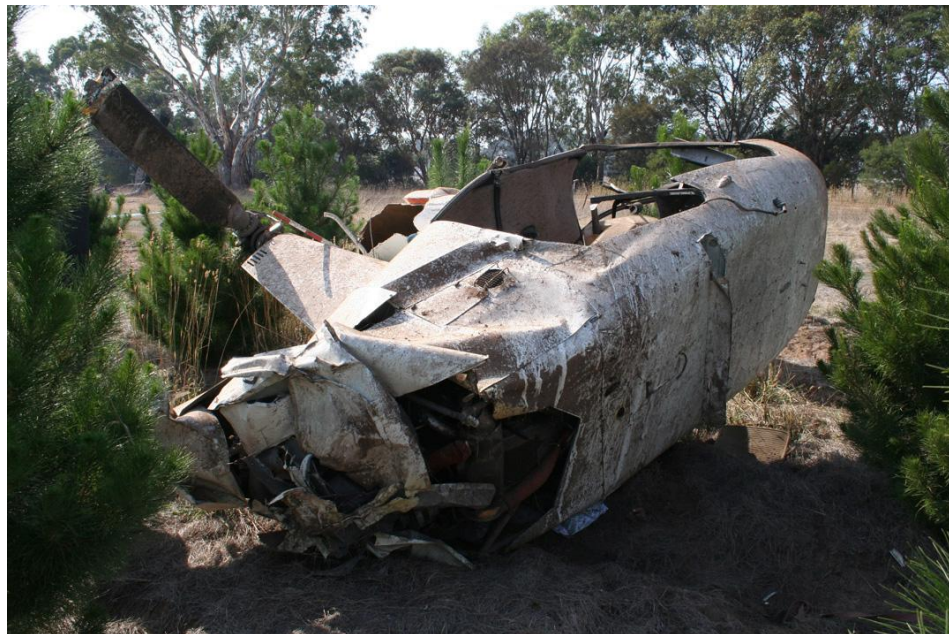
The majority of the damage was to the rear-left section of the helicopter (Figure 5). That damage and the separation of the tail boom were consistent with a compressive impact from the rear. The main fuselage and cabin area also sustained significant structural damage.

**Figure 5: Rear fuselage compression**

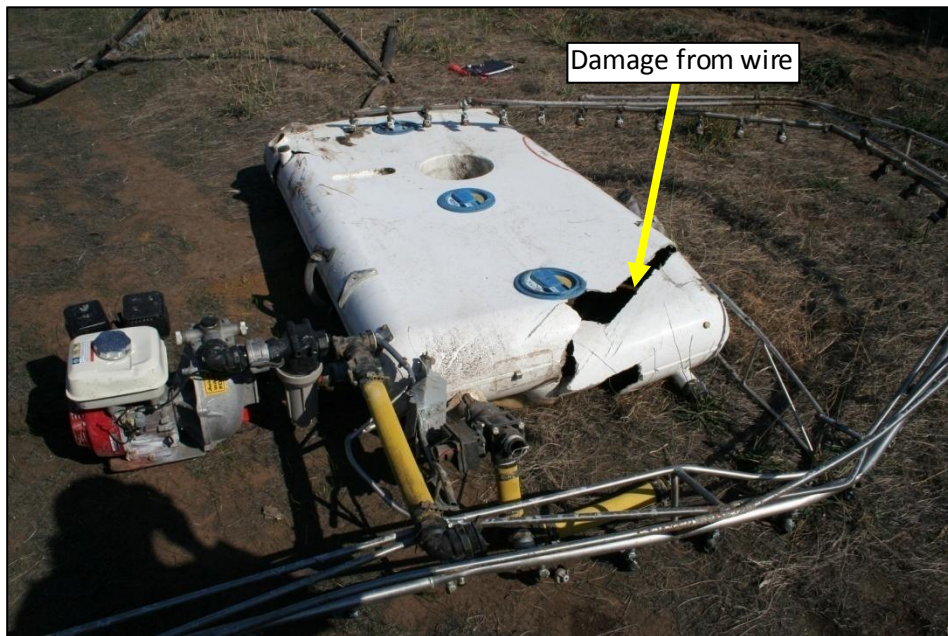
An on-site examination of the spray gear and boom determined that the front-left corner of the tank had separated from the main tank structure. The separation was

relatively clean, and the angled scrape marks on the tank's blue plastic cap towards the front of the spray tank, and on the surface of the tank were consistent with a wirestrike. The spray boom also showed evidence of contact with the powerline.

**Figure 6: Overview of the reassembled spray tank showing the damage caused by the powerline**

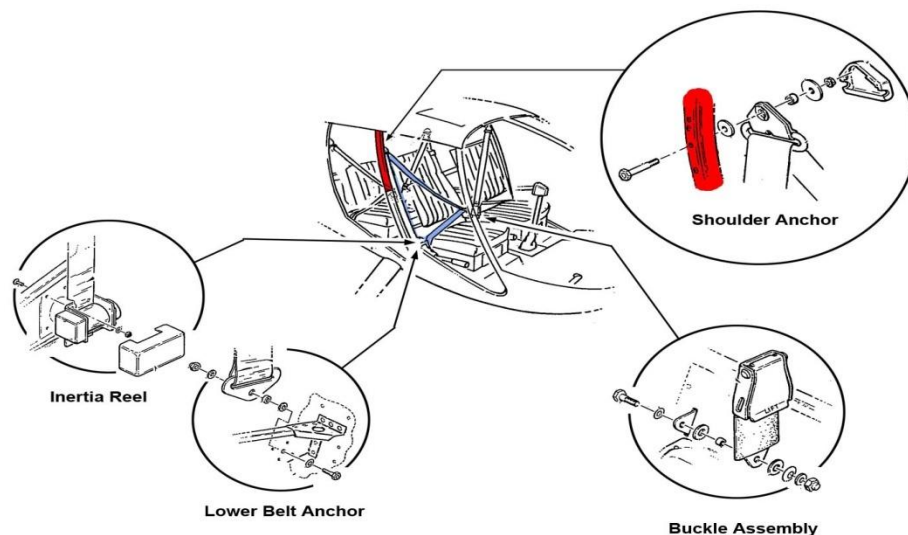
Examination of the pilot's seat belt assembly showed that two out of the three attachment points had failed. The uppermost section of the right pillar that anchored the shoulder harness had fractured and had separated from the airframe.

**Figure 7: Illustration of the R44 cabin showing the three-point seat belt assembly. The fractured pillar that anchored the shoulder harness is highlighted**

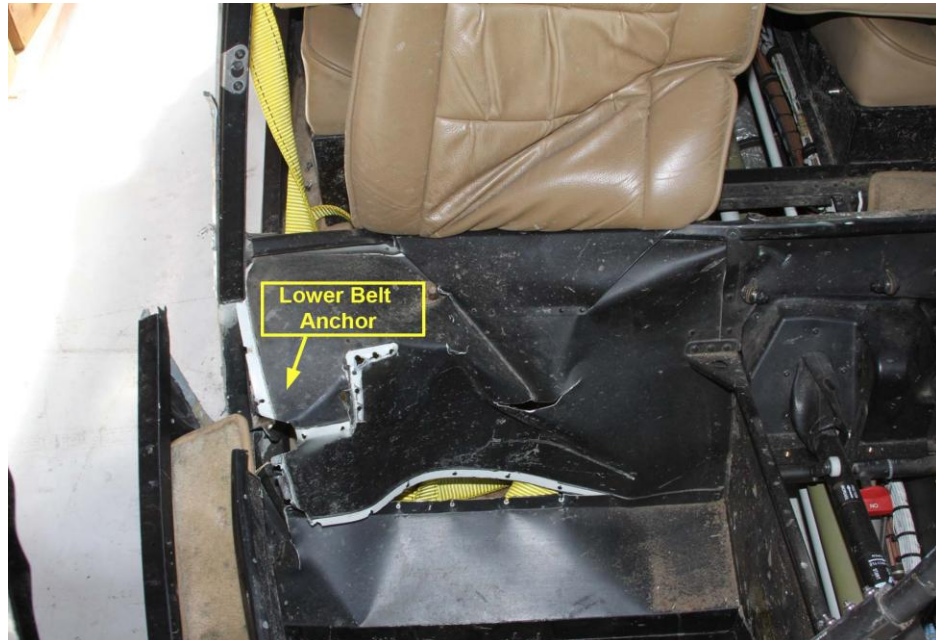
The buckle assembly was securely attached to the airframe and the seat belt harness was found latched in that assembly. The lower belt anchor bracket remained attached to a small section of the airframe, which had itself separated from the main structure (Figure 8).

**Figure 8: View of the pilot's seat showing where the lower belt anchor bracket had been attached to the seat/airframe structure**
