ATSB TRANSPORT SAFETY REPORT
Aviation Occurrence Investigation AO-2009-021
Final

**Flight control system event
520km NW of Gold Coast Aerodrome
Queensland
18 May 2009
VH-VNC
Airbus Industrie A320-232**

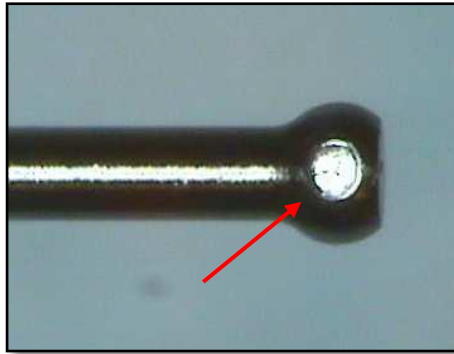
Figure 3: Abnormal ball wear

The servo valve was sent to another facility for testing. That testing found that during the manufacture of the servo valve, the neutral or null bias position had been incorrectly set. The incorrect setting led to the abnormal wear of the ball and seat within the servo (Figures 3 and 4). That wear allowed the bypass of hydraulic fluid within the unit, which caused the aileron servo oscillations.

- The servo valve within the left green aileron servo was incorrectly adjusted during manufacture. *[Minor safety issue]*
- The incorrect adjustment of the left green servo valve led to the abnormal wear of a number of components within the servo valve.
- The Elevator and Aileron Computer (ELAC) 1 sustained a fault during the flight, and the ELAC 2 automatically switched to primary control of the ailerons by utilising the stand-by aileron servos.
- Control of the ailerons by the Elevator and Aileron Computer 2 meant that the incorrectly-adjusted left green aileron servo switched to active control of the left aileron, causing oscillations of the aileron, left wing flexure and the vibration of the aircraft.

The manufacturer has introduced a semi-automated setting of the null bias, which replaced the previous manual setting. This will prevent the incorrect adjustment of the null bias during the assembly of the servo valve.

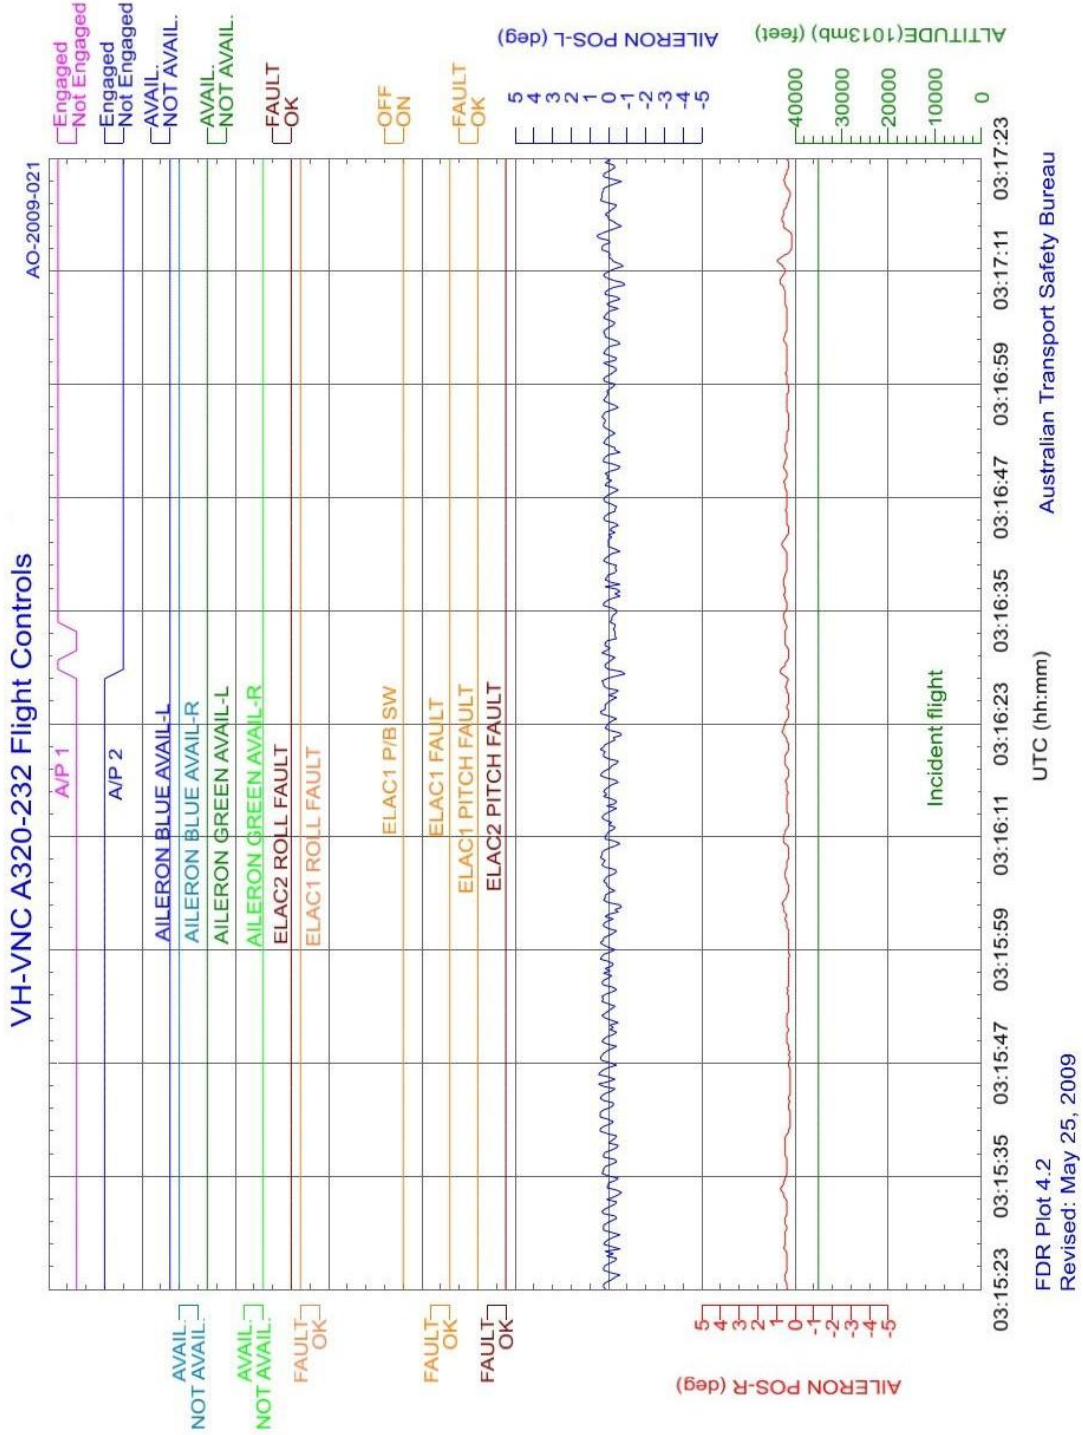
APPENDIX A: FLIGHT DATA RECORDER INFORMATION

The FDR data was downloaded and forwarded to the Australian Transport Safety Bureau (ATSB) for examination. That examination showed an ELAC 1 roll fault for the duration of the flight until ELAC 1 was turned off and then on (reset) 15 minutes before landing. Left aileron deflections, with an oscillatory effect, were also noted up until ELAC 1 was reset. The FDR readout showing the left aileron oscillations is at Appendix A.
