ATSB TRANSPORT SAFETY REPORT
Aviation Occurrence Investigation A0-2009-051
Preliminary

Collision with terrain

81 km NE Winton, Qld

17 August 2009

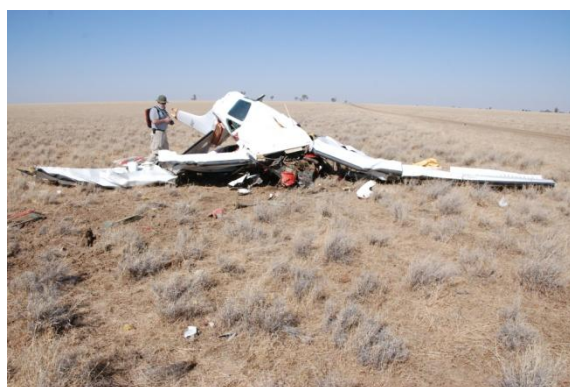
Figure 1: Accident site

The aircraft was seriously damaged² by impact forces (Figure 1). The right wingtip struck the ground first, followed by the propeller and engine; indicating that the aircraft was in a nose-low, right wing-low attitude at impact. There was no fire. There was fuel staining on the bottom surface of the right wing and a strong smell of fuel in the area.

Damage to the propeller indicated that the engine was delivering significant power at the time of impact.
