# Aircraft proximity event, VH-FKU and VH-HJH Bankstown Aerodrome, New South Wales 25 August 2009

## Abstract

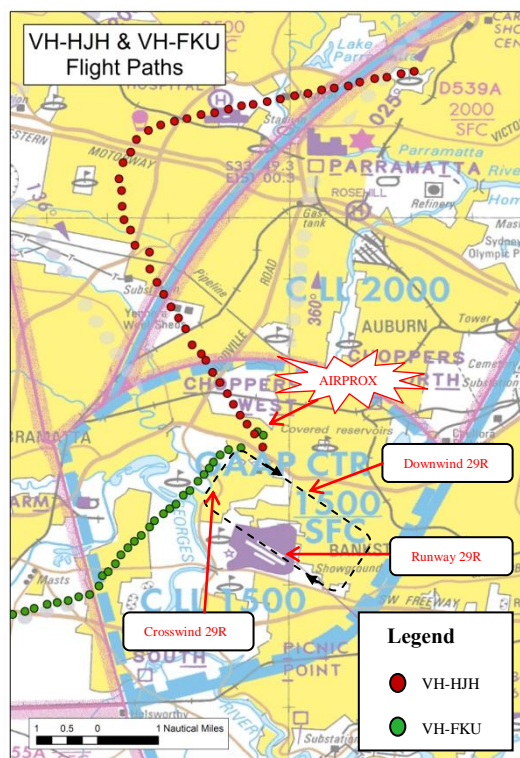
**Figure 1: Flightpaths of Chieftain VH-HJH and Cherokee VH-FKU.**

Standard Time<sup>3</sup>, when approaching reporting point 2RN from the south-west, the pilot of the Cherokee made a radio broadcast to ATC and was instructed to join the circuit on a crosswind leg for runway 29 (Figure 1).

At 17:08:25, when the Cherokee was continuing approach on an early crosswind leg for runway 29R, the pilot was instructed to ‘...widen to the left, expect to follow a Chieftain on early downwind...’. The pilot of the Cherokee conducted a slight course deviation to the left and continued on the crosswind leg. The Chieftain was in the Cherokee’s 10 o’clock position at about 3.1 NM (6 km) at that time.

At 17:08:54, the aerodrome controller, who was under training,<sup>4</sup> asked the pilot of the Cherokee whether the Chieftain was in sight. The pilot replied in the negative. The trainee controller then instructed the pilot of the Cherokee to ‘...widen out to the left’. The aircraft were by now on converging courses at 1.6 NM (3 km).

Instead of turning left, the pilot of the Cherokee turned to the right to join on a downwind leg for runway 29R, in front of and inside the flightpath of the Chieftain. The Chieftain continued on a south-easterly heading to also join on a downwind leg for runway 29R.

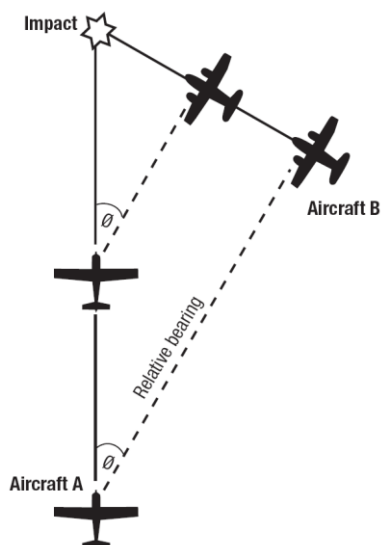
Figure 2: Lack of relative motion.

The human visual system is particularly attuned to detecting movement but is less effective at detecting stationary objects. Unfortunately, because of the geometry of collision flightpaths, an aircraft on a collision course will usually appear to be a stationary object in the pilot's visual field. If two aircraft are converging on a point of impact on straight flightpaths at constant speeds, then the bearings of each aircraft from the other will remain constant up to the point of collision. From each pilot's point of view, the converging aircraft will grow in size while remaining fixed at a particular point in his or her windscreen [Figure 2].

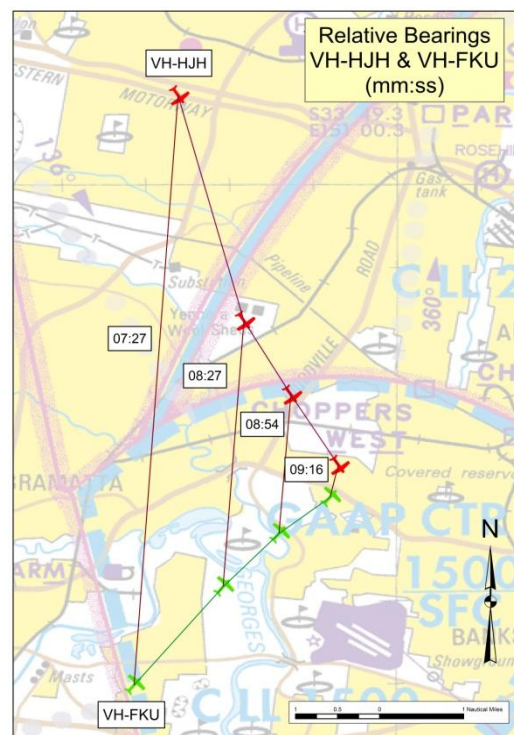
Figure 3: Lack of relative motion between VH-HJH and VH-FKU.

The flightpaths of both occurrence aircraft were such that the relative motion was not obvious to either pilot (Figure 3).

In any event, traffic information about the Cherokee was not communicated to the pilot of the Chieftain until immediately before the occurrence. In that context, the aircraft's converging courses resulted in a lack of relative motion between the two aircraft. That would have made each aircraft difficult to sight by the respective pilots.

- Both aircraft would have appeared to be stationary objects in each pilot's visual field, decreasing the likelihood that the respective pilots would sight the other aircraft.
