ATSB TRANSPORT SAFETY REPORT
Aviation Occurrence Investigation A0-2009-061
Final

Engine failure, VH-SBA

Wagga Wagga Aerodrome, New South Wales

4 October 2009

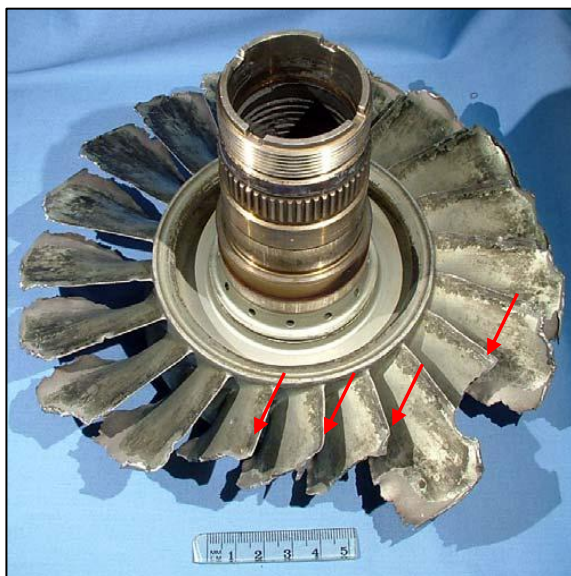
A metallurgical examination of the failed stage 1 compressor blisk blades was performed in the UK. That examination confirmed that the four failed blades from that blisk exhibited a fatigue mechanism.

- the failures of the four blades on the subject blisk were the result of reverse-bending

fatigue, under the influence of high frequency aerodynamic vibrations

- fatigue cracks were present on both sides of each fractured blade
- the overall period of stable crack growth was most likely in the hundreds of flight (engine) cycles
- the rate of fatigue crack growth abruptly and significantly increased six flight cycles before the separation of the blades
- there was no evidence that material defects or abnormalities had contributed to the failures (Figures 2 and 3).

Figure 2: Failed compressor blisk (fractured blades indicated)

The failure of four of the left engine's stage 1 compressor blisk blades was consistent with the findings of the technical investigation into a May 2001 occurrence. In both cases, the blade failures were related to high-frequency vibratory aerodynamic loading of the stage 1 compressor blisk, which resulted in the development of reverse-bending fatigue cracks in the blisk blades.

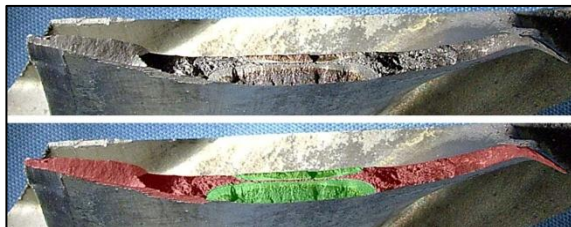
Figure 3: Typical failure blade cross-section

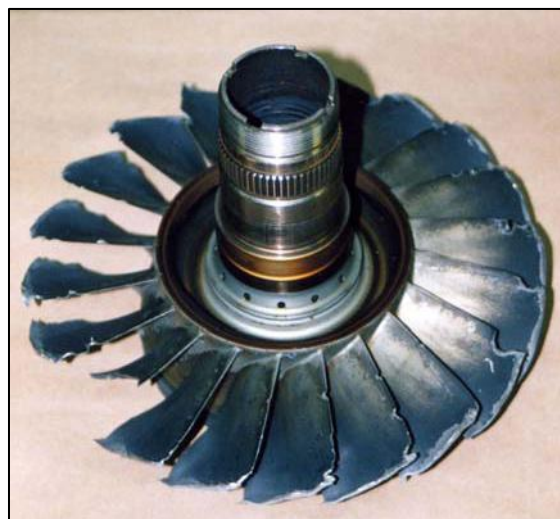
On 23 May 2001, the flight crew of SAAB 340 aircraft, registered VH-EKX discontinued the takeoff after a right engine failure. Subsequent examination revealed a failure of the stage 1 compressor blisk. At the time of the failure, the engine had accumulated a total of 13,931 hours TTIS and 16,226 hours CSN.

- no anomalies within the blisk material
- failure of the aerofoil section resulted from the growth of reverse-bending fatigue cracking at the mid-span location
- vibratory loading, exciting blade resonance was the principal source of stress driving the fatigue cracking (Figures 4 and 5).

Figure 4: Compressor blisk – VH-EKX

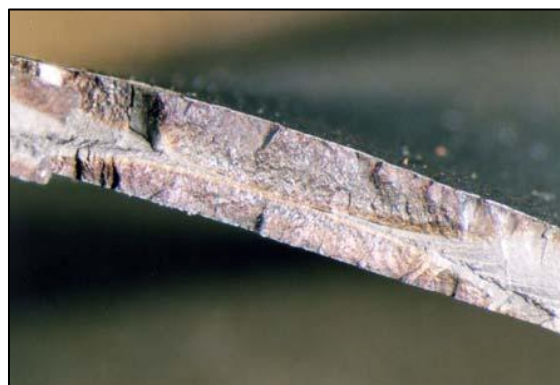
Figure 5: Failed blade cross-section – VH-EKX
