# In-flight engine failure – Christmas Island

## 19 October 2009

On 19 October 2009, a British Aerospace Avro-RJ70 aircraft sustained an in-flight engine failure shortly after taking off from Christmas Island.

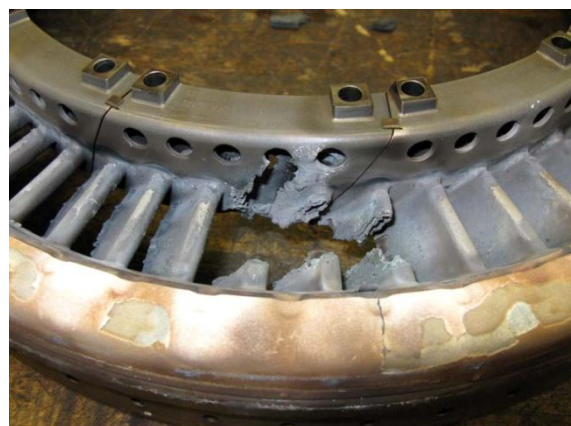
Disassembly of the HPT section found that the stage-1 nozzle guide vanes were in relatively good condition, with the notable exception of the complete burn-through of three vanes and the inner shroud at the 6 o'clock position (Figure 3). The leading edges of all stage-1 turbine blades showed evidence of heat damage and erosion (Figure 4).

**Figure 3: Stage-1 nozzle guide vanes showing burn through at the 6 o'clock position**

Based on the localised heat damage to the stage-1 and -2 nozzle guide vanes, it is probable that a defective injector nozzle allowed incomplete combustion of the fuel prior to entering the turbine section. The engine manufacturer considered it unlikely that such an event would have left any evidence, such as carbon deposits in the combustion liner, but would have caused considerable damage to the turbine section.

- The number-2 engine failed as a result of severe localised overheating and burn-through of the stage-1 nozzle guide vanes, and the subsequent destruction of the downstream turbine components.
- Damage to the stage-1 nozzle guide vanes was probably related to pre-existing and undetected defective fuel injector nozzle/s.

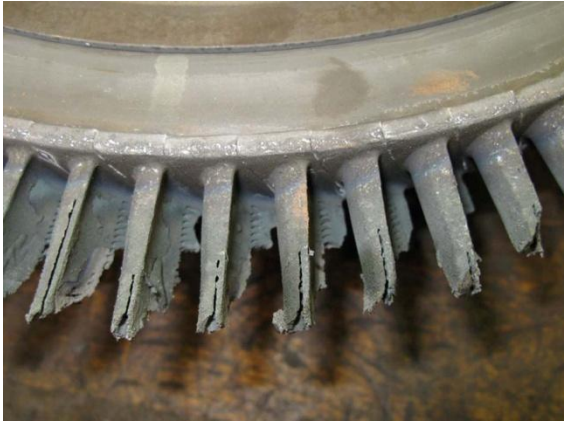
Figure 4: Stage-1 HPT with leading edge vane erosion and melting

From the evidence established during the investigation, it was apparent that the number-2 engine failed due to severe heating and destruction of the internal turbine components. The stage-1 turbine blades had sustained severe heat and erosion damage, but no impact damage. All of the rotating turbine blades and the stationary vanes downstream of the stage-2 nozzle guide vane displayed the effects of sustained high temperature exposure and related mechanical impact damage. Liberation of the stage-2 turbine blades would have produced an out of balance condition within the engine, leading to vibratory forces that allowed the rotating components to collide with the engine's stationary assemblies.

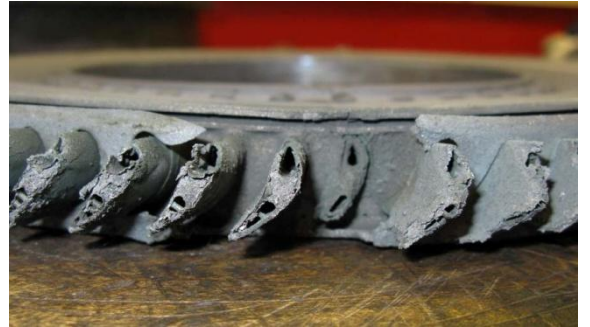
All of the stage-2 turbine blade tips had fractured unevenly along their span. The blade stub fracture surfaces were obscured by molten metal deposits and showed no evidence of solid object impact (Figure 5). The stage-2 turbine damage was consistent with blade separation from exposure to engine operating temperatures above the melting temperature of the blade material. A stage-2 nozzle guide vane was also completely burnt through at the 6 o'clock position, in a similar manner to the stage-1 nozzle (Figures 6 and 7).

Figure 7: Close-up of burn through of stage-2 HPT nozzle guide vane

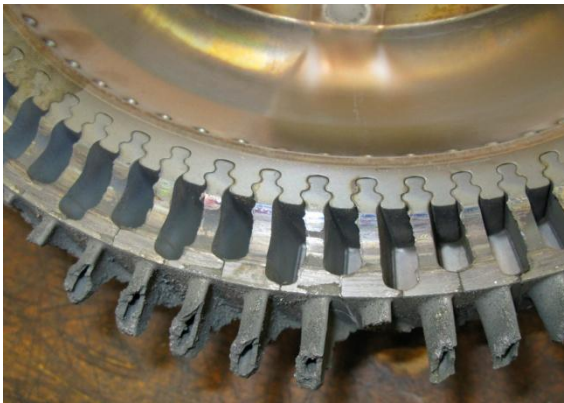
Figure 5: Stage-2 HPT blade separation

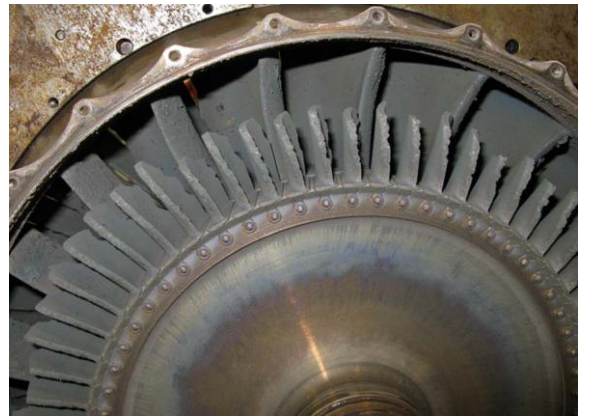
Disassembly of the LPT section revealed that all of the stage-3 and -4 low pressure turbine blades had separated at the mid-span position, with heavy impact damage and metallization<sup>10</sup> present (Figure 8).

Figure 8: Thermal damage and metallization of the stage-3 LPT showing blade tip separation

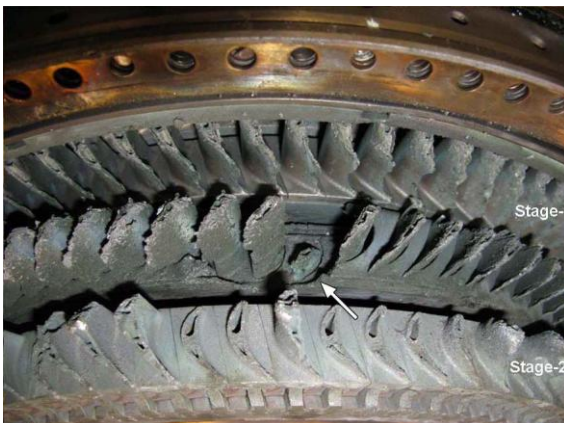
Figure 6: Severe heat damage to the stage-1 and -2 HPT, showing burn through of a stage-2 nozzle guide vane at the 6 o'clock position (arrowed)

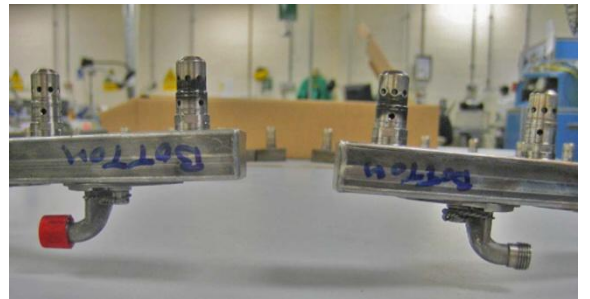
On the basis of the low time between the replacement of the fuel manifolds/nozzles and the engine failure, together with the heat damaged condition of the power turbine, the AAIB quarantined the fuel manifolds and injector nozzles for further testing and examination. Testing of all 28 nozzles from both manifolds did not reveal any undesirable nozzle spray pattern or fuel flow characteristics. All the nozzles were

reportedly clean and free from deposits (Figures 9 and 10). Examination and testing of the previously-fitted fuel injector nozzles/manifolds was not possible, as they had already been overhauled by the time the request was made.

Figure 9: View of the fuel manifold at the 6 o'clock position

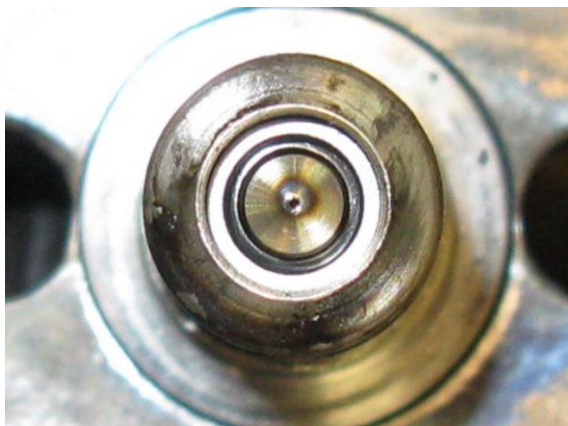
**Figure 10:** Close view of an injector nozzle from the 6 o'clock position with no blockages evident

nozzles passing the acceptance testing, a transient blockage from carbon or other detritus material may have affected the injector spray patterns. The engine's in line fuel filter was found heavily contaminated with fine particles of corrosion product. It is possible that not all of the corrosion product was captured by the in-line filter, and that some may have accumulated downstream, producing undesirable injector nozzle spray patterns and anomalous fuel atomisation behaviour.

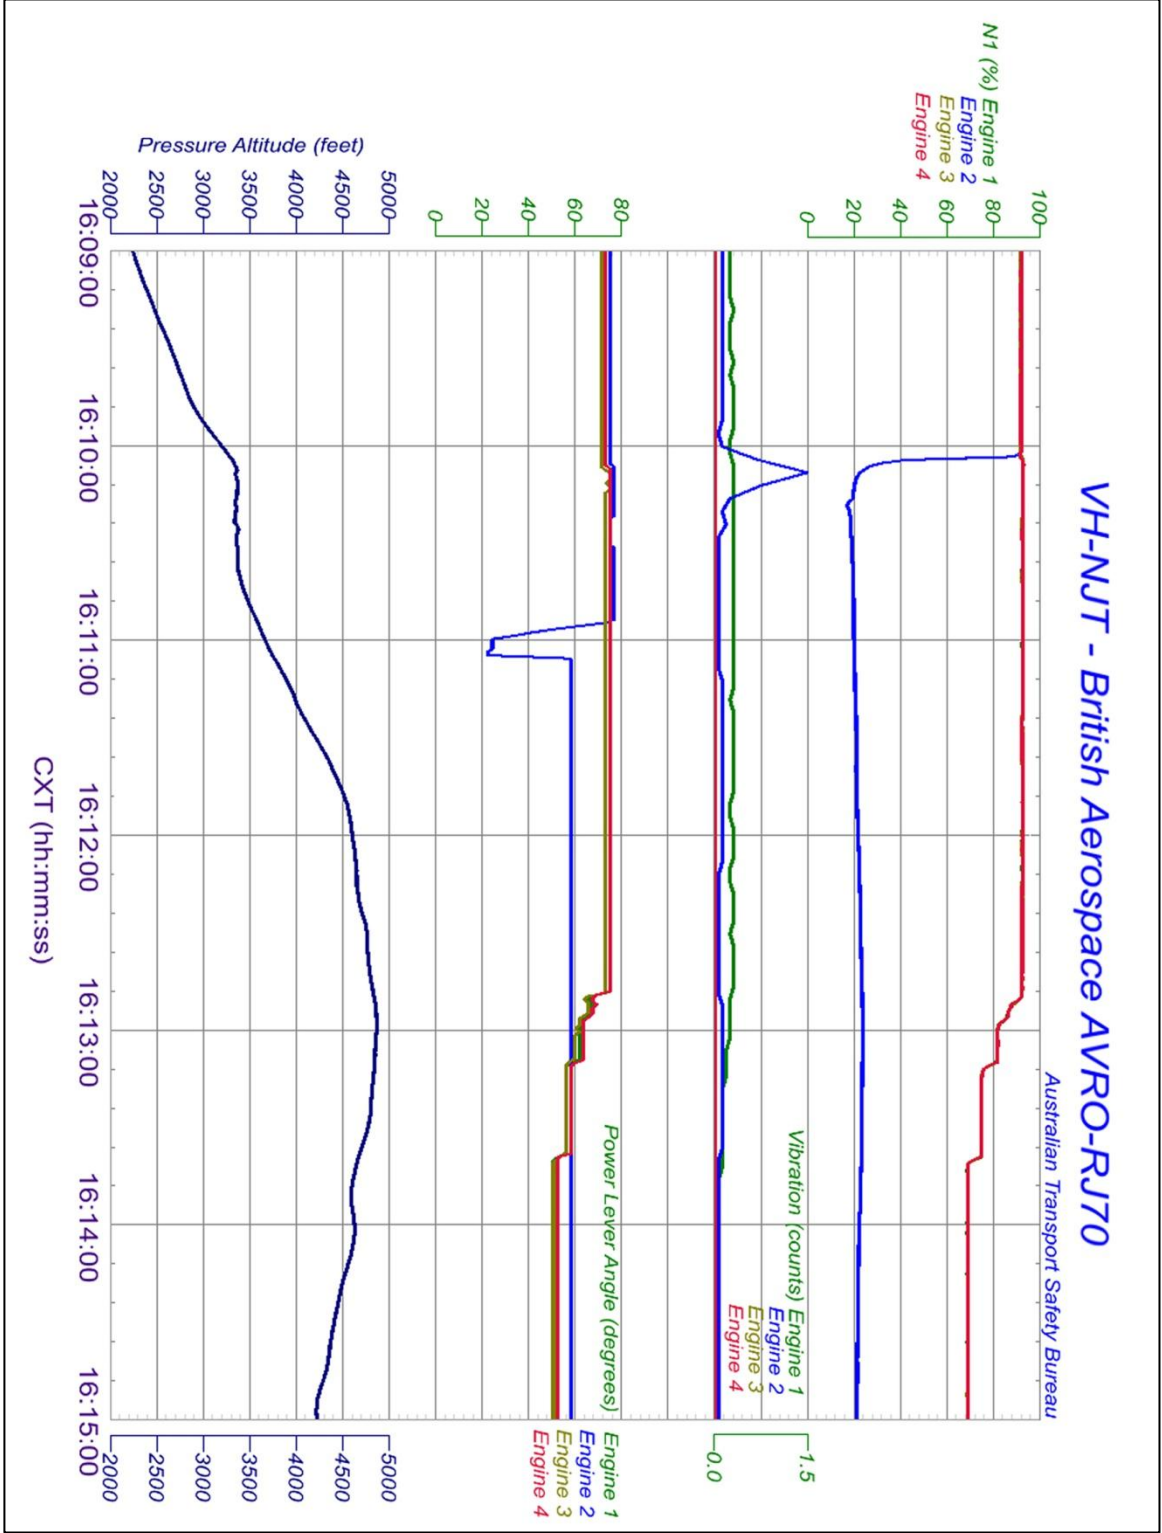
APPENDIX A: Graphical representation of flight data recorder (FDR) data from the occurrence flight

The FDR information indicated that at around 1607, the aircraft commenced the take-off roll from runway 18. The engine failure occurred approximately 2 minutes after takeoff, at an airspeed of 142 kts, as the aircraft climbed through 3,200 ft AMSL. The engine failure was revealed in the recorded data as a rapid decay in fan speed (%N1), immediately followed by an elevated spike in vibration and a low oil pressure warning. At no stage during the flight did the number-2 engine fire detection circuit trigger. About 1 minute after the engine failure and with the aircraft still climbing, the number-2 engine power lever angle was reduced.

aerodrome, and at 1626, the aircraft touched down on runway 18, after a total flight time of 18 minutes. A plot of the recorded data is presented at Appendix A of this report.
