ATSB TRANSPORT SAFETY REPORT
Aviation Occurrence Investigation AO-2009-075
Final

Midair collision
20 km south-east of Orange
New South Wales, 8 December 2009
VH-NFO, Aerospatiale AS.350B
VH-LXC, Kawasaki BK117

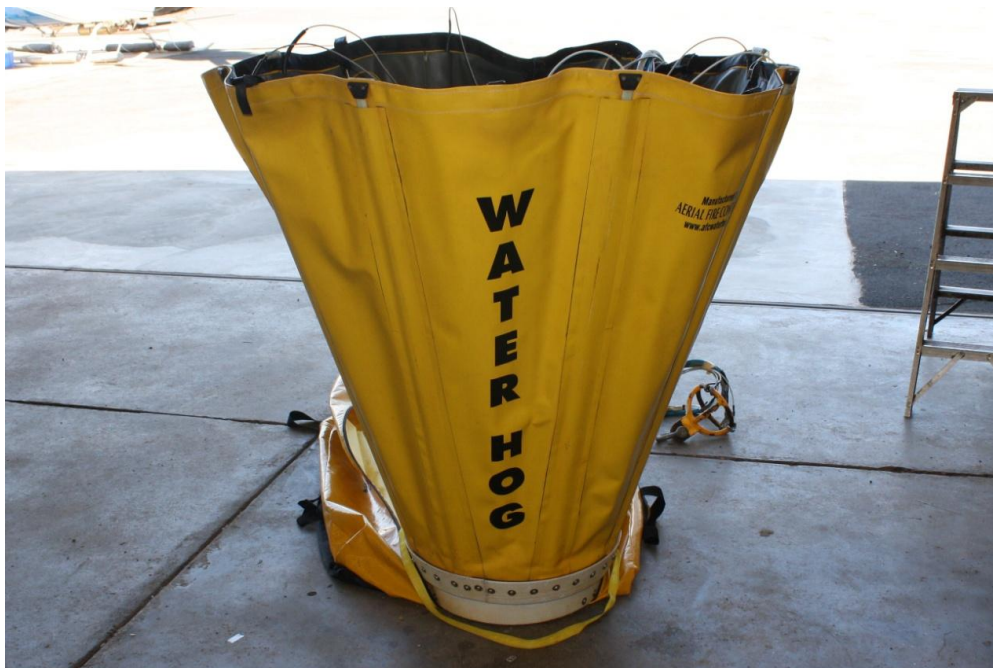
Figure 3: The 1,000 L Water hog bucket that was carried by LXC

An 800 L orange Bambi® bucket⁵ was attached to the cargo hook of NFO by the bucket's 7.5 m long suspension cables and line. A 1,000 L bright yellow Water hog® bucket⁵ (Figure 3), was attached to LXC via a 15.2 m line. That positioned the bucket, including its suspension cables, about 75 ft (23 m) below LXC. The

pilot of LXC advised that his usual practice was to use a 150 ft (45.7 m) line but that he had opted for the shorter line on this occasion because of the extreme conditions.

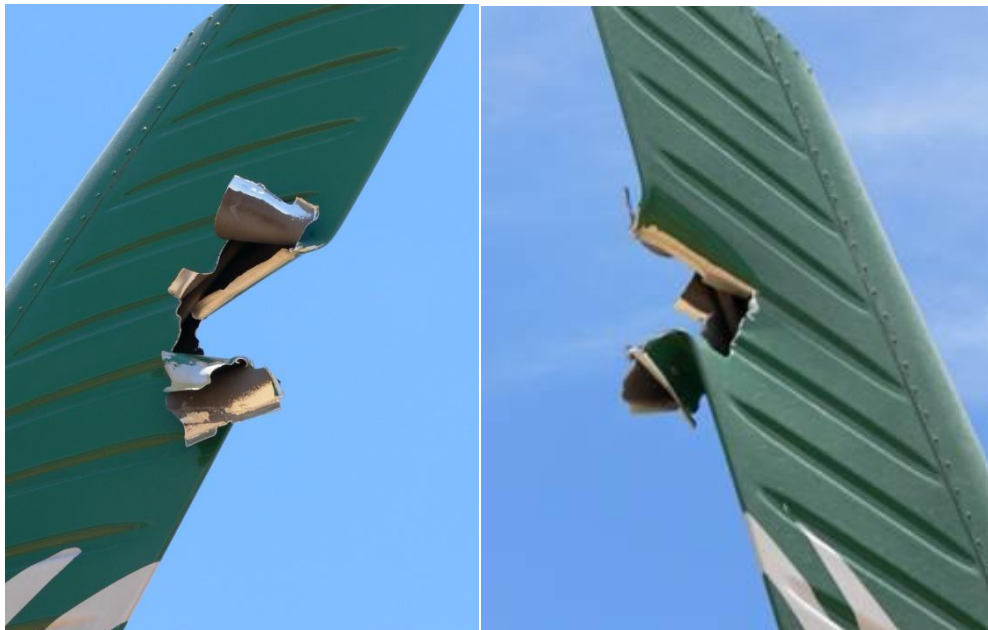
Figure 4: Damage to the vertical fin of NFO as viewed from the left and right sides

Examination of a series of photographs of the damaged vertical fin of NFO revealed that the impact was about 50 cm from the arc of rotation of the tips of the tail rotor blades (Figure 4).

Examination of the damaged skin sections following their removal for repair confirmed that the damage displayed the characteristics of a high energy impact. It was evident that the direction of impact was horizontal and from right to left (looking forward).

It was apparent from the damage to the fin of VH-NFO (NFO) that impact from the main rotor blade tip(s) of VH-LXC (LXC) was the source of the damage. Only the slimmest of margins prevented the collision becoming a catastrophe involving the destruction of both helicopters and the likely loss of life of the pilots. The accident sequence began when the system of traffic separation in the circuit between the water sources and the fire front broke down. Subsequently, the sole remaining line of defence, 'see and avoid', also failed. Chance then determined the severity of the outcome.

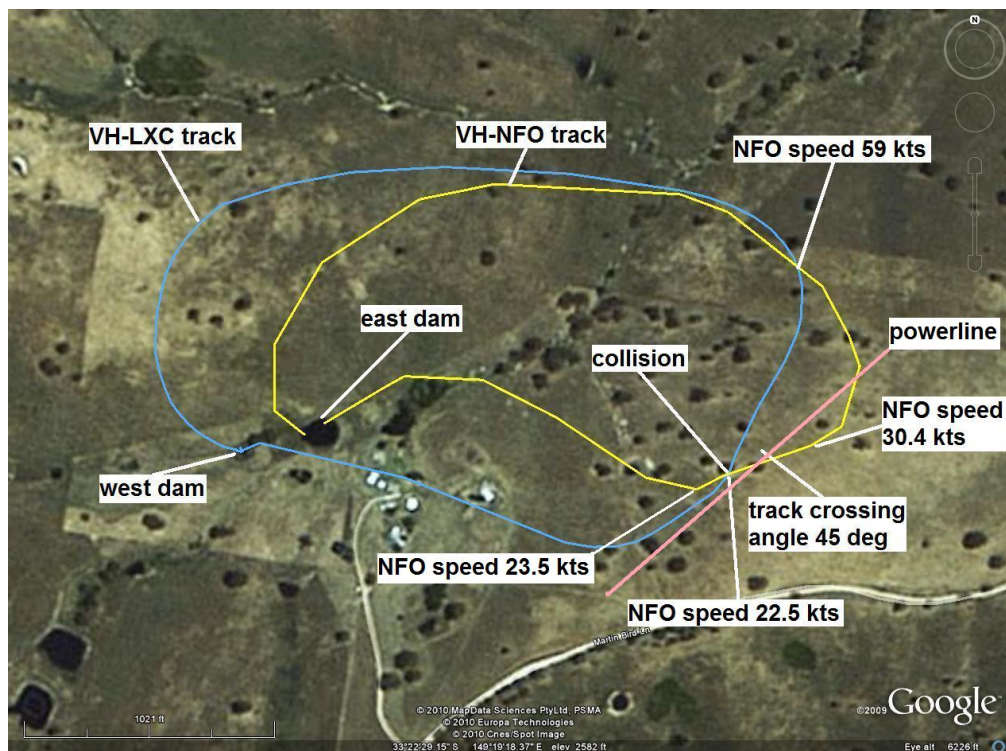
Figure 5: Probable track combination for NFO (yellow) and LXC (blue) showing the location of the collision and the track crossing angle

Figure 5 shows the track combination of NFO (yellow) and LXC (blue) that best fits the above conditions. The recorded data showed that, subsequent to these circuits, NFO and LXC each completed two more circuits before departing the fire area.

- The recorded speed of NFO at the collision point of 22.5 kts (41.8 km/h) was the minimum recorded speed for that circuit (except for the acceleration and deceleration segments at the dam).
- The crossing angle between the helicopters’ tracks was about 45°.
- The distance between the probable collision point and NFO’s right turn at 23.5 kts was about 35 m. The time interval between those data points was 3 seconds.

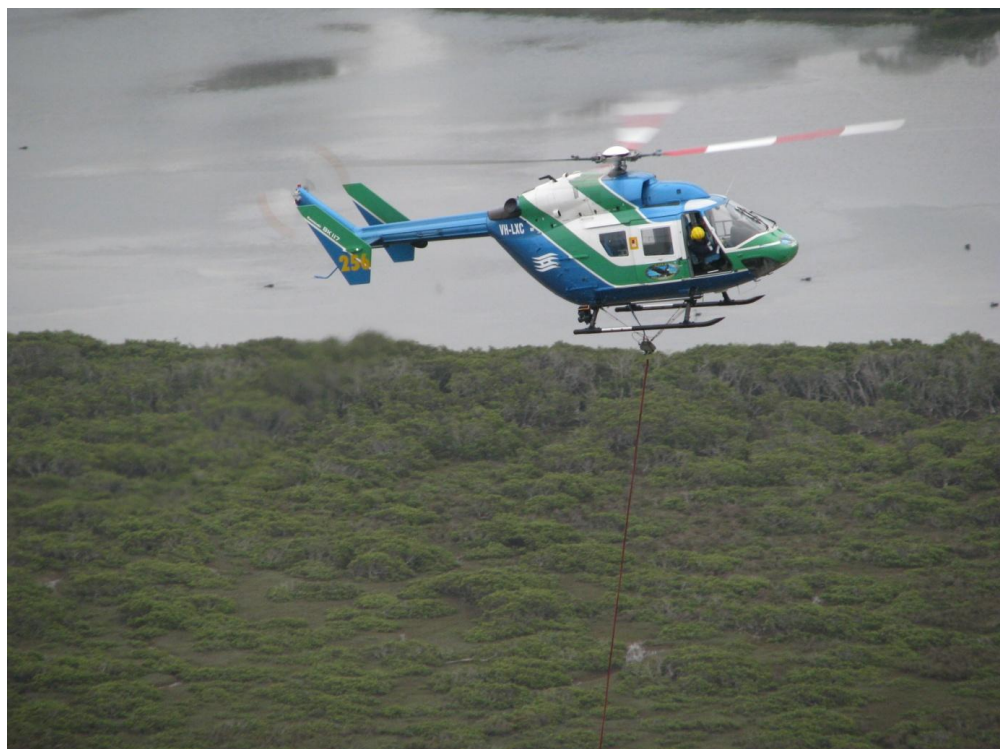
Figure 6: Showing LXC operating with a long line, with the pilot leaning outwards through the door opening, looking downwards, and ‘flying the bucket’

- Long lines were advantageous for extinguishing 'hot spots' such as burning logs beneath tree canopies.
- Long line operations involved a higher pilot workload and demanded increased pilot finesse than for short line operations. Pilots referred to the concept of 'flying the bucket' where the pilot leaned out of the cockpit door and manoeuvred the helicopter as required by the in-flight behaviour of the bucket (Figure 6). The pilot's attention was directed primarily below the helicopter. Compared with short line operations, long line operations required more attention to 'flying the bucket', and reduced the level of attention the pilot could devote to looking out for other traffic. The level of pilot attention directed

- In the case of short line operations, the pilot was able to observe the behaviour of the bucket via a mirror that was attached to the lower forward fuselage and visible through the aircraft’s chin window. Bucket behaviour was more predictable and required less attention to control. Consequently, the pilot could devote much of his attention to looking out for other traffic, compared to the long line situation.
- Because of the magnitude of their main rotor downwash and its likely affect on fire behaviour, larger helicopters such as the BK117 were restricted to using long lines to achieve a greater distance between the fire and the helicopter.

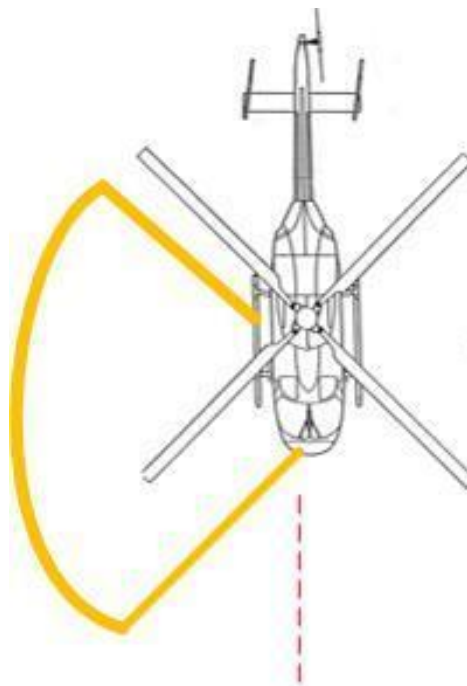
Figure 7: Illustrative pilot's field of view from LXC while 'flying the bucket'

- The pilot's seating position in LXC meant that he had a largely unobstructed view to the right and ahead of the helicopter, while his view to the left was restricted by the cabin frame. However, during the periods when he was attentive to 'flying the bucket', his view ahead and level with the helicopter was likely to have been limited. Figure 7 is illustrative of the pilot's field of view while 'flying the bucket'.
- The collision occurred close to the drop position, which meant that the pilot of LXC at that stage would have been increasingly focused on the drop with less attention devoted to looking out for other traffic.
- Because the pilot of LXC had been engaged in long line operations for more than 2 hours, his performance may have been affected by fatigue associated with the workload involved in long line operations.

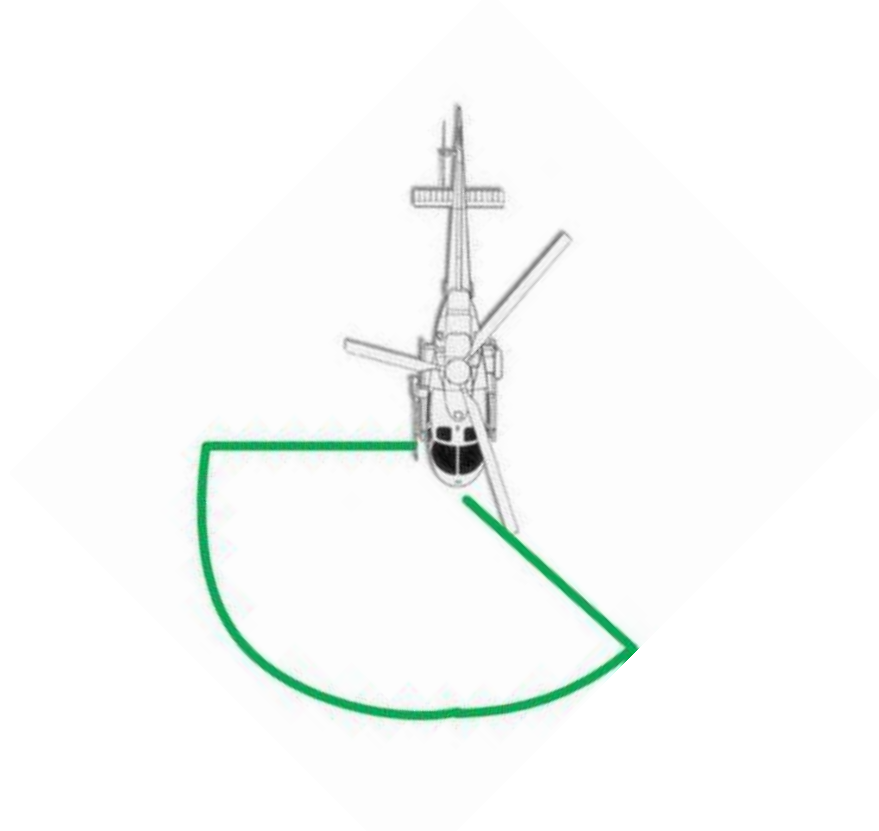
Figure 8: Illustrative pilot's field of view in NFO

- Because he was not using a long line, the pilot's workload was lower than that of the pilot of LXC, and therefore allowed him more spare capacity that could have been devoted to lookout.
- The pilot's seating position meant that he had a largely unobstructed view right and ahead of the helicopter, while his view to the left was restricted by the cabin frame (see illustrative view in Figure 8).
- The collision occurred close to the drop position, which meant that he would have been increasingly focused on the drop with less attention devoted to lookout.

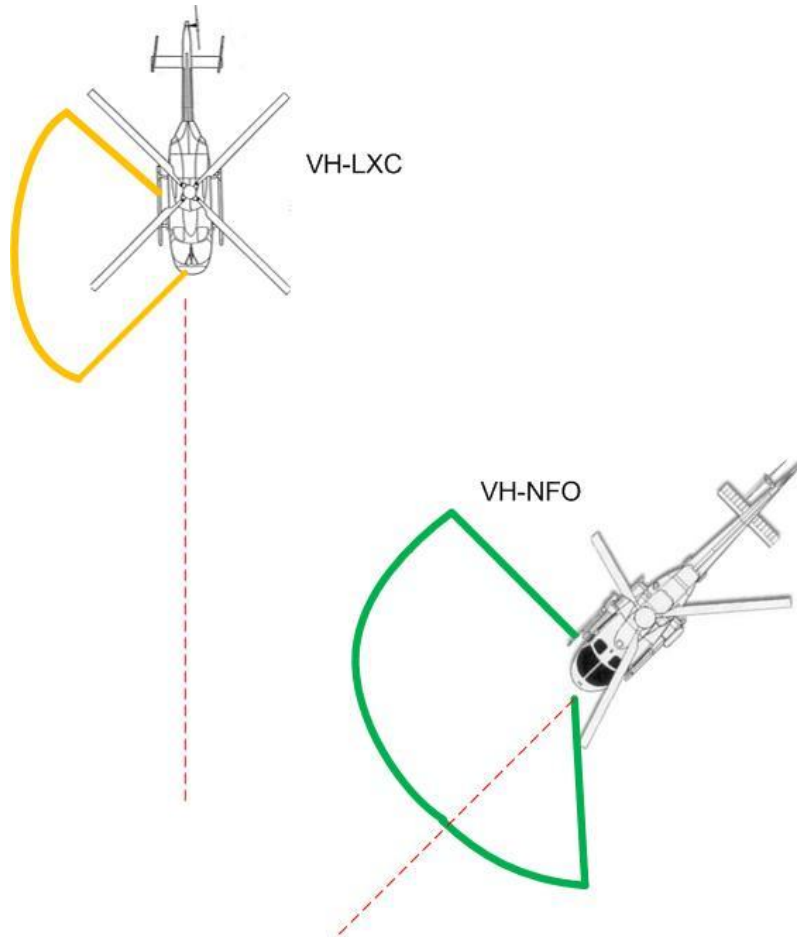
Figure 9: Converging helicopter tracks and illustrative pilots’ fields of view

- In comparison, the pilot of NFO had a greater capacity for lookout because he was not required to ‘fly the bucket’ and LXC would have been to his right as the flight paths converged. However, his focus of attention would have been the target drop area ahead of the helicopter. Unless LXC had been forward of an approximate abeam position relative to NFO, there was little likelihood of the pilot of NFO seeing LXC (Figure 9).

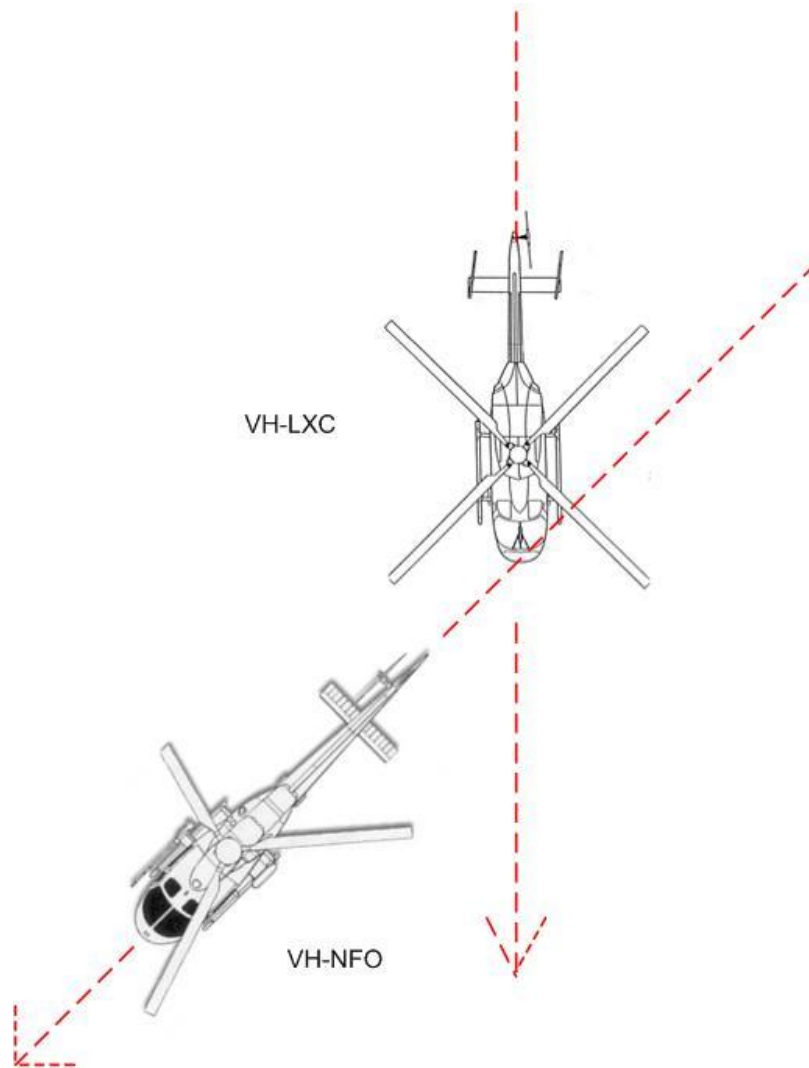
Figure 10: Showing probable collision geometry

If LXC was sufficiently behind the right abeam position in respect of NFO to have been outside the field of view of NFO’s pilot, it was entirely plausible that neither pilot became aware of the other helicopter prior to the collision. That was consistent with the evidence from both pilots that neither saw the other helicopter prior to the collision, and indicated that the collision occurred as LXC passed behind NFO as the tracks crossed (Figure 10).

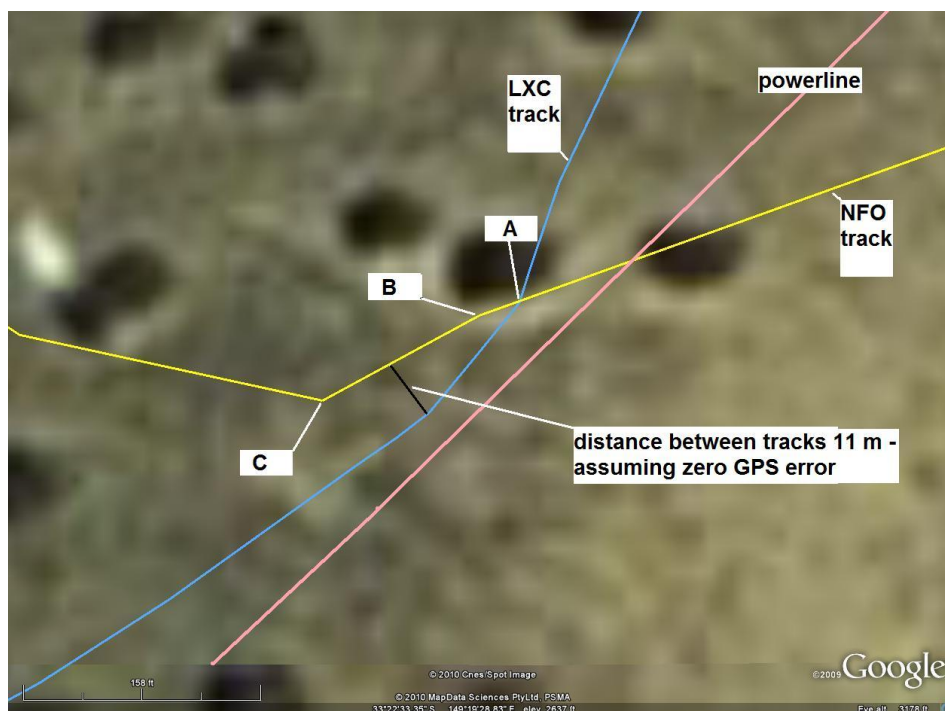
Figure 11: Expanded view of GPS track data

- For the tail fin of NFO to have contacted the main rotor of LXC as NFO turned right (location C) as suggested, NFO would have had to have passed very close to LXC between locations B and C. Under those conditions, there was a strong possibility that the main rotor systems of the helicopters would have enmeshed.

In summary, there were aspects of the scenario proposed by the pilot of LXC that were not robust. The investigation considered that, compared to the probable collision geometry developed earlier in this analysis, the scenario proposed by the pilot of LXC did not offer the same level of conviction.
