Abstract

Midair collision

20 km SE of Orange, New South Wales

8 December 2009

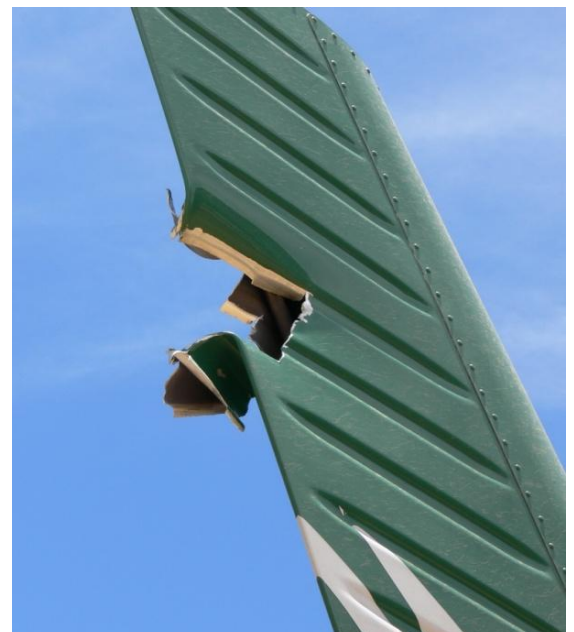
Figure 1: Damage to the vertical fin of VH-NFO

After the pilot of NFO had landed to refuel, he noticed damage to the trailing edge of the helicopter's vertical fin (Figure 1). In addition, the plastic navigation light cover on top of the vertical fin was broken. The pilot reported the damage to the pilot of LXC. Examination of LXC did not reveal any apparent damage. There were no injuries.

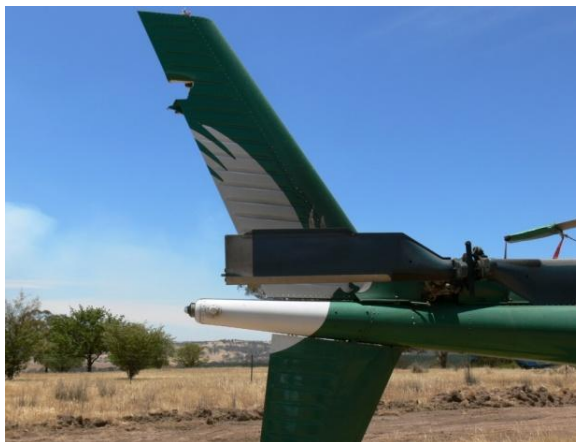
Figure 2: Damage in relation to tail rotor

Examination by the Australian Transport Safety Bureau (ATSB) of a series of photographs of the damaged vertical fin of NFO revealed that the impact was about 50 cm from the arc of rotation of the tips of the tail rotor blades (Figure 2).

Examination of the damaged skin sections following their removal for repair confirmed that the damage displayed the characteristics of a high energy impact. It was evident that the direction of impact was horizontal and from right to left (looking forward).
