ATSB TRANSPORT SAFETY REPORT
Aviation Occurrence Investigation
AO-2010-023
Final

**Collision with terrain
43 km east of Perth Airport
Western Australia
28 March 2010
VH-KDS
Piper Aircraft PA-30-160B
Twin Comanche**

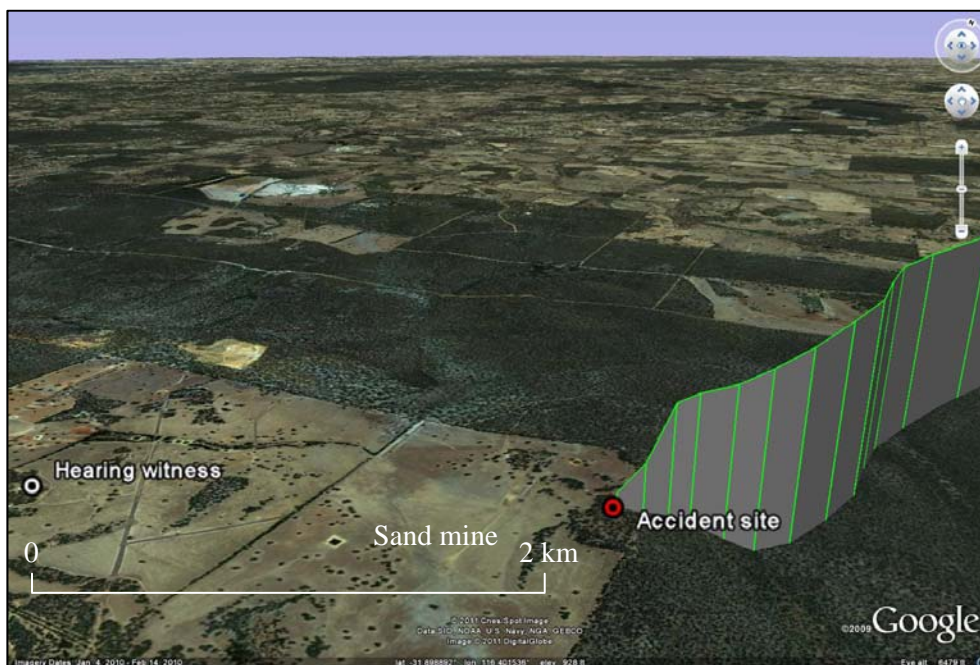
Figure 2: Final flight segment

Information on the aircraft's flight path was recovered from a Global Positioning System (GPS) unit onboard the aircraft. That information, which included position, groundspeed and altitude, indicated that following departure from Jandakot Airport, the aircraft tracked to the north via a VFR route to the east of Perth Airport (Figure 1). The aircraft overflew Northam township prior to conducting operations between Toodyay and Goomalling township, before tracking to the south via the same VFR route towards Jandakot. The GPS data indicated that, at 0948 on 28 March 2010, the aircraft commenced a steep descent from about 3,500 ft that continued to ground level (Figure 2). The GPS data also indicated that in the minute before the descent, the groundspeed steadily decreased while the aircraft maintained an approximately constant track and altitude (see the section titled *Examination of recovered components*).

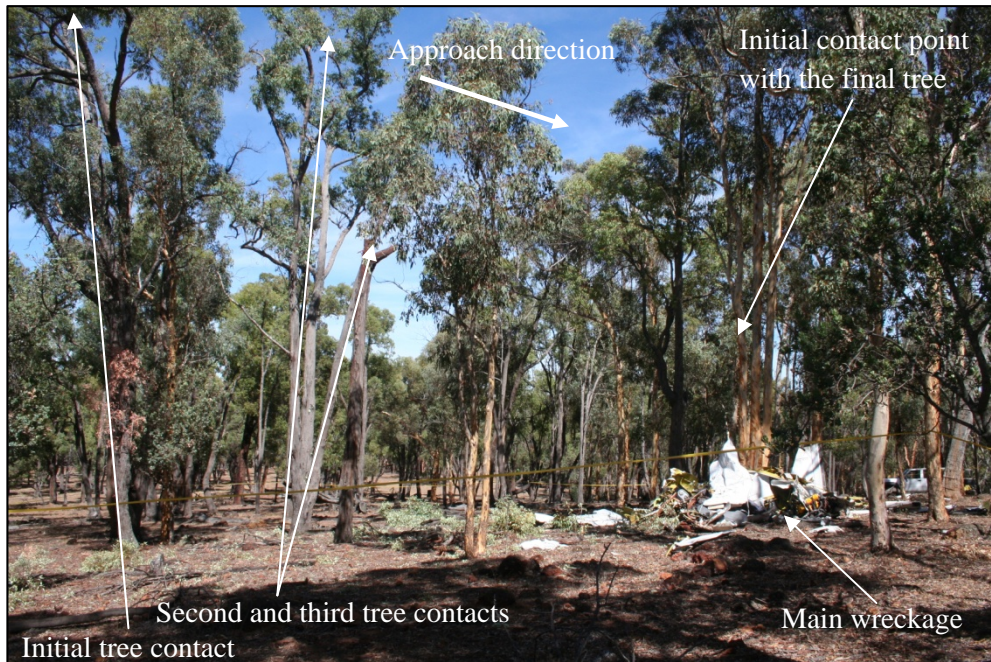
Figure 4: Accident site

the approach direction (Figures 4 and 5). The aircraft occupants were found outside of the cockpit, adjacent to the main wreckage.

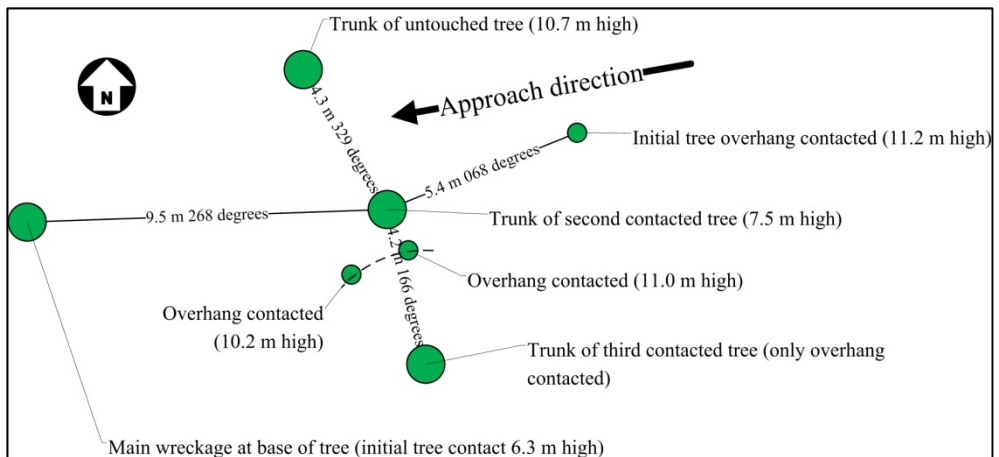
Figure 5: Accident site plan view

A comparison of the aircraft's 10.6 m wingspan with the relative height and position of the contacted and untouched trees in the vicinity identified that the aircraft was banked during the contact with the second and third trees.

The tree contact marks indicated that the descent angle of the aircraft was between about level and 34° down immediately prior to the collision. An examination of the recovered GPS data indicated that the aircraft descended from 3,500 ft to the accident site at an average angle of about 38°.

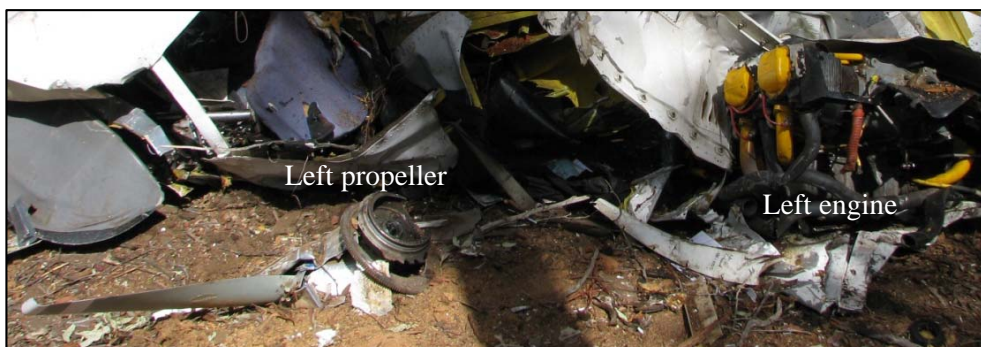
Figure 6: Left propeller

Both left propeller blades appeared to be in the feathered position with no rotational damage evident.

Disassembly and examination of the left propeller identified contact marks and damage that were consistent with the propeller being in the feathered position prior to impact (see the section titled *Multiengine aeroplane propellers*). Examination of the right propeller indicated that the propeller was in the low (fine) pitch position and operating at low RPM.

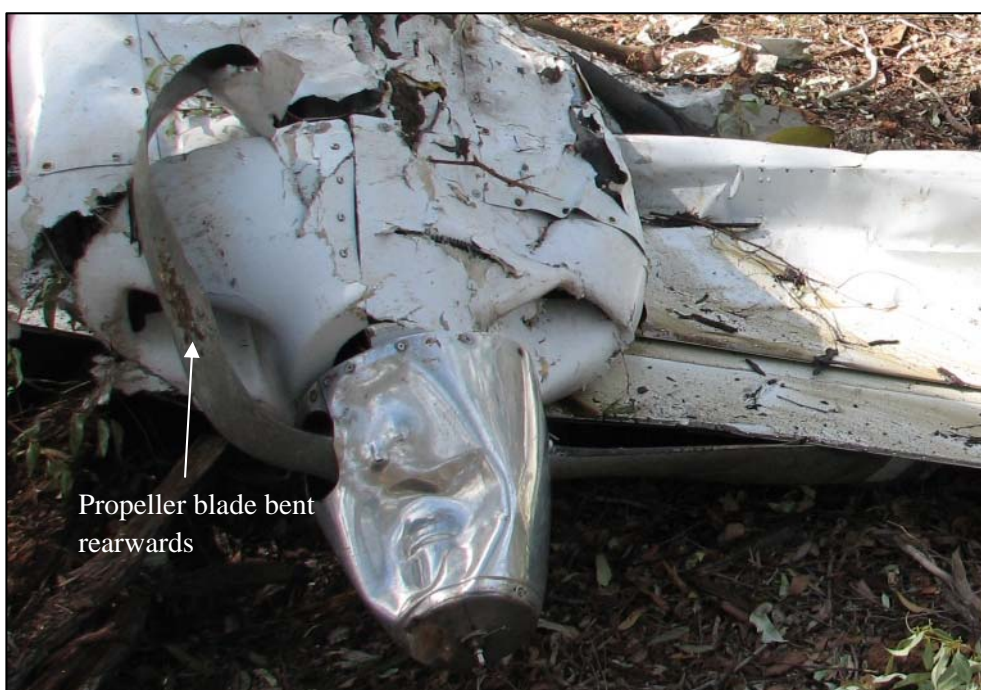
Figure 7: Right propeller

The right propeller remained attached to the engine with one blade bent rearwards about 90° (Figure 7). Both right propeller blades appeared to be at low (fine) pitch angle.

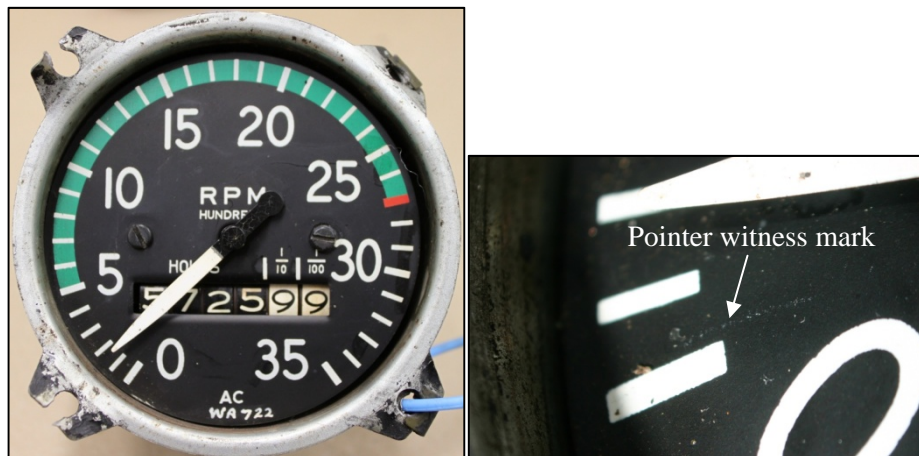
Figure 8: Left engine tachometer

An examination of the engine tachometers identified a witness mark on the left tachometer at about zero rpm (Figure 8), and a circumferential score mark between 900 and 1,000 RPM on the right tachometer (Figure 9).

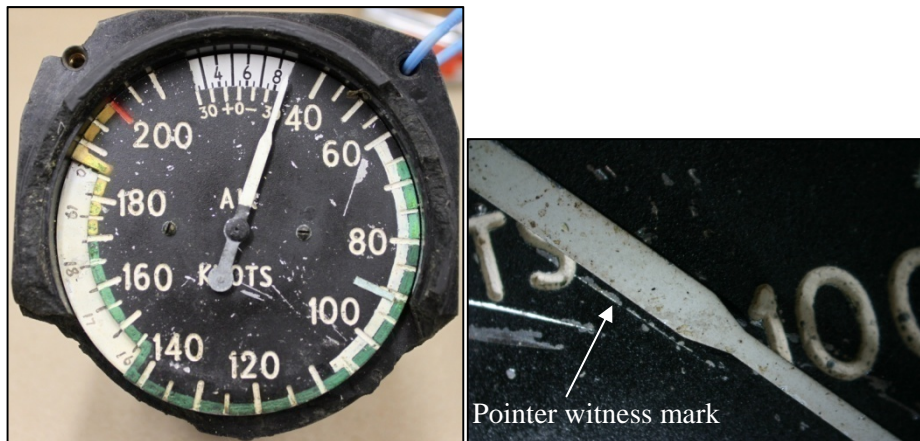
Figure 10: Airspeed indicator

In addition, a witness mark was present on the airspeed indicator (ASI) at about 100 knots (Figure 10). Examination of the face of the ASI showed a blue radial line identifying the best rate-of-climb airspeed with one engine inoperative (V_{YSE}) of 91 KIAS¹⁶. However, the minimum control airspeed with the critical engine inoperative (V_{MCA})¹⁷ (see the section titled *Asymmetric operation*) was not identified. The owner of the aircraft advised that he could not recall any airspeed values marked on the glass surface of the ASI.

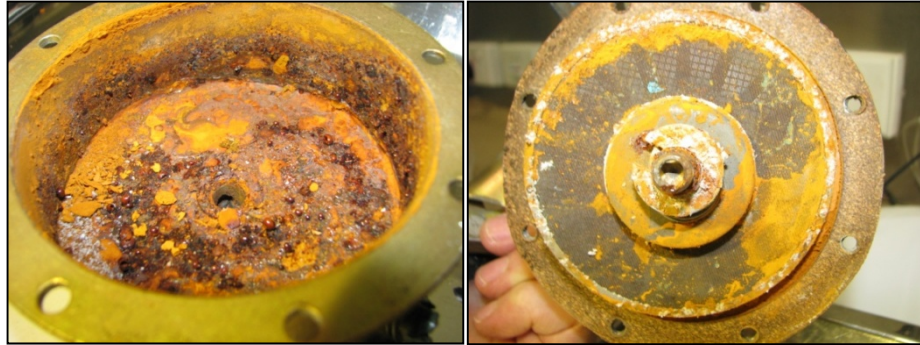
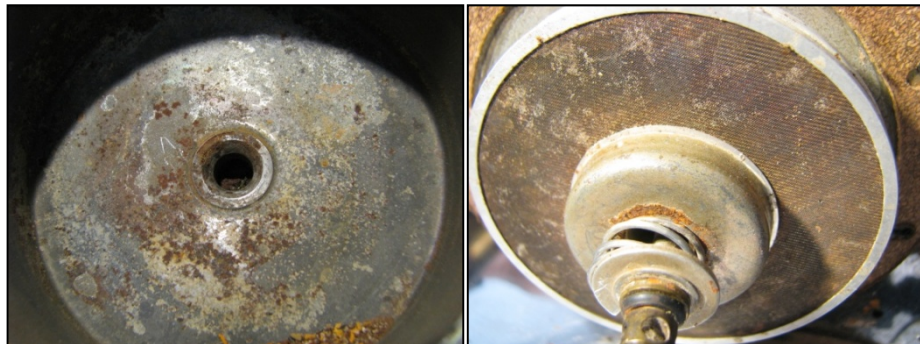
An examination of the fuel selector assembly found corrosion in both of the filter bowls (Figures 11 and 12). Both filter elements, however, appeared relatively clear of debris and there was no evidence of particulates or blockage in any of the fuel valve ports or engine fuel system components. No evidence of water contamination was identified in either engine fuel injector unit. Water and a small amount of debris were identified within the right fuel injector filter; however, the debris was not considered sufficient to restrict the fuel flow.

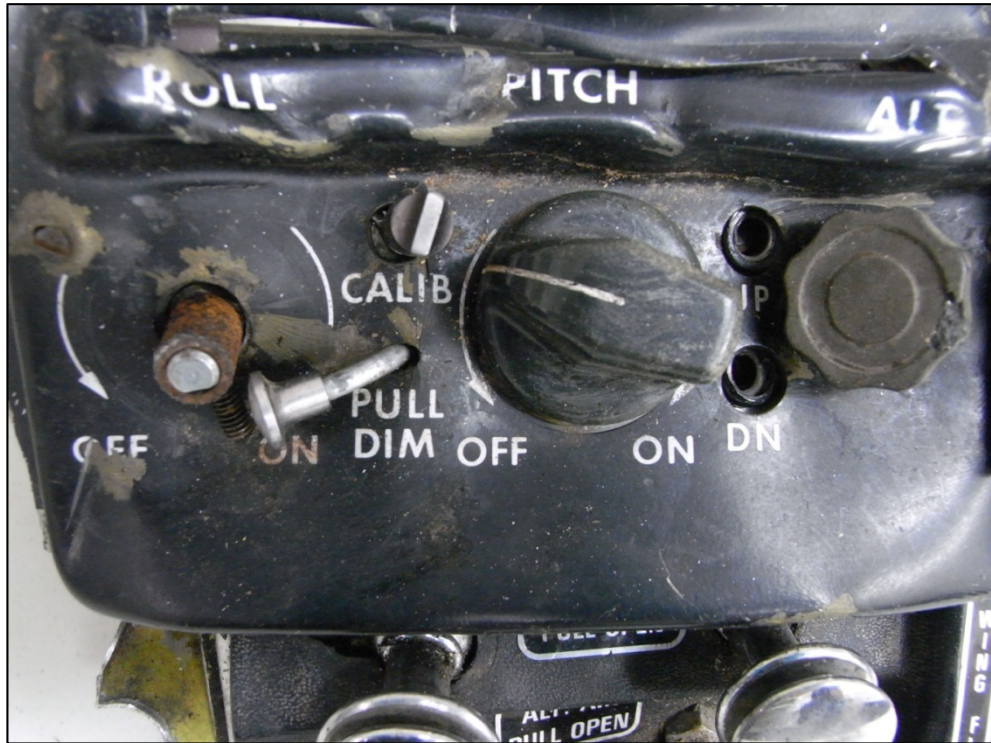
Figure 13: Autopilot controller

being in the fully OFF position¹⁸ (Figure 13), examination of the components found no evidence that the system was in use prior to impact. Although limited by the degree of impact damage, testing of the pitch servo breakaway link and the roll servo indicated that the system was capable of being overridden by the pilot. An assessment of the pitch servo override mechanism was not possible.

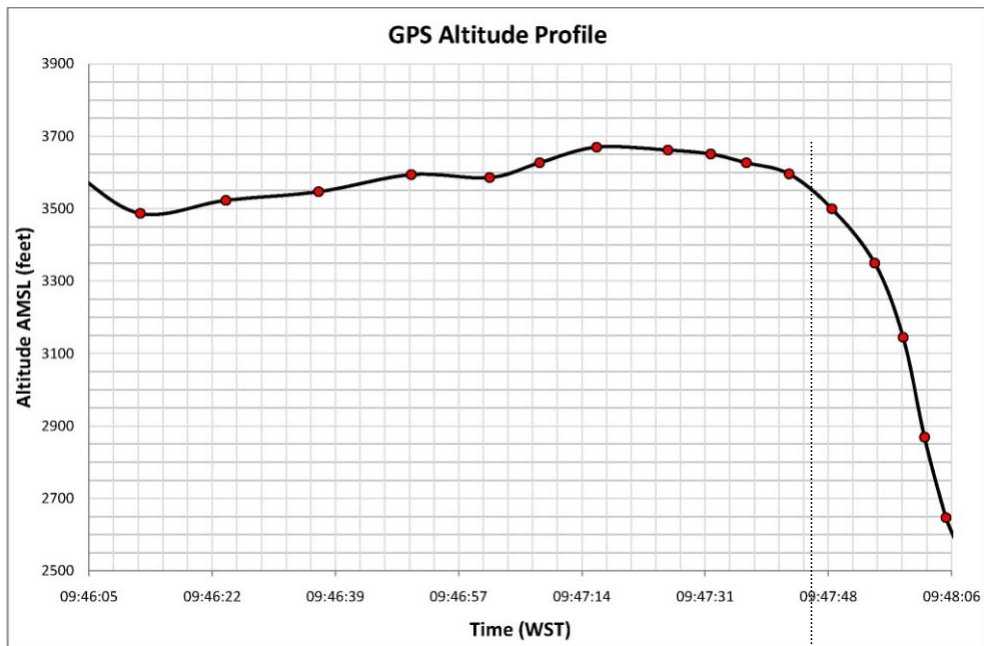
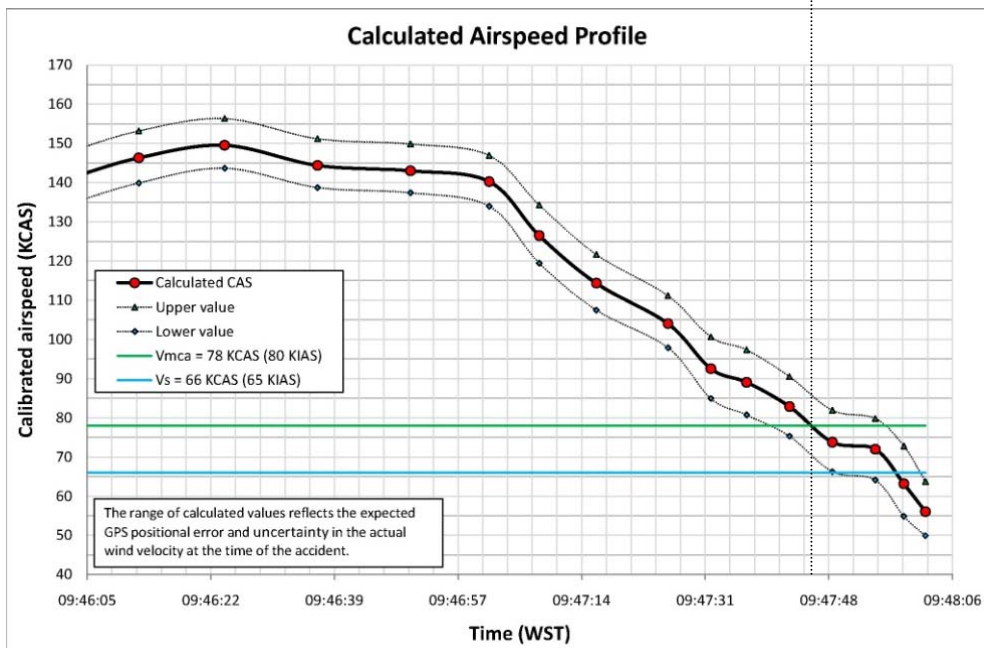
The on-board GPS unit retained data for a number of parameters for the flight including position, time, altitude (Figure 14) and groundspeed. Applying the meteorological data that was provided by the BoM allowed the derivation of the aircraft's calibrated airspeed¹⁹ from the GPS-recorded groundspeed (Figure 15).
