ATSB TRANSPORT SAFETY REPORT
Aviation Occurrence Investigation – A0-2010-023
Preliminary

Collision with terrain, VH-KDS 43 km east of Perth Aerodrome, Western Australia 28 March 2010

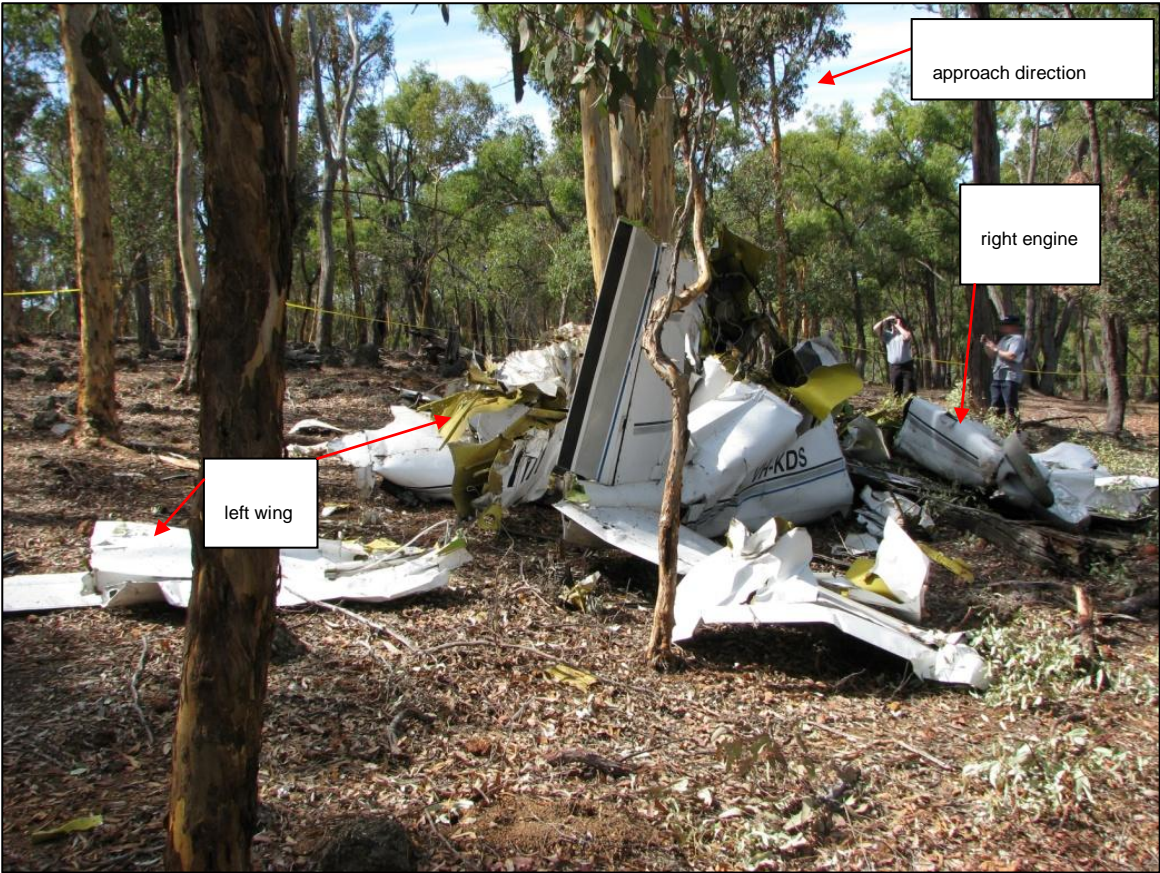
Figure 2: Accident site

The accident site was located in sloping, timbered terrain adjacent to a large cleared area. Contact marks on a number of surrounding trees indicated that the aircraft descended steeply in a westerly direction before coming to rest at the base of a tree and facing back along the approach direction (Figure 2).

On-site examination of the wreckage identified a number of components, including the left stabiliser, left propeller and outboard sections of both wings that had detached during the accident sequence. All major parts of the aircraft were accounted for at the accident site.
