Operational non-compliances, 9M-XXB

Gold Coast Airport, Queensland

4 and 29 May 2010

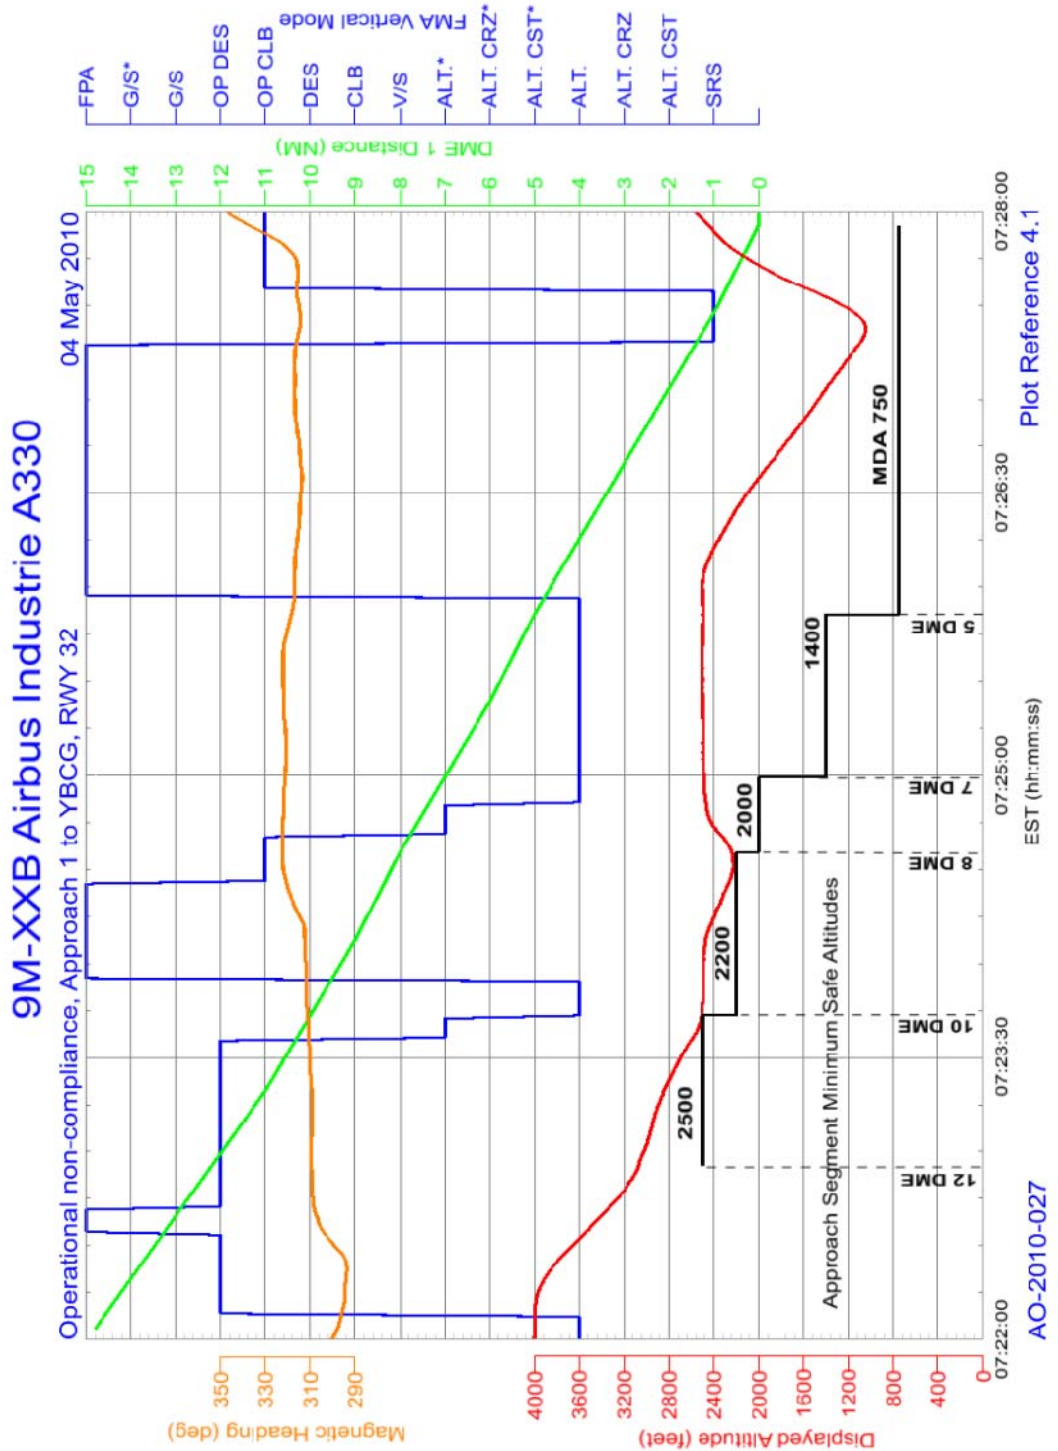
APPENDIX A: PLOT OF QUICK ACCESS RECORDER DATA - FIRST APPROACH 4 MAY 2010

When the aircraft was about 5 DME³ (9 km) from the Gold Coast Airport, and 2,500 ft above mean sea level (AMSL), the aircraft was above the recommended descent profile for that approach. With the selected flightpath angle (FPA) of -4.9°, the aircraft was descending at a rate of about 1,300 ft/min. The flight crew continued descent until the aircraft was about 1,000 ft at 1 DME (2 km). At that point, a landing was not possible and they initiated a missed approach.

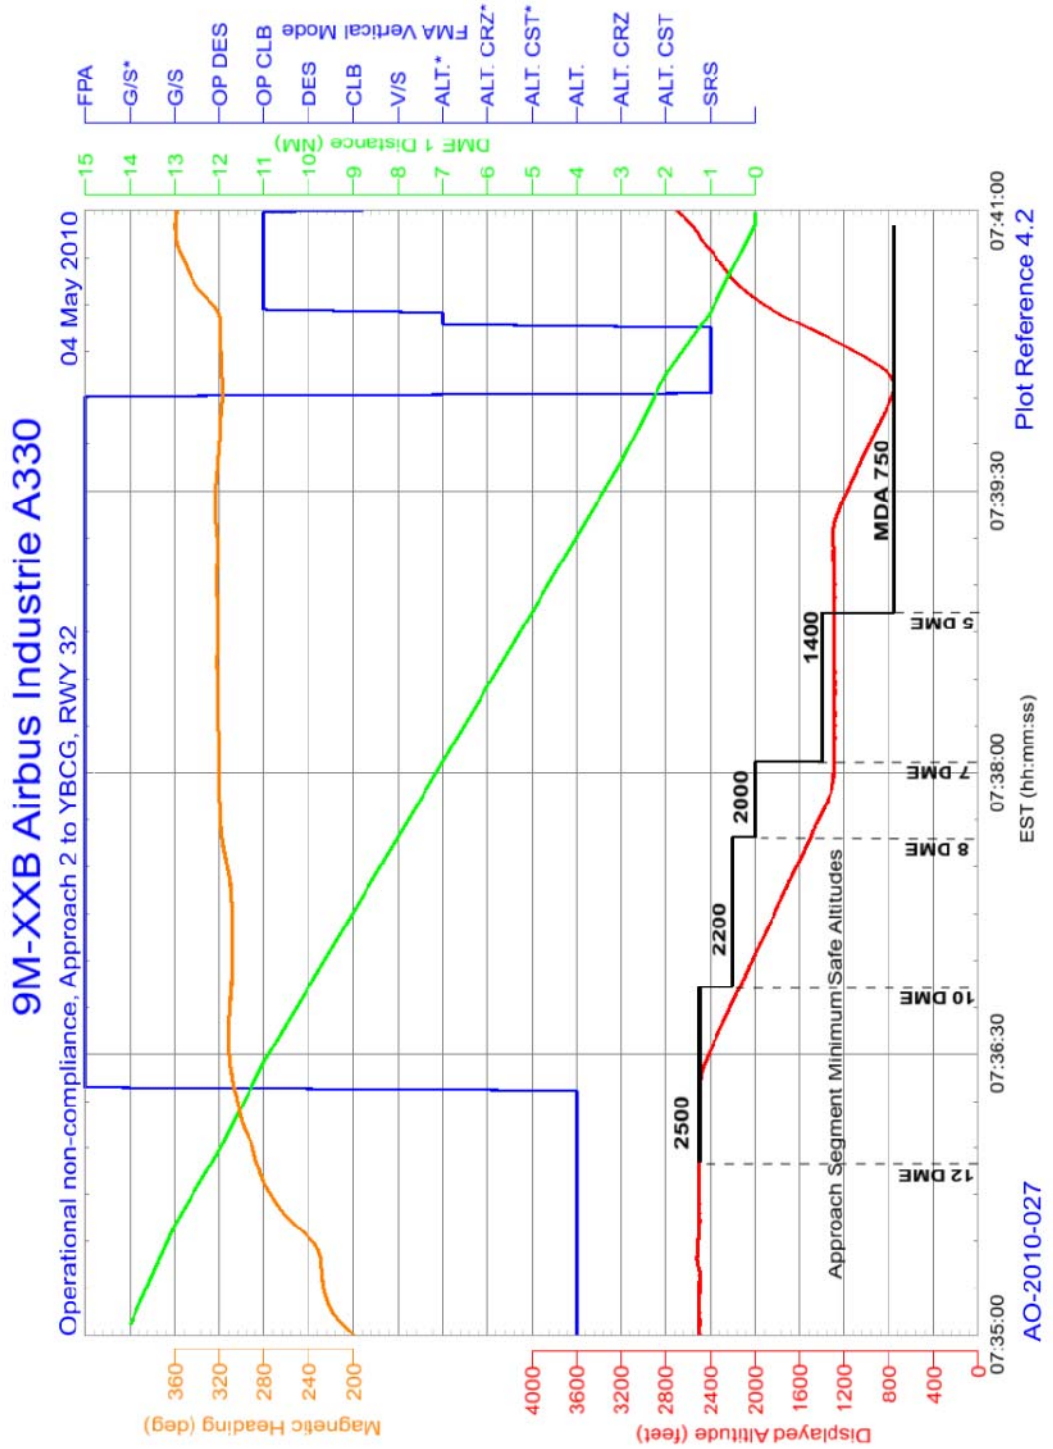
APPENDIX B: PLOT OF QUICK ACCESS RECORDER DATA - SECOND APPROACH 4 MAY 2010

The crew used the autopilot in selected mode to fly the approach. At 11 DME (20 km) they commenced descent, selecting an FPA of -3°. At that point, the aircraft was below the recommended descent profile and was descending below the procedure's segment minimum safe altitudes⁴ (Appendix B).

Approaching 7 DME (13 km), the flight crew reduced the FPA to achieve level flight at 1,300 ft. At about the same time, the aerodrome controller advised the crew to check their altitude and that the radar lowest safe altitude in that area was 1,500 ft. The controller cleared the crew for further descent in accordance with the runway 32 VOR procedure. The aircraft remained below the segment minimum safe altitude until reaching 5 DME (9 km). Soon after, the controller provided the crew with surface wind information and cleared the aircraft to land.

On the second approach, at an altitude of 2,500 ft and about 11 NM (20 km) from the distance measuring equipment (DME), the aircraft was already at the segment minimum safe altitude and about 900 ft below the recommended descent profile. Although the flight crew had been radar vectored to the final approach track at an altitude of 2,500 ft, the aircraft would not intercept the recommended descent profile until about 8 DME (15 km).

The descent from 2,500 ft to 1,300 ft at the selected flight path angle (FPA) of -3° was continuous and was conducted without apparent regard for the published segment minimum safe altitudes. That resulted in the aircraft operating below the segment minimum safe altitude prior to the aircraft reaching the final approach fix at 5 DME (9 km), with the effect that separation from terrain and other aircraft operating in non-controlled airspace was no longer assured.

It was not clear why the flight crew commenced descent prior to the aircraft intercepting the recommended profile for the approach. Being above the recommended flightpath on the first approach might have influenced the crew to descend earlier to avoid being similarly high during the second approach. Unfamiliarity with the conduct of non-precision approaches, and especially those that incorporated intermediate segment minimum safe altitudes, was another possibility.

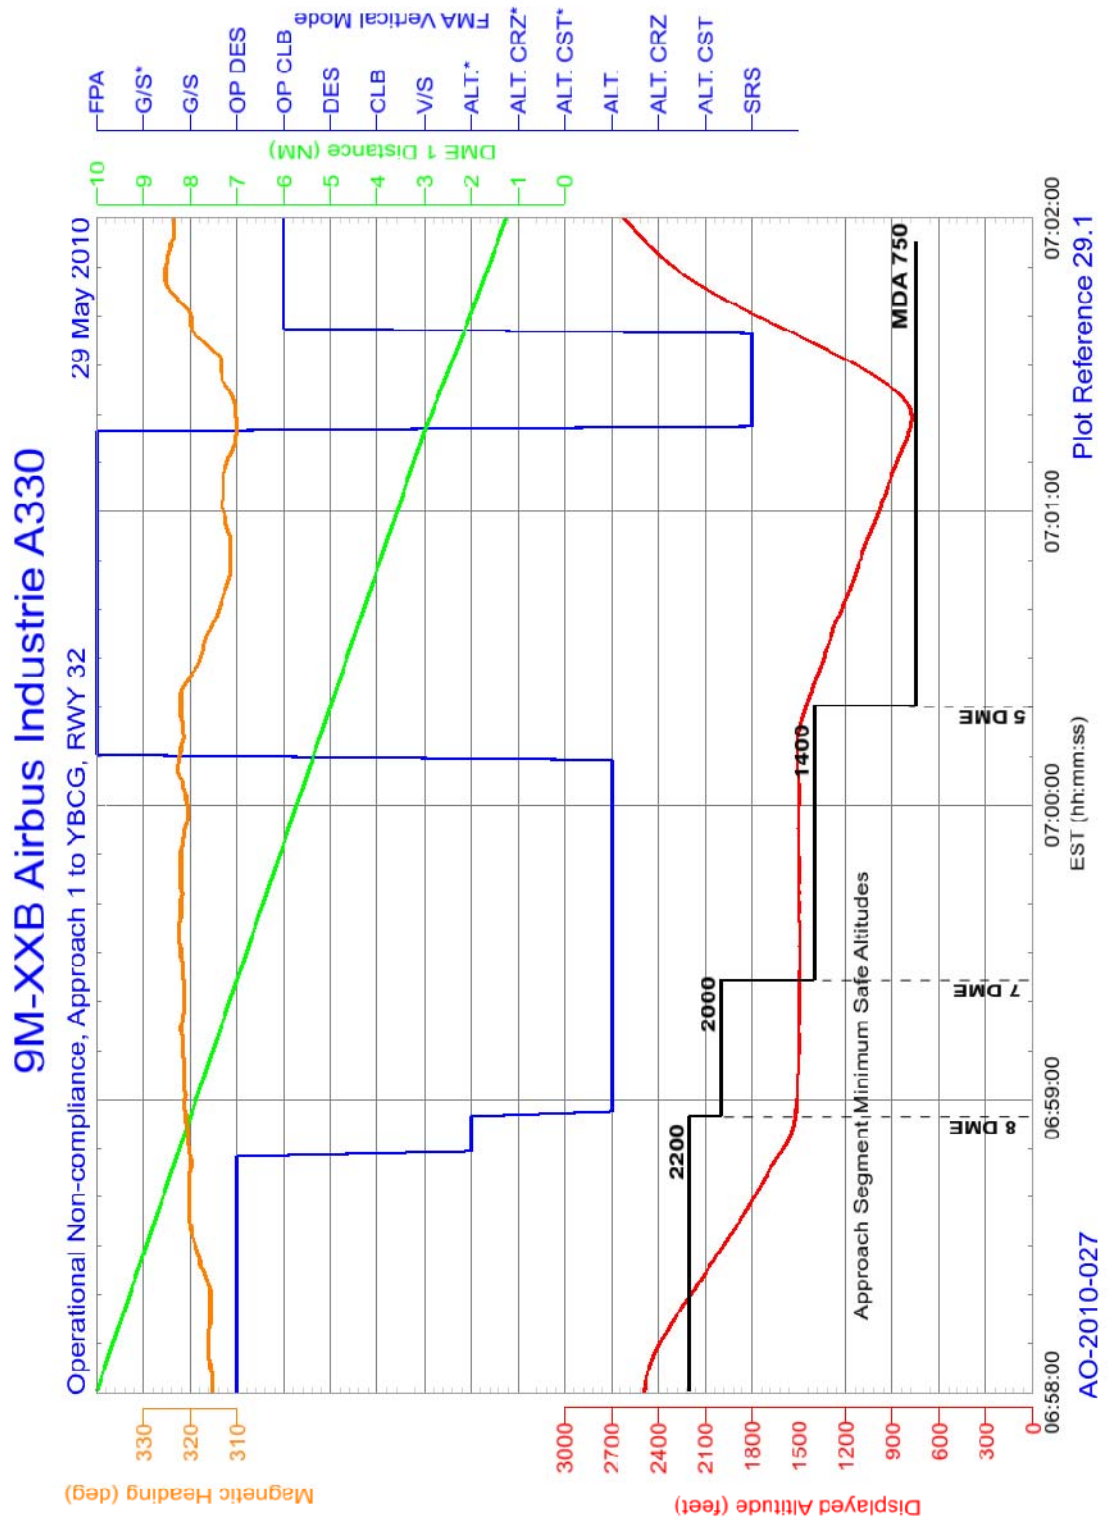
APPENDIX C: PLOT OF QUICK ACCESS RECORDER DATA - FIRST APPROACH 29 MAY 2010

For both approaches, the crew commenced descent from 2,500 ft at about 10 DME (19 km), which was below the recommended descent profile. During each of those approaches, when between 9 and 7 DME (17 and 13 km), the aircraft was below the procedure's segment minimum safe altitude.

Both approaches were conducted in selected mode, with the vertical navigation of the aircraft initially conducted in 'open descent'. In open descent, engine power reduces to flight idle and the aircraft descends at the FPA required to maintain the selected airspeed. The aircraft reached 1,500 ft by about 8 DME (15 km), recording a maximum FPA of -5.6° and a rate of descent of about 1,500 ft/min.

In both approaches on 29 May 2010, the crew initiated descent at about 10 DME (19 km) and before the aircraft had intercepted the recommended descent profile for the non-precision approach. Those descents were conducted without apparent regard for the published segment minimum safe altitudes. As a result, separation from terrain and other aircraft operating in non-controlled airspace was no longer assured.

It was not clear why the flight crew commenced descent prior to the aircraft intercepting the recommended profile for the approach and descended below the segment minimum safe altitudes. However, unfamiliarity with the conduct of VOR approaches that included intermediate segment minimum safe altitudes was again a possibility.

The use of open descent by the flight crew on 29 May 2010 resulted in a rate of descent that was greater than that required to maintain the recommended profile. High rates of descent during an instrument approach can be destabilising and increase the risk of significant altitude excursions.

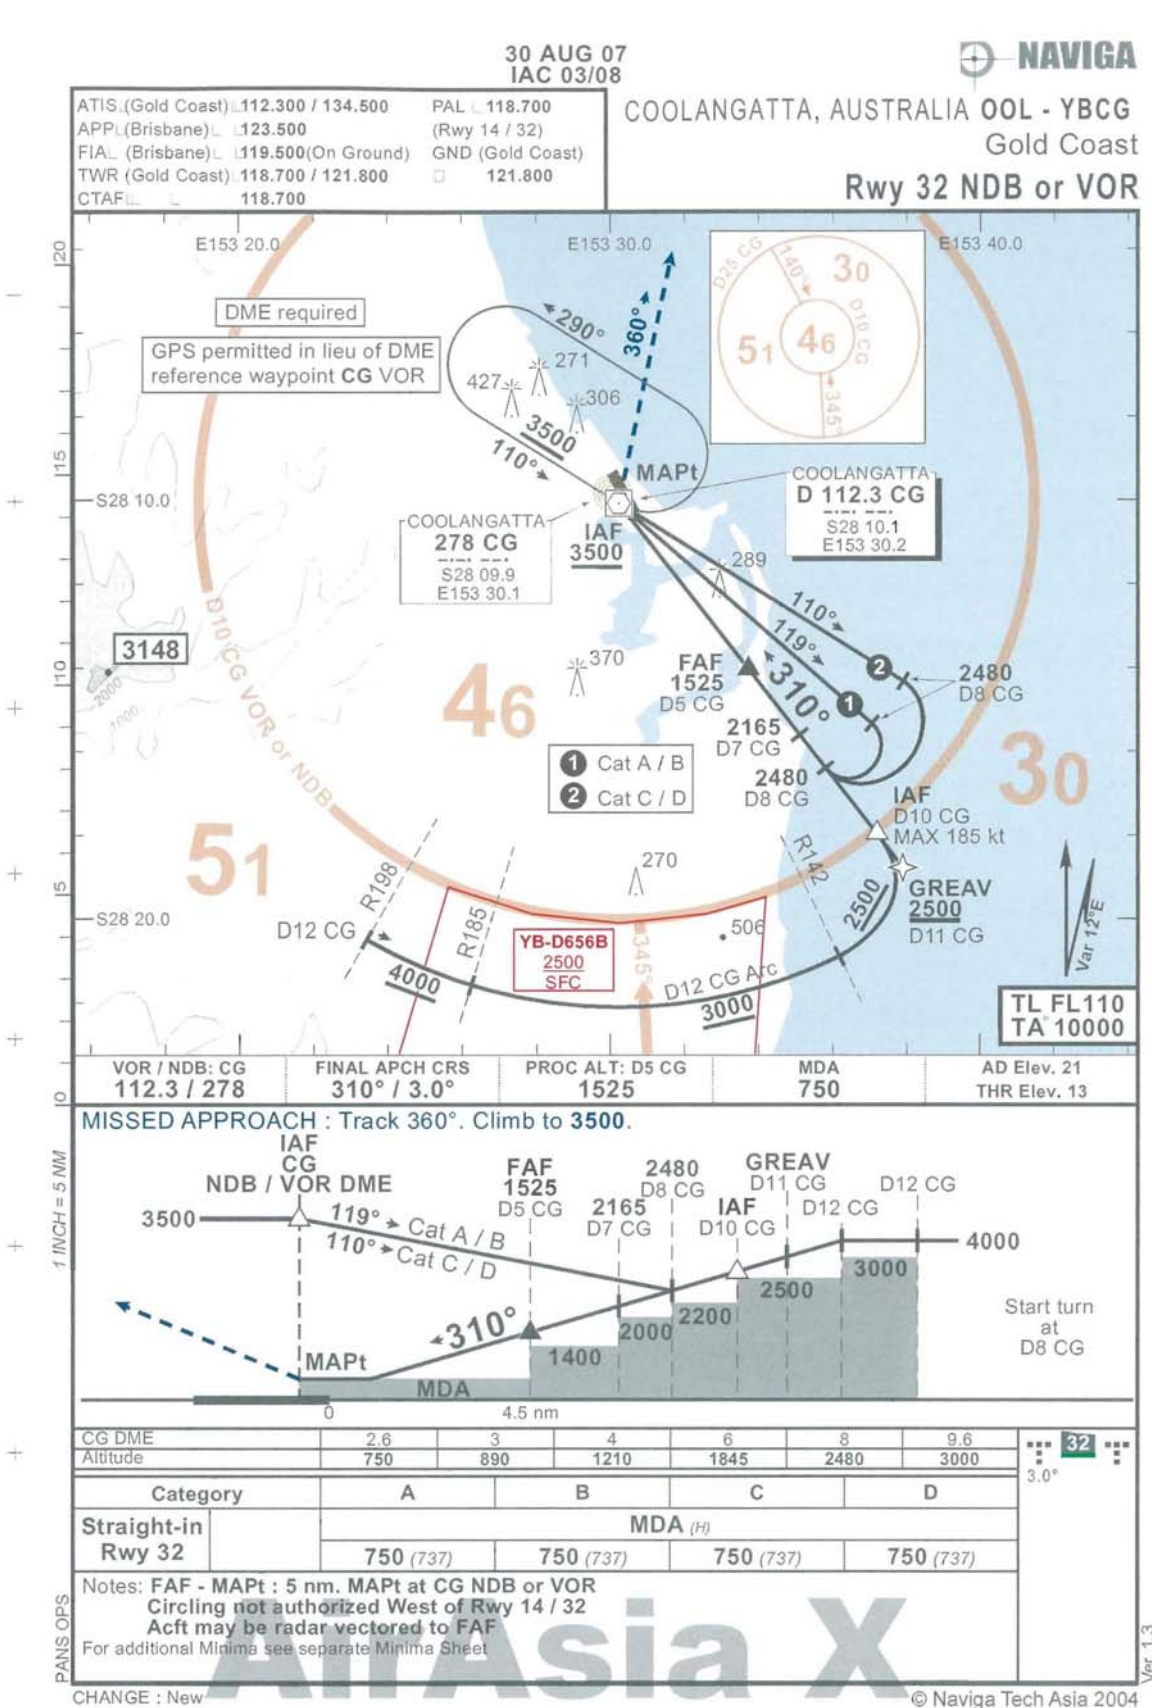
APPENDIX D: APPROACH PROCEDURE

The Gold Coast Runway 32 VOR approach is depicted at Appendix D. The approach comprised an inbound azimuth track to the airport's VOR and a series of descending segment minimum safe altitude 'steps'. Flight crews typically fly the approach as a continuous descent towards the runway, following a recommended descent profile not below the approach segment minimum safe altitude.

Intermediate altitude restrictions between the IAF and FAF required the crew to not descend below 2,200 ft until passing 8 DME (15 km), not below 2,000 ft until passing 7 DME (13 km) and not below 1,400 ft until passing the FAF. After the FAF, the aircraft could descend to the MDA. The published procedure included altitudes and DME distances to achieve a recommended descent profile of 3°.
