# Loss of control, VH-FPP

## Jandakot Aerodrome, Western Australia

### 12 May 2010

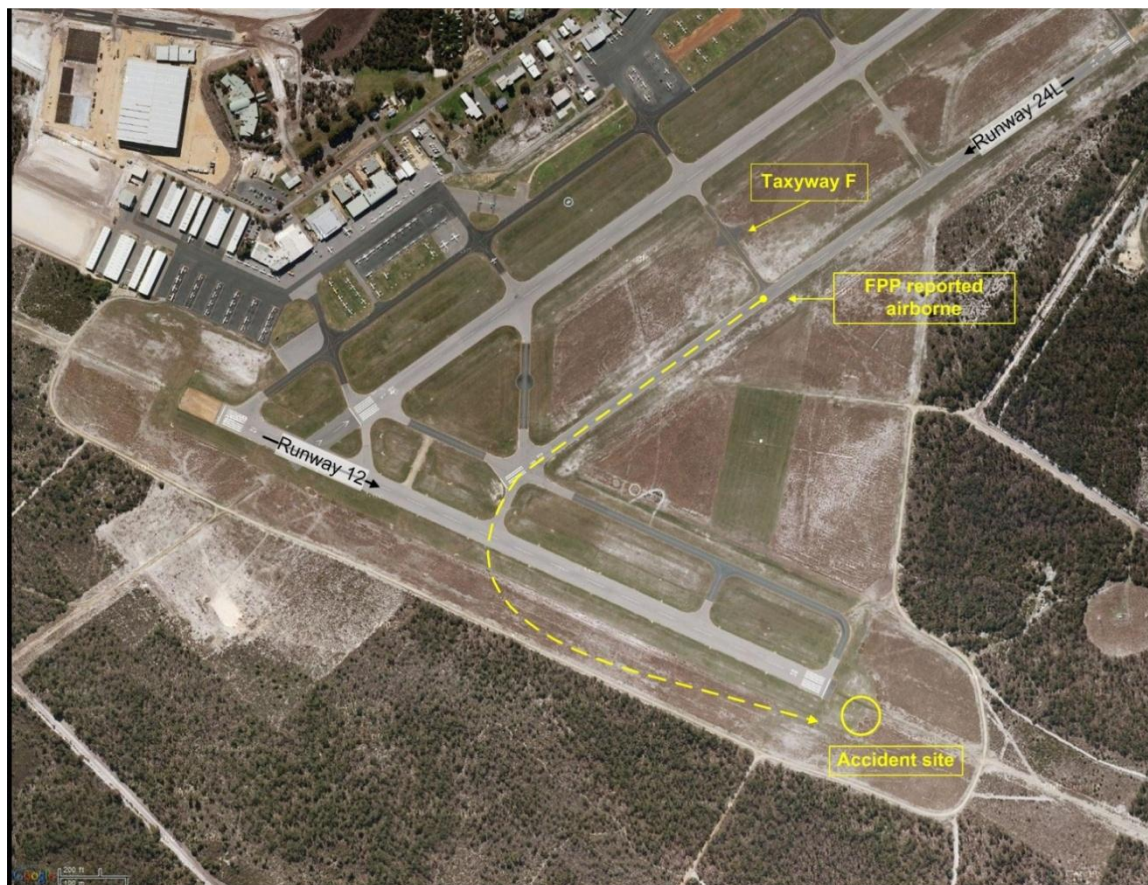
Figure 1: Flight path derivation

At the end of runway 24L the instructor turned the aircraft left through about 120°. The instructor recalled that the decision to turn left was made prior to the radio call to the controller because of the parallel runway to the right of the aircraft. Another reason given for the left turn was that the trees in the area ahead of the aircraft would have prevented a survivable landing at 80 kts and the intention was to land on runway 12. However, there was not enough room to land at that speed and the instructor initiated a further turn.

The investigation derived the probable aircraft flight path based on information from the instructor, witnesses and the accident site (Figure 1). The investigation calculated that after the engine power loss was recognised, the aircraft was airborne for about 25 to 27 seconds and traversed about 1,000 m.

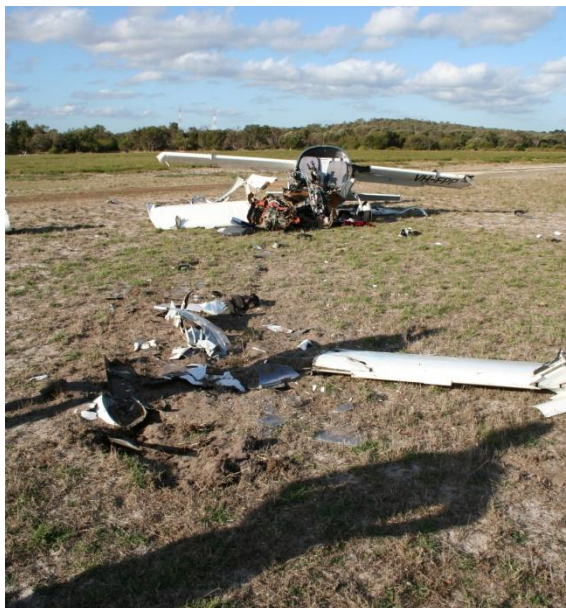
**Figure 3: Accident site looking east**

The initial impact with the ground was about 62 m from the end of runway 12 and 15 m to the south of the extended centreline. The propeller was embedded in the ground with the left canard nearby, while the remainder of the aircraft was located 11 m to the east (Figure 3).

The orientation of the propeller indicated that the aircraft's heading was 335° magnetic and attitude was 45° nose-down when the collision with the ground occurred. The nature of the damage to the left canard and the mainplane was

consistent with a 45° bank to the left at the initial impact.

The forward fuselage area including the engine and instrument panel was disrupted, leaving the occupant seats exposed and the under-seat structure compromised. The seatbelts remained attached to the structure.
