# Collision with water, VH-UFN

## Woolcunda Lake, New South Wales

### 21 June 2010

#### Abstract

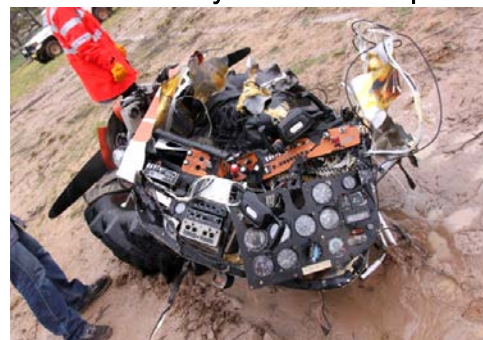
- Engine section (Figure 2). The engine was located in its mounts and affixed to the firewall. The firewall also formed the forward bulkhead of the cabin and had the aircraft's instrument panel still attached. The firewall had detached from the fuselage at the forward cabin pillars, but remained connected to the cabin by the control yoke flight control cables.
- Cabin section of the fuselage/wing (Figure 3). The cabin's forward bulkhead was detached from the cabin. The rudder pedals and associated nosewheel steering assembly remained attached to the cabin section of the fuselage. The forward and rear windshields were destroyed by the impact and pieces of the forward windshield were located in the

**Figure 2: The engine, propeller and firewall assembly and instrument panel**

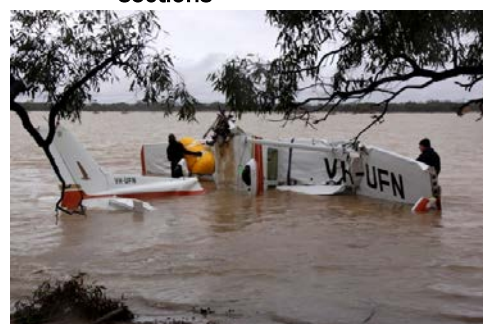
**Figure 3: Cabin section of the fuselage/wing and tailplane sections**

- Tailplane section (Figure 3). The tailplane and a section of the fuselage immediately aft of the cabin had detached, but also remained connected to the fuselage by flight control cables.

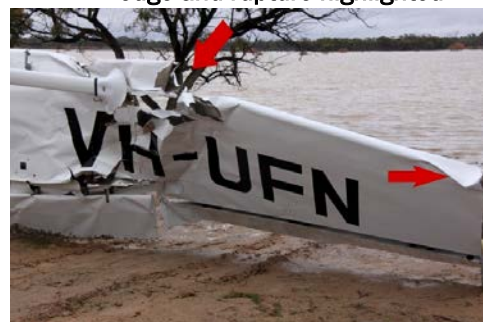
**Figure 4: Left wing with flattened leading edge and rupture highlighted**

The leading edge of the left wingtip had been flattened and that wingtip's fairing torn from the wing (Figure 4). This type of damage was isolated to the left wing only.

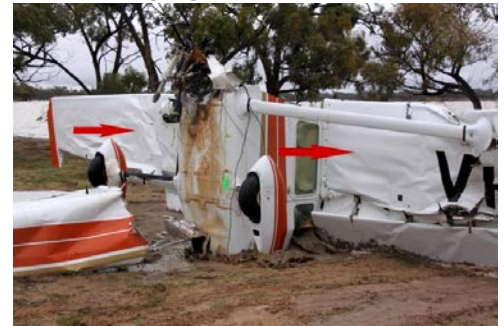
The lower surfaces of both wings displayed significant water impact damage (hereafter referred to as hydraulic damage), which was particularly prevalent at the rear sections of each wing (Figure 5).

The tailplane section exhibited a clean tear of the fuselage skin on the left side, with tearing and buckling on the right side (Figure 5).

**Figure 5: Lower wing surfaces with the hydraulic buckling damage highlighted**

the pilot to ditch the aircraft. While the right aileron was unable to be located, it probably detached from the wing as a result of the considerable hydraulic force applied to the rear of the wings during the impact sequence. The investigation concluded that aircraft/engine mechanical failure was not a factor.

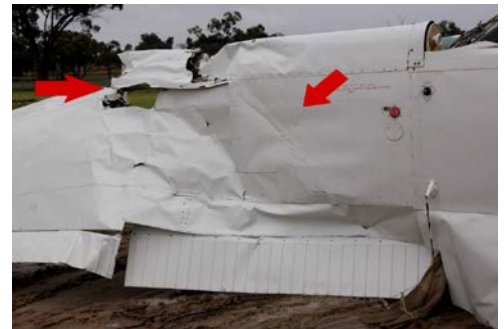
The forward section of the left wing structure just outboard of the wing strut had been ruptured during the impact sequence. The upper wing surface immediately adjacent to the rupture was scored, with evidence of paint transference consistent with the orange engine cowl (Figure 6).

**Figure 6: Upper surface of the left wing, showing the ruptured section and adjacent scoring and paint transference**

The initial contact of the left wingtip with the water yawed the aircraft to the left, such that the subsequent impact was almost front on in a level or slightly nose-low attitude. That yaw and the aircraft's forward momentum combined to detach the aircraft's engine section from the fuselage, and resulted in the engine section impacting the left wing.

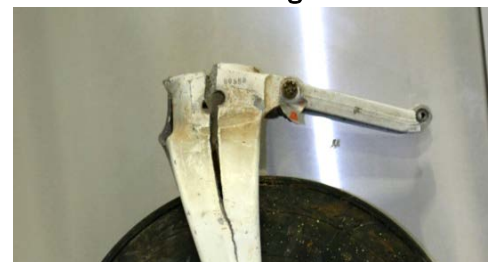
The aircraft's nosewheel was detached from the wreckage and recovered with other flotsam on the lake shorefront to the north of the wreckage. The nosewheel mounting collar displayed evidence of over-stress failure in the longitudinal direction (Figure 7).

**Figure 7: Nosewheel unit showing damage to the mounting collar**

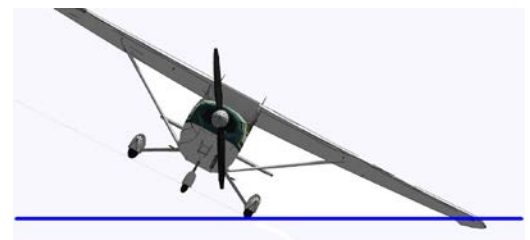
**Figure 8: Angle of bank required for a wingtip to contact a surface**

The angle of bank required for one of the aircraft's wingtips to contact a surface without any other part of the aircraft contacting that surface, was estimated to be a minimum of about 25° (Figure 8).
