Depressurisation, VH-NGX

120 km NNE Perth Airport, Western Australia

16 August 2010

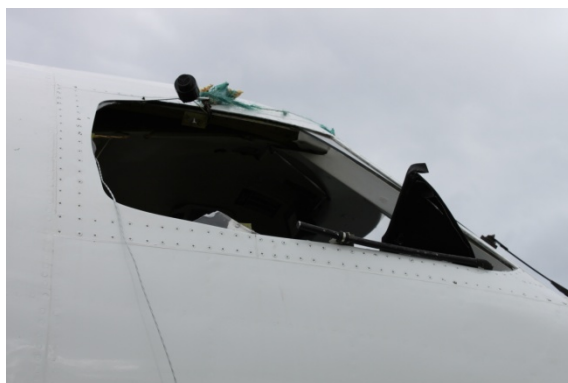
Damage to the aircraft was confined to the right cockpit side window and the cabin trim and fittings in the immediate vicinity (Figure 1). That included the oxygen mask that was stowed adjacent the right (copilot) seat.

Figure 1: Right cockpit side window

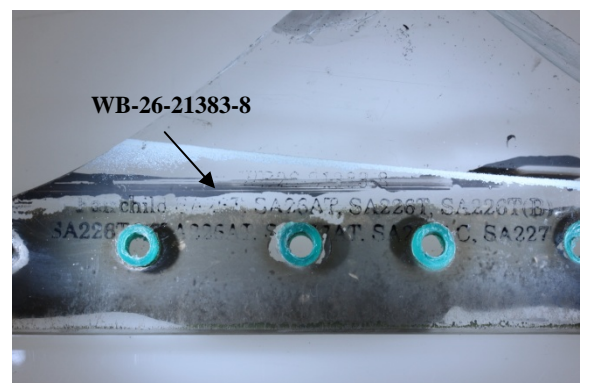
Examination of the aircraft's maintenance records indicated that the right cockpit side window was replaced due to crazing⁴ in July 2006, when the aircraft was being maintained and operated by its previous owner. The replacement window was identified by part number as a right cockpit side window inner-pane and was accompanied by an authorised release certificate identifying it as such (Figure 2). However, that window was fitted as a replacement for an outer pane.

Figure 2: Window fragment with part number

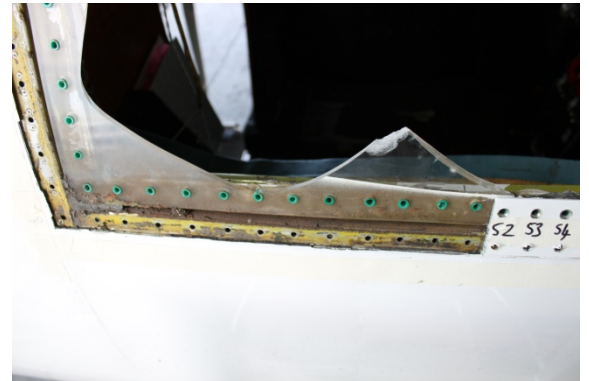
Figure 3: Remnant fragments, right side window

The thickness of the acrylic fragments that were recovered from the right cockpit side window was between 0.194 and 0.198 in. (4.93 and 5.03 mm). The upper edge of the window had the least acrylic material remaining. Every retaining hole examined had a combination of cracks running from the hole to the edge of the pane, and cracks running laterally between the holes. The lateral cracks along the upper edge of the window had conjoined to form a continuous crack.

Examination of fragments from the right cockpit side window found that the upper retaining holes were closer to the edge of the pane than was stipulated by the aircraft manufacturer. The reduced hole-to-edge dimension increased the stress on the acrylic pane and made it more susceptible to in-service, hole-to-edge cracking. The hole-to-edge cracks along the upper edge of the pane were each single events. That is, they had each propagated from hole-to-edge in one step.

The aircraft manufacturer required the retaining holes in the acrylic window to be drilled undersize and then correctly-sized using a counterbore from each side of the pane. Examination of the retainer holes indicated that they had been drilled from one side using a large-diameter twist drill. In addition, a twist drill had been used to roughly chamfer the edges of the holes, in contrast to being sanded or countersunk as specified by the manufacturer.

The incorrect preparation of the retaining holes created additional stress raisers, with resultant cracking detected in some of the retaining holes. Chamfer-initiated lateral cracking was evident in the retainer holes along the upper edge of the window, which had in many cases progressed as a series of radiating steps.

The bushings that were fitted to the retaining holes were oversized and had not been trimmed flush with the edges of the acrylic pane. Clamping forces from the mounting screws had forced the bushings into the chamfers, creating a 'bobbin' effect, acting as additional stress raisers in the acrylic pane. Bushing material and sealant extruded into some cracks and was evidence that some of the lateral cracks were created during the installation of the window. There was also evidence that one bushing was not fitted when the window was installed.

The window failed as a consequence of cracks that propagated from the retainer holes to the upper edge of the pane. That edge cracking, combined with the additional lateral cracking between the retainer holes, significantly weakened the window's structural integrity.

In response to this occurrence, the aircraft operator audited the aircraft's documentation to verify the remaining window installation. As the aircraft was the only one purchased from the organisation that fitted the failed right cockpit side window, the operator considered the audit as terminating action.

Subsequent to that investigation, CASA resolved any possible airworthiness issues affecting another similar aircraft that was maintained by the organisation that installed the window, and initiated action to address the fitting of the failed window.
