ATSB TRANSPORT SAFETY REPORT
Aviation Occurrence Investigation AO-2010-066
Preliminary

Uncontained engine failure and air turn-back Near San Francisco Airport, USA

30 August 2010

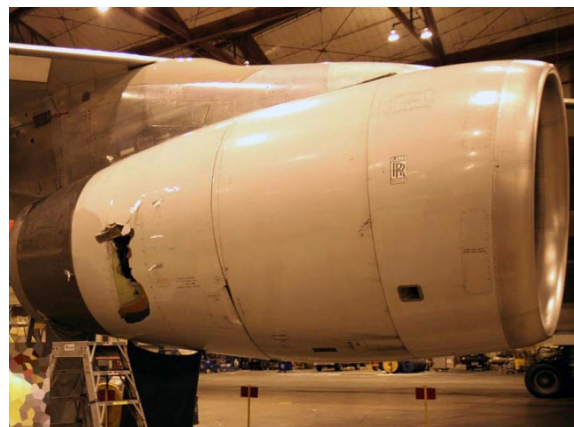
Figure 1: Right side of the number-4 engine

The number-4 engine had ruptured through the left and right sides of the turbine case and fairings, resulting in a large perforation in the right side of the engine nacelle (Figures 1 and 2) and several smaller punctures through the left side (Figure 3).

Debris ejected through the hole in the right side of the engine had impacted the underside of the wing, producing superficial nicks and scratches to the wing skin. There was a puncture through the composite, leading-edge, variable-camber flaps and the associated torque tube was slightly bent.

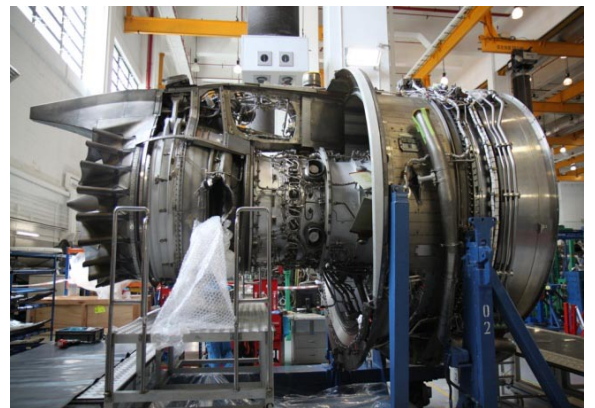
Figure 5: Engine serial number: 13247

Figure 4 shows the general layout of the RB211-524 engine and Figure 5 presents the subject engine with the fairings removed. During the early stages of the examination, it was evident that the internal turbo-machinery had been significantly disrupted, with extensive damage sustained by the intermediate pressure (IP) and low pressure (LP) turbine rotors (Figure 6 and 7).

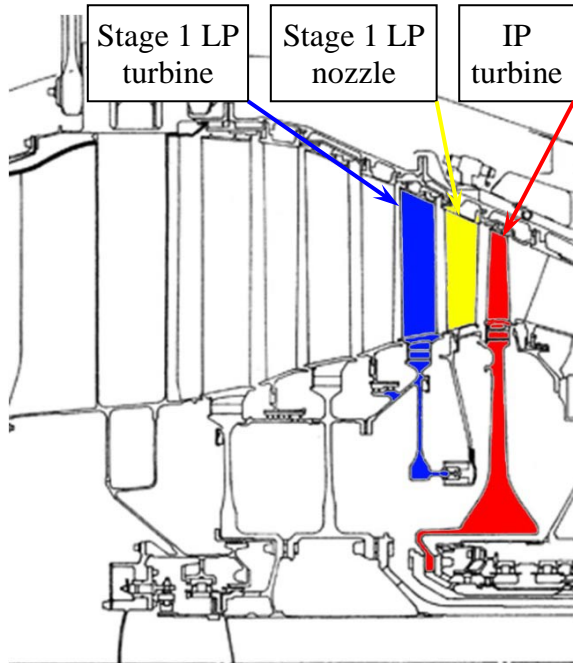
Figure 6: RB211-524 turbine section

- All of the turbine blades had separated from the IP turbine disk.
- Blades from the three LP turbine stages were either fractured through the airfoil section or separated from the disk.
- The LP stage 1 nozzle guide vanes were destroyed. The remaining LP nozzle stages were substantially damaged.

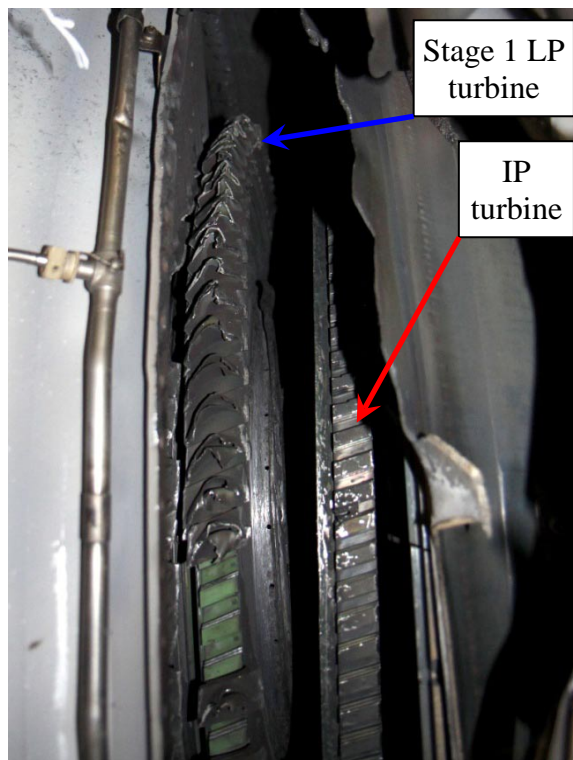
Figure 7: IP and stage 1 LP turbine disks

- The LP turbine bearing and adjacent phonic wheel and speed probes were destroyed.
- The IP shaft was severed towards the aft end.
