Ditching, VH-LMT

46 km north-east of Gurney, Papua New Guinea

26 September 2010

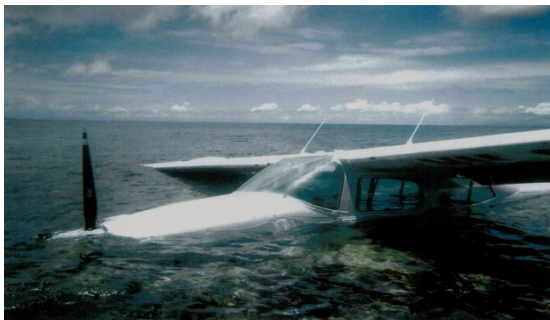
Figure 2: LMT after the ditching

The pilot turned the aircraft into wind and, with full flap selected and the aircraft's landing gear retracted, touched down tail first at about 40 kts. The pilot described the rate of deceleration as 'gentle'. He had earlier instructed the passenger who was seated in the right front seat to open his door prior to impact. All occupants were able to quickly exit the aircraft. There were no injuries and the aircraft settled in about 1 m of water with little evidence of impact damage apparent.

Approximately 1 week after the occurrence, the pilot advised that arrangements to recover the aircraft from the water had been unsuccessful and that the engine, avionics, instruments and most of the airframe had been exposed to salt water during that period. The pilot also advised that there appeared little future prospect of the aircraft being salvaged.
