Loss of control Robinson Helicopter R44 Astro VH-HFH

Cessnock Airport, New South Wales | 4 February 2011

ATSB Transport Safety Report
Aviation Occurrence Investigation
AO-2011-016
Final – 30 April 2012

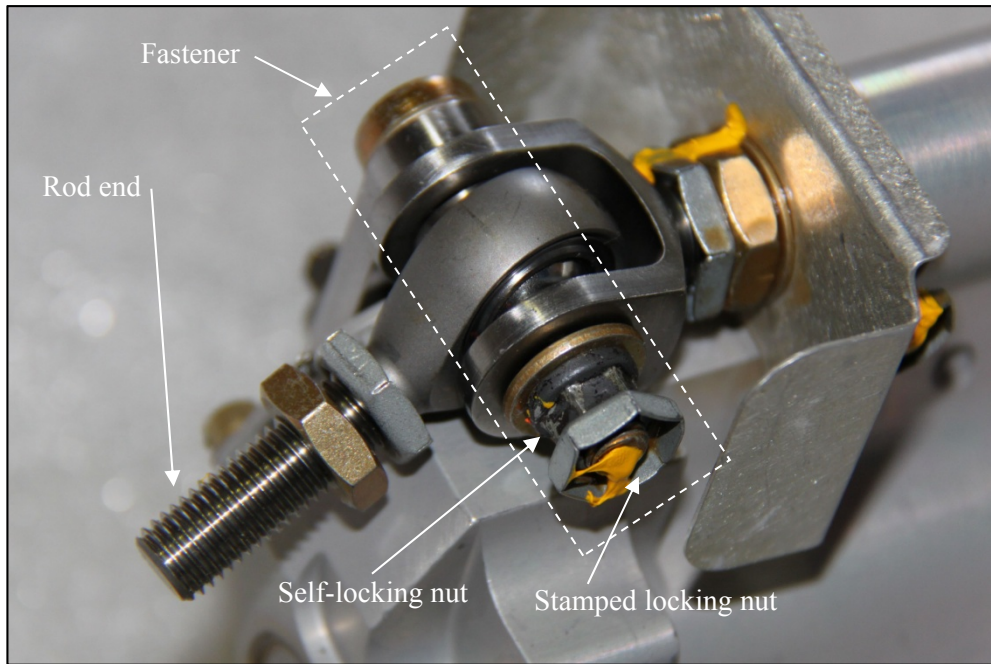
Figure 8: Lower flight control push-pull tube rod end

The securing fastener consisted of seven individual components, including a self-locking nut and a secondary stamped locking nut (Figures 8 and 9). The assembly of the fastener only permitted detachment of the spacers if the bolt moved free of the rod end. The washer that was located under the bolt head could only detach if the bolt completely separated from the servo. In order to discourage removal of this fastener, the bolt head had an uncommon tri-slot recess that required a specific tool to disassemble/assemble the fastener (Figures 3 and 14).

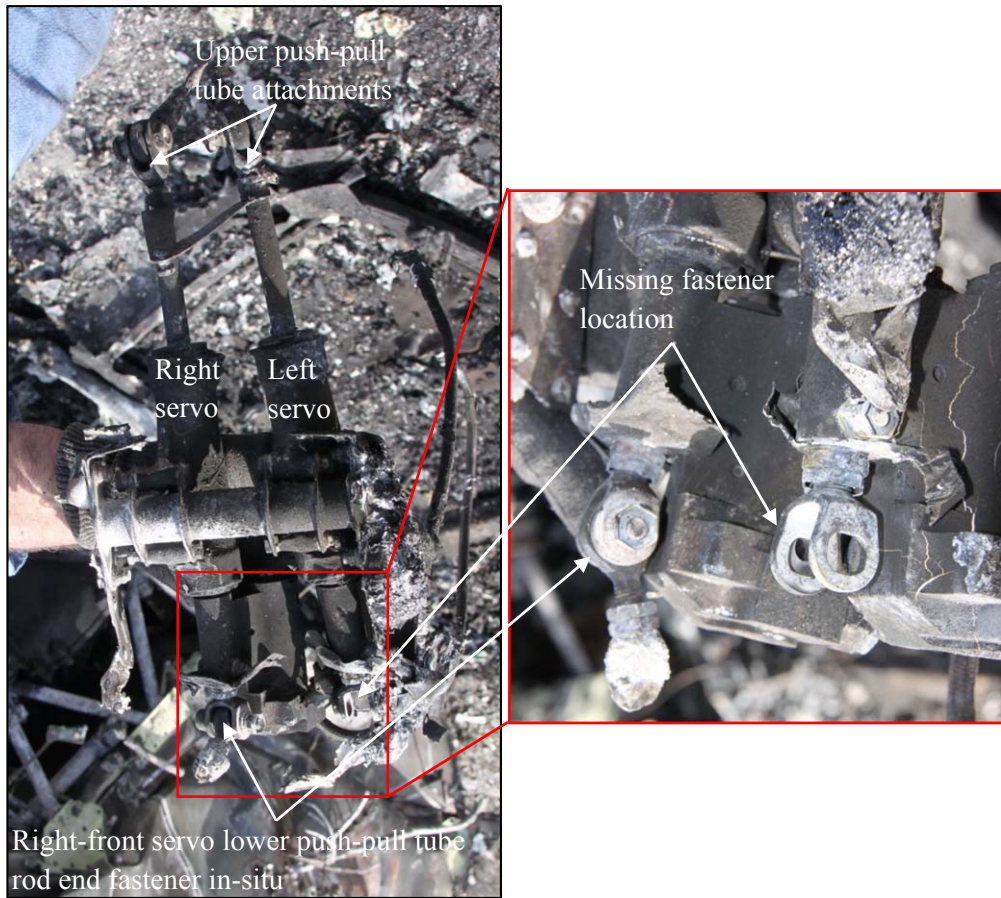
Figure 11: Front hydraulic-boost servos

On-site wreckage examination identified that the securing fastener that retained the lower flight control push-pull tube rod end to the left-front hydraulic-boost servo was missing (Figures 11 and 13).

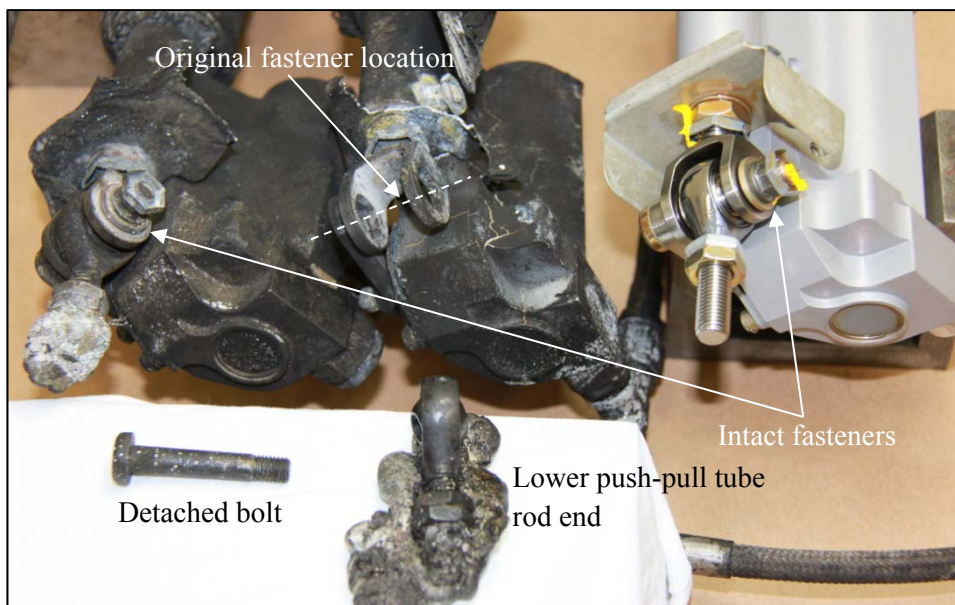
Figure 13: Right-front, left-front and exemplar hydraulic-boost servos

The lower push-pull tube rod end was subsequently found in the vicinity of the front servos (Figure 13). The bolt was also located within the wreckage close to the cabin floor (Figures 13 and 14) and about 1 m from the installed position of the front servos.

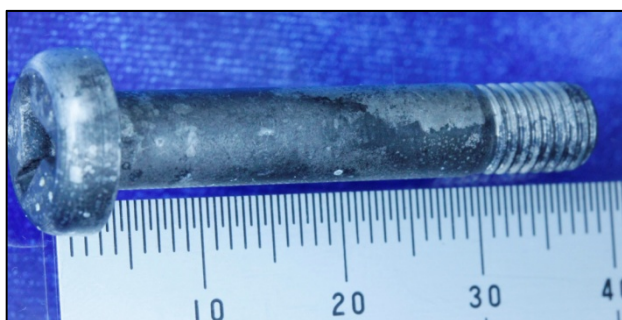
Figure 14: Detached bolt

The hardness of the bolt was found to be less than that specified; however, this may have been due to the post-impact fire as the bolts from the right-front and aft servos were similarly affected. There was no evidence of damage to the bolt head that might suggest tampering (see the section titled *Testing conducted by the ATSB*). Some of the witness marks on the bolt's thread and tri-slot head indicated that a self-locking nut had previously been fitted to the bolt and that the fastener had previously been disassembled. This was consistent with the documented repair history of the left-front servo.

The absence of physical damage or defect on the detached bolt, combined with the testing conducted by the Australian Transport Safety Bureau (ATSB), identified that the fastener likely failed as a result of its incorrect assembly, or a material defect that affected the serviceability of the retaining nuts, or a combination of both.

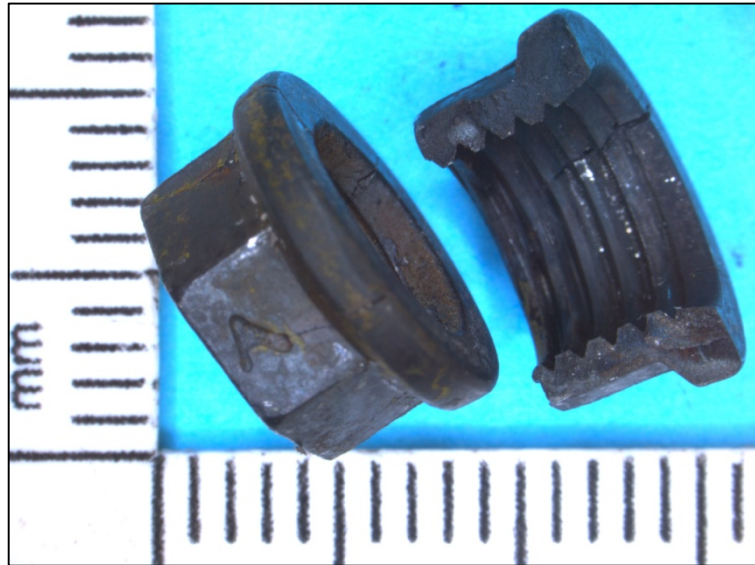
Figure 15: Cracked self-locking nuts

During the examination of the hydraulic-boost servos, a number of cracked self-locking nuts that secured the servos to the helicopter were identified (Figure 15). These nuts were of the same type as those fitted to the detached fastener. Detailed analyses of these nuts identified that they had failed due to the effect of the post-impact fire and not a pre-existing defect (see the section titled *Liquid-metal embrittlement*). No cracks were identified in any of the stamped locking nuts.

The presence of cracked self-locking nuts, which were identified to have failed due to liquid metal embrittlement, introduced the possibility that the fastener failed during the post-impact fire. Assuming that the fastener was correctly assembled, a failure mechanism would have been required that enabled both nuts to separate from the bolt. While cracked self-locking nuts were identified in the wreckage, no cracked stamped locking nuts were identified. In any event, given the orientation and relative position of the front servos, it was unlikely that the bolt could have fallen free of the servo, even if both the nuts were absent. Finally, the distance that the bolt was found from the virtually co-located front servos and lower push-pull tube rod end was not consistent with it having detached during the post-impact fire.

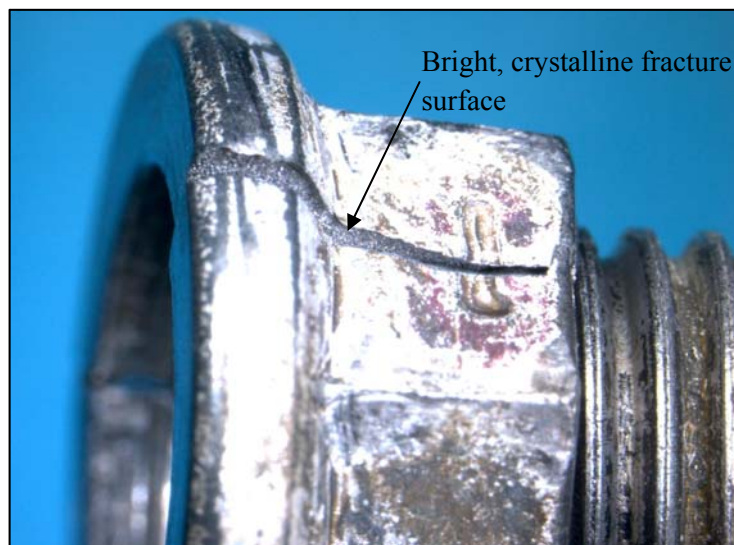
Figure 19: Cracked self-locking nut following paint removal

During the course of this investigation, three cracked self-locking nuts (Figure 19) from R22 helicopters, of the same specification as that fitted to the detached fastener, were subjected to detailed examination. This examination identified that they had cracked due to hydrogen-induced delayed cracking.

When high-strength steel, which has been exposed to hydrogen is sufficiently stressed, it can fail prematurely in a sudden, brittle manner. In the case of the examined self-locking nuts, the source of hydrogen was likely to have been from the cadmium plating process that was specified during manufacture for corrosion resistance. Under conditions of sustained stress, such as that associated with an assembled fastener, plus any residual tensile stresses from manufacturing, the presence of hydrogen can result in brittle cracking, typically less than 1 week from the time of application of the sustained stress.
