Controlled flight into terrain – Cessna Aircraft Company 310R VH-XGX

Near Bathurst Island Aerodrome, Northern Territory | 5 February 2011

ATSB Transport Safety Report
Aviation Occurrence Investigation
AO-2011-017
Final

Report No. AO-2011-017

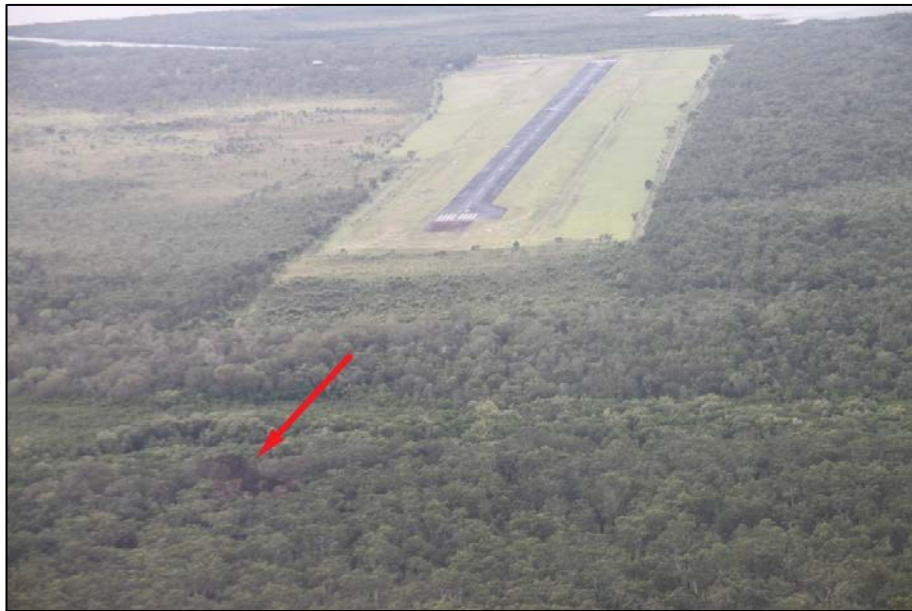
Figure 1: Location of wreckage (arrowed) with respect to the runway at Bathurst Island Aerodrome

Shortly after takeoff, a number of witnesses reported hearing a loud noise or seeing a light from the direction of departure. A search and rescue operation was initiated, with both air and ground responses. XGX was found to have impacted terrain approximately 1 km from the upwind end of runway 33 (Figure 1).

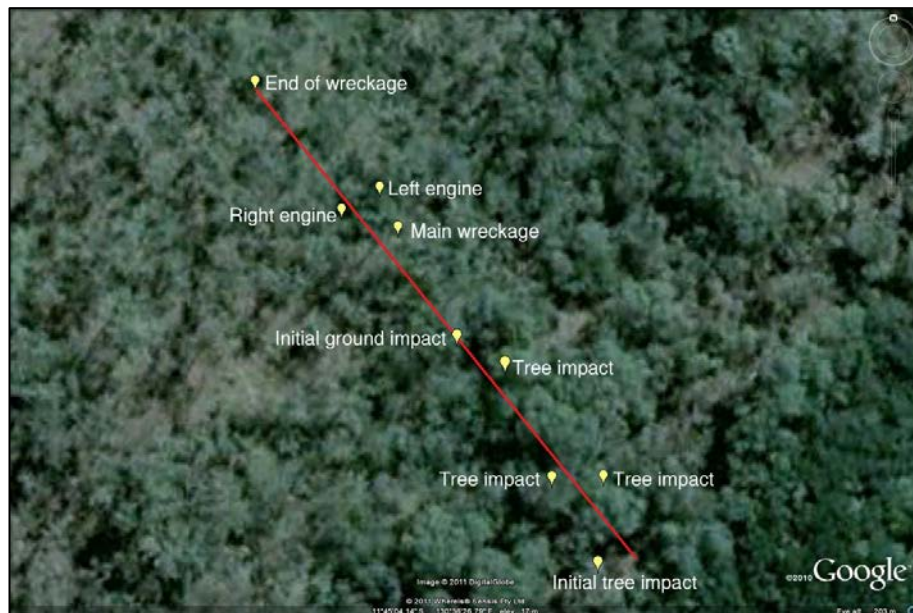
Figure 3: Overview of wreckage trail

The wreckage trail was approximately 140 m in length, and was oriented in line with, and on the same heading as runway 33 (Figures 1 and 3).

The aircraft had been significantly disrupted during the impact sequence, breaking into numerous sections, which were distributed throughout the accident site.

Examination of the wreckage at the accident site accounted for all the major parts of the aircraft, including all the flight control surfaces. All structural fracture surfaces for the aircraft were examined, with no evidence of pre-existing defects identified. Considerable disruption of the wreckage precluded a check for continuity of the engine and flight controls. However, the engine and flight control cables and push pull tubes were examined at their fracture points, with no pre-impact defects identified.

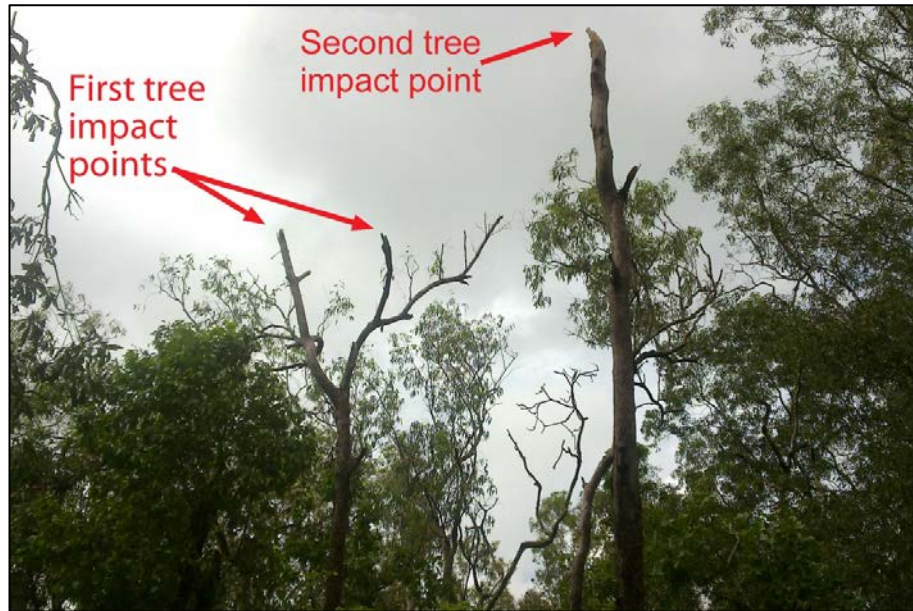
Figure 4: Initial tree impact points

Contact marks on a number of trees indicated that the aircraft was wings-level and had a shallow angle of entry into the slightly rising terrain (Figure 4).

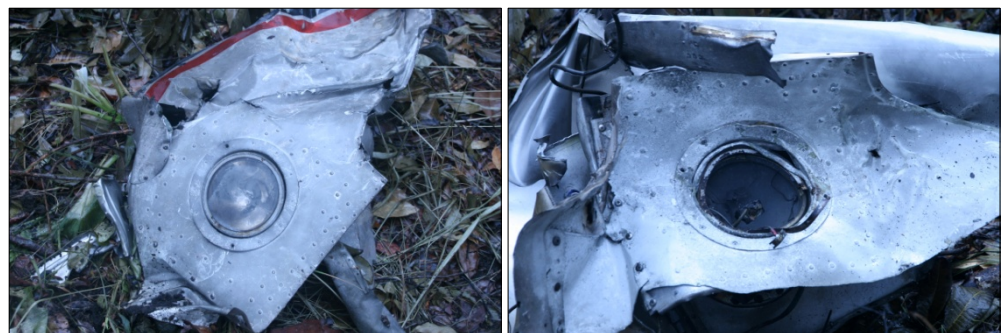
Figure 5: Left and right landing lights in retracted position

The position of the aircraft landing gear retraction motor and actuator indicated that the landing gear was in the retracted position at the time of impact. The right main gear was confirmed to be in the fully-retracted position; however, the left gear and nose gear had separated from the aircraft during the impact sequence. The aircraft landing lights were located in the underside of the wing tips and retract when not in use. Both landing lights were located at the accident site and were in the retracted position (Figure 5).

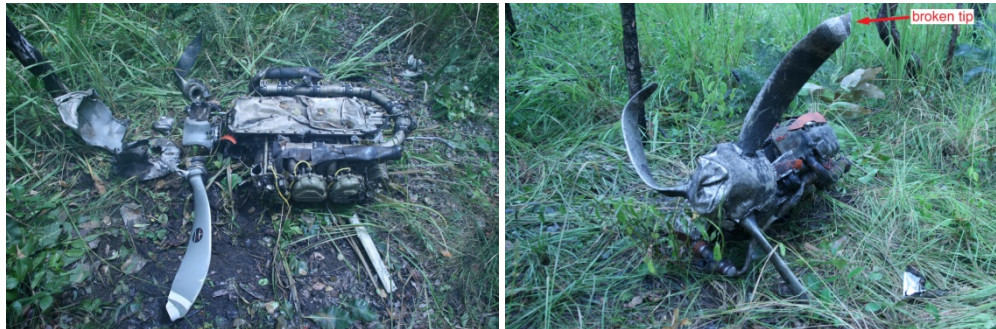
Figure 6: Left and right engines

Both engines had detached from the aircraft during the accident sequence. The extent of the rotational damage observed on both propellers indicated that both engines were producing significant power at the time of impact (Figure 6).

The right propeller assembly was attached to the engine and was intact apart from a small section of the tip of one blade which was located in the wreckage trail. The left propeller assembly had sustained a direct impact at the hub; the propeller subsequently breaking into several pieces and releasing the propeller blades. Only two of the three blades were located at the accident site; however, all of the other components of the propeller assembly were accounted for. The propeller hub fracture surfaces were inspected, with no pre-existing defects identified. Figure 6 shows the left engine with the relocated propeller components placed back in position.

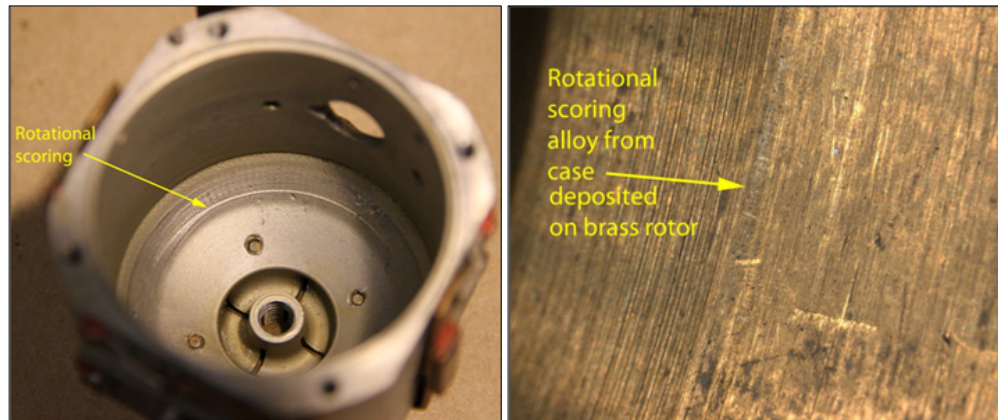
Figure 7: Rotational scoring observed on the copilot's artificial horizon

The artificial horizon instruments (AH) from both the pilot's and copilot's instrument panels were examined. The pilot's AH had been significantly damaged during the impact sequence; the gyroscope rotor had been ejected from the outer casing and was not recovered. The copilot's AH was dismantled and the gyro rotor and internal case were examined (Figure 7a). Rotational scoring was found on both the bottom of the gyro rotor (Figure 7b) and on the bottom of the gyro case, indicating that the gyro was rotating at impact.

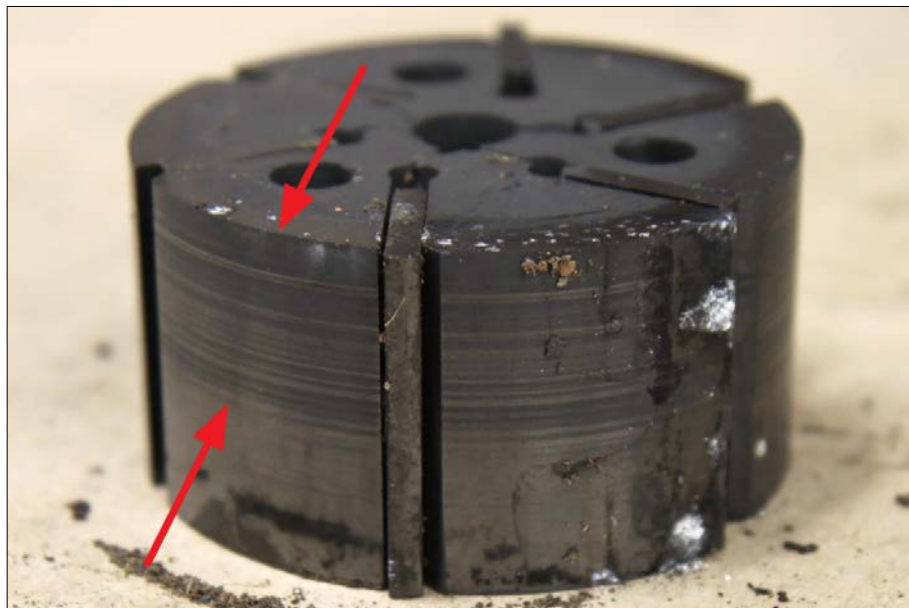
Figure 8: Rotational scoring on left vacuum pump

The left engine vacuum pump was examined and exhibited body damage, but the frangible drive mechanism was intact. Disassembly of the vacuum pump revealed a fractured rotor; however, the carbon vanes were intact and operated normally. Evidence of rotational scoring was observed on the external surfaces of the rotor components (Figure 8).

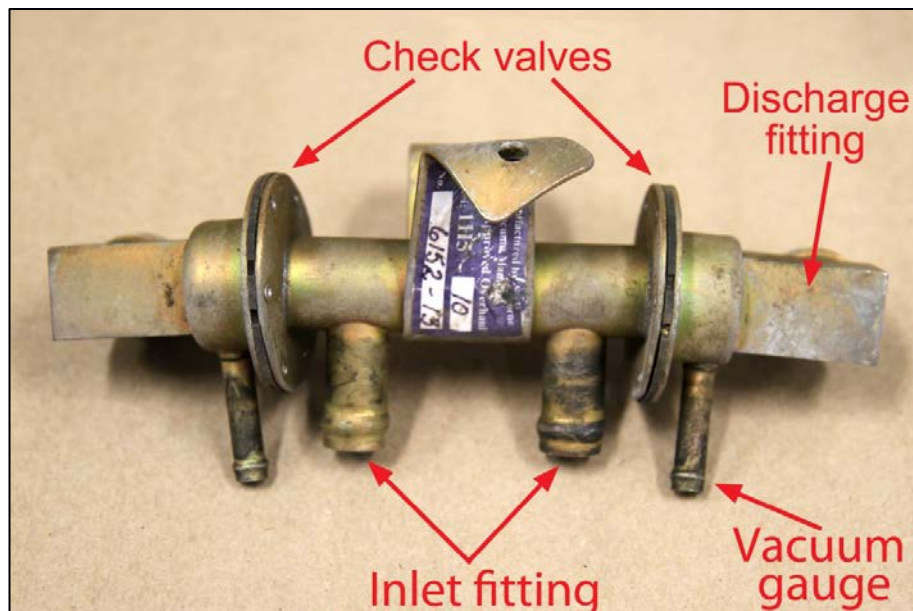
Figure 9: Vacuum manifold valve

The vacuum manifold also exhibited damage consistent with the impact forces during the accident sequence (Figure 9). Operational leak tests were conducted on the unit using procedures from the manufacturer's maintenance manual. A slight leak was observed through the check valve seals; however, the seals were physically in good condition, and the leakage was considered to be the result of distortion in the manifold, sustained during the impact sequence.

No evidence was found to suggest that the vacuum system was partially or completely inoperative at the time of the accident. All equipment damage observed was consistent with forces sustained during the accident impact sequence.
