Rejected takeoff, VH-EBL Perth Airport, Western Australia 23 February 2011

Abstract

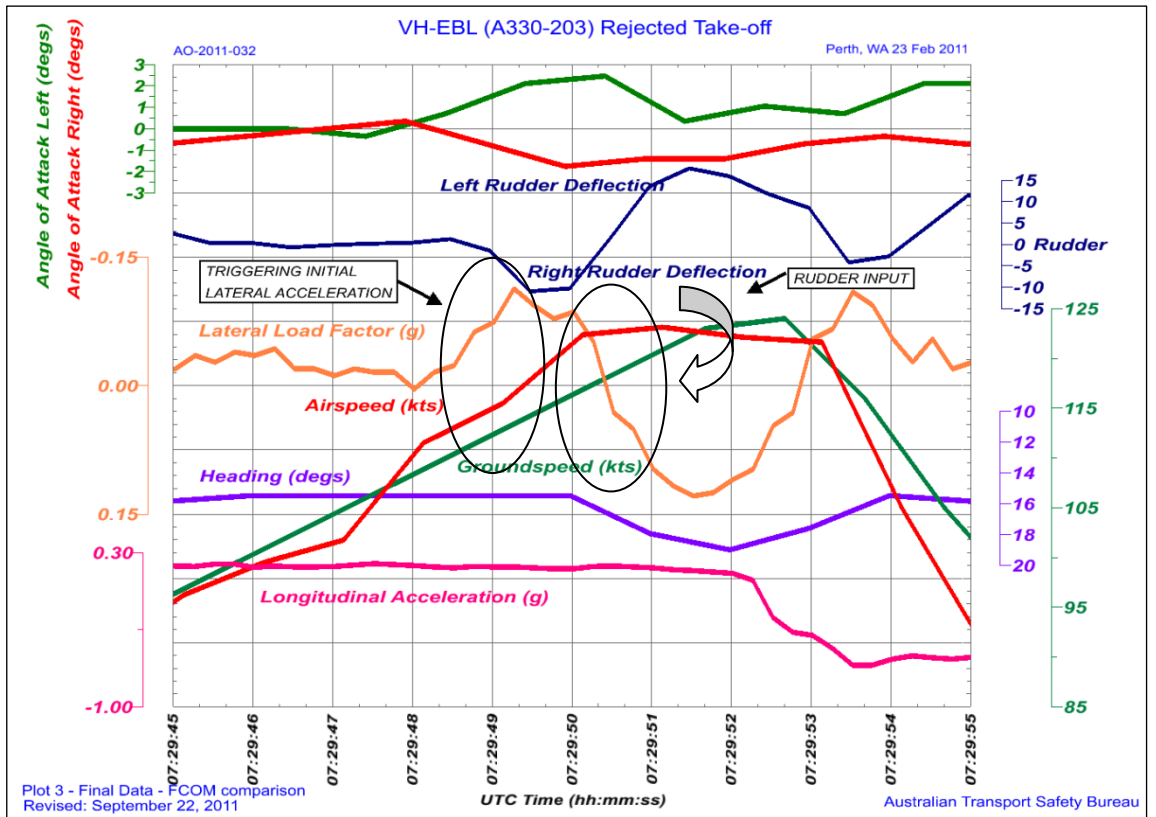
APPENDIX A: DIGITAL FLIGHT DATA RECORDER PLOT

The aircraft was also equipped with a digital flight data recorder (DFDR) that was designed to record over 25 hours of flight data covering about 1,000 parameters. The ATSB obtained a copy of the DFDR data for the occurrence and examined the parameters relevant to the rejected takeoff. A plot of the relevant data is at Appendix A.

The data for the takeoff showed only minor variations in lateral load factor until the aircraft reached a groundspeed of 111 kts at 1529:49. At that time, the lateral acceleration to the left began to increase without any significant left rudder input or engine power asymmetry. One second later, at a groundspeed of 115 kts (213 km/h) and with the acceleration to the left still increasing, right rudder was applied by the PIC.

The aircraft yawed to the right in response. Left rudder was applied and both engines were reduced to idle before the selection of reverse idle thrust at 0729:52. Shortly after the brakes were applied, the ground spoilers deployed and reverse thrust was momentarily applied.

Analysis of the DFDR data by the French investigation agency, the Bureau d'Enquêtes et d'Analyses (BEA) identified a variation in the values and direction of the left and right angle of attack parameters at the time of the initial lateral acceleration. This was considered by the BEA to be the result of a 'right lateral wind gradient' (gust).

The bulletin included a typical DFDR trace of acceleration, groundspeed, heading and rudder inputs that had the same features as the DFDR trace of these parameters for the rejected takeoff involving EBL.
