Controlled flight into terrain, VH-LKI

Moree Airport, New South Wales

30 March 2011

Abstract

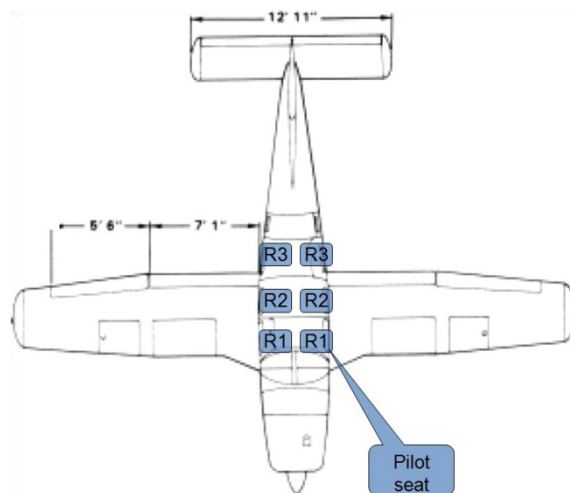
Figure 1: Aircraft seating

The aircraft's rear four seats were configured in a 'club seating' arrangement, whereby the two second row seats (R2) were facing rearward and the two third row seats (R3) were facing forward (Figure 1).

Based on the known passenger weights and reports that the aircraft wing tanks were both full with fuel, the aircraft was estimated to be about 250 kg above the its maximum take-off weight (MTOW) when departing Moree. It was determined that, based on the day's flying activities and estimated fuel usage, the aircraft was still about 90 kg above the MTOW when the accident occurred. The centre of gravity (c.g.)⁷ of the aircraft during both flight sectors would have been close to or beyond the aircraft's rearmost c.g. limit.

The effects of an aft c.g. on aircraft handling are well documented in many pilot training manuals. That includes the possibility for an out-of-limits aft c.g. to lead to aircraft pitch stability issues, in that the aircraft may become difficult to control.

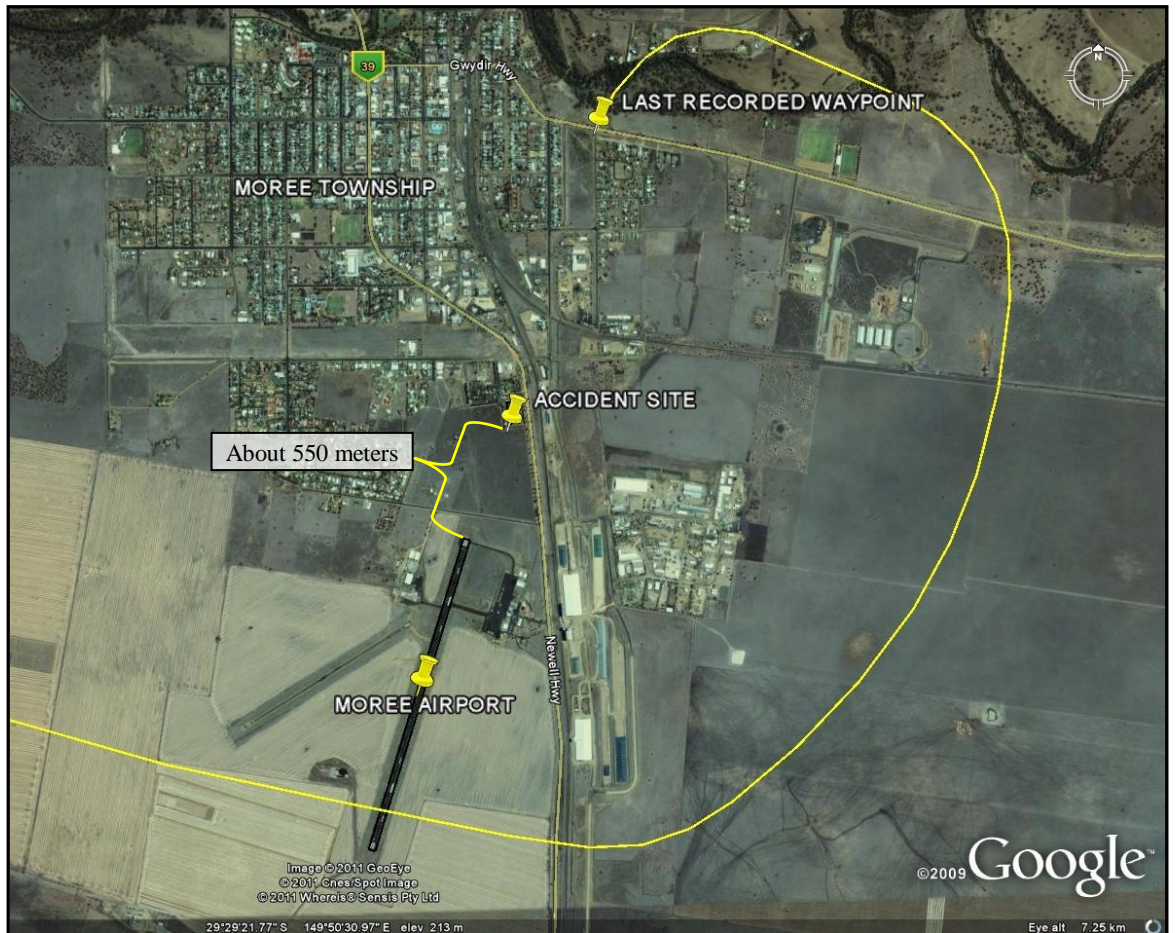
Figure 2: Approach into Moree Airport

The recorded GPS data showed that the pilot flew a normal left circuit pattern for runway 19 at Moree Airport (Figure 2). After turning toward the runway on the final leg of the approach, the aircraft converged toward the extended runway centreline from the left.

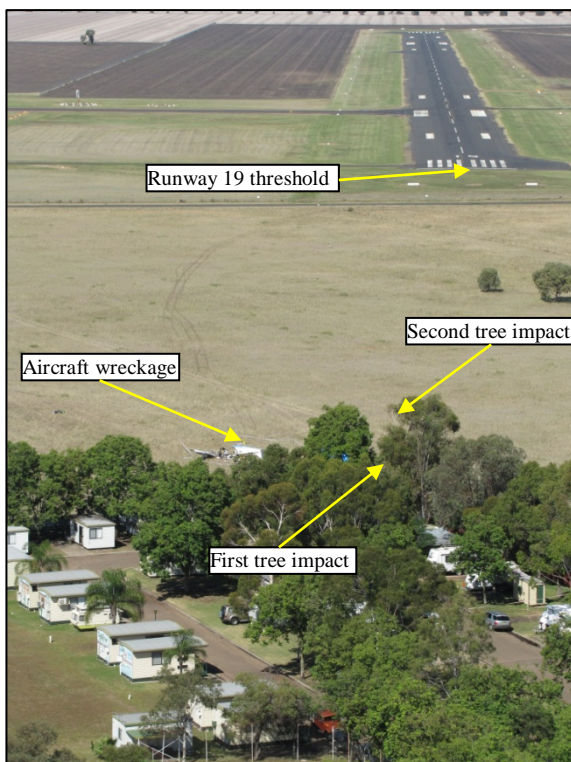
Figure 3: Final approach path to runway 19

An aircraft with a 3° runway approach profile that was overhead the position of the first tree impact would have been about 33 m above ground level (AGL). The aircraft impacted the first tree at about 14 m AGL.

The aircraft impacted the first of two trees within the caravan park perimeter about 16 m to the left of the extended runway centreline before rolling left and impacting the ground in an inverted, steep nose-down attitude. The aircraft came to rest in a level, grassed paddock about 550 m from the threshold of runway 19. On-site examination of the wreckage found no pre-impact anomalies with the aircraft's flight control systems. That was consistent with their ability to operate normally at that time.

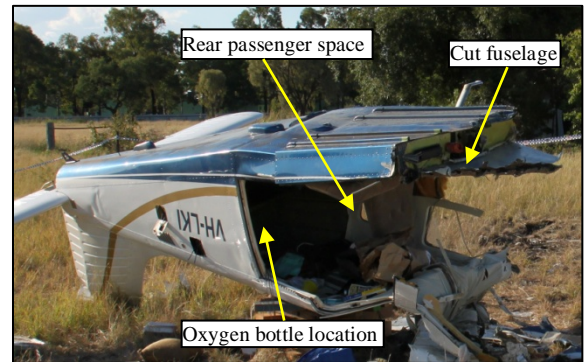
Figure 4: Survivable space and pilot oxygen supply location

The survivable space encompassing the two front seats was significantly compromised. This was consistent with minimal chance of survival for the occupants of those seats. The two front seats had lap belt/shoulder harness-type restraints; however, it could not be confirmed if the shoulder harnesses were in use when the accident occurred.

The survivable space encompassing the rear two rows of seats appeared to have been mostly maintained. It was reported that the four passengers in those seat rows were wearing lap-type seat belts at the time of the accident.

The oxygen bottle regulator that was fitted to the aircraft was in the ON position and indicated 1,100 psi of oxygen remaining.

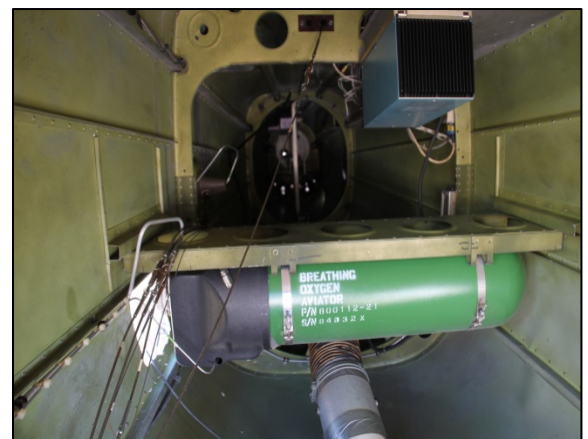
Figure 5: Rear fuselage area showing the oxygen bottle installation

In response to emergency calls, fire and rescue services attended the accident site to remove the surviving passengers from the aircraft wreckage. That necessitated emergency services personnel cutting through the floor surface of the inverted fuselage (Figure 4). It was reported that there was a smell of fuel in the vicinity of the aircraft and that it was difficult to see the wreckage because of the dark night and lack of lighting at that time. The roof section of the fuselage did not require cutting during the removal of the occupants as the aircraft was inverted. The aircraft's roof section contained the oxygen feed line to the cockpit from the pilot's oxygen bottle that was located in the rear of the aircraft. It is not uncommon for light aircraft to include an oxygen supply for use during higher altitude operations.
