# Loss of control, VH-ETT

## 4 km south-east of Kilmore, Victoria

### 30 April 2011

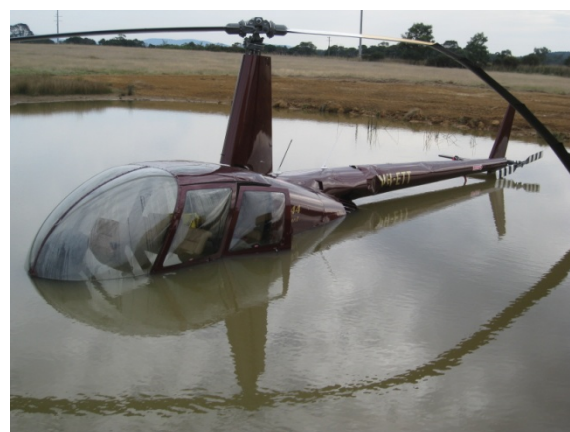
**Figure 1: Helicopter in the dam**

The pilot lowered the collective rapidly and heard a splash as the helicopter descended into the water of the dam (Figure 1). The engine stopped immediately and the main rotor blades hit the water and/or mud. The helicopter partially submerged before the pilot and passenger exited the helicopter and made their way to the bank of the dam. The pilot and passenger sustained minor injuries and the helicopter was seriously damaged. The pilot estimated that the accident occurred at 1305.

- During low-level manoeuvring at low airspeed, the pilot lost directional control of the helicopter and landed heavily, probably as a result of loss of tail rotor effectiveness.
