# Rotor drive failure – Robinson R22 Beta II, VH-DSD

83 km NW of Julia Creek, Queensland | 9 May 2011

**ATSB Transport Safety Report**  
Aviation Occurrence Investigation  
AO-2011-060  
Final

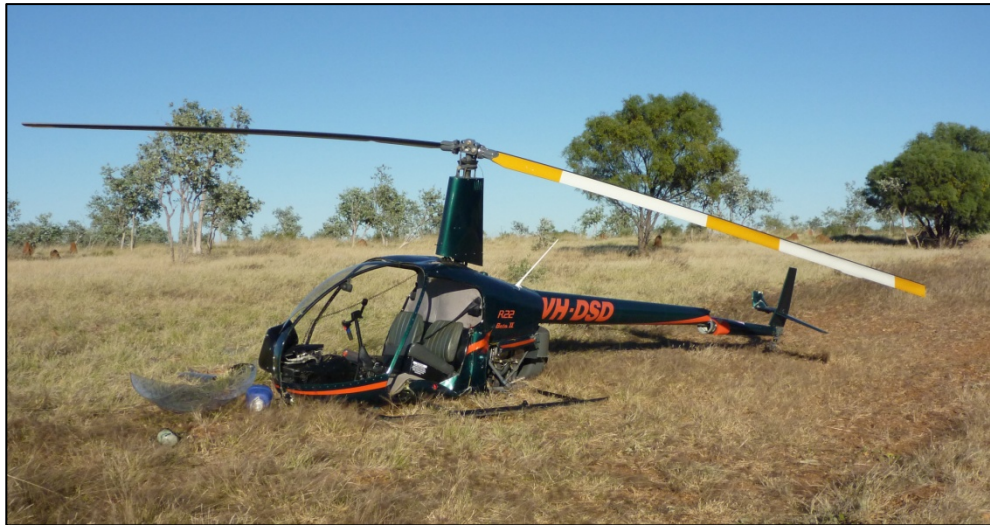
**Figure 2: Aircraft wreckage**

The other two pilots immediately flew to the area that the pilot of DSD had been working. After locating the helicopter wreckage they landed and established that the pilot was deceased. The helicopter sustained serious damage<sup>3</sup> (Figure 2).

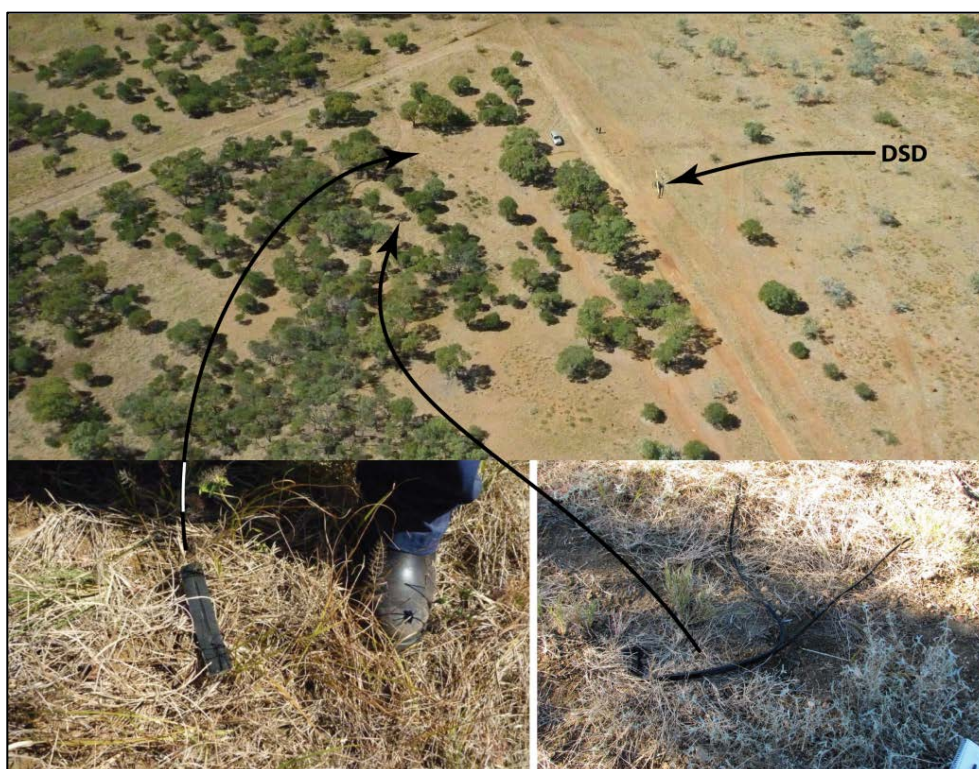
**Figure 4: Location of the main wreckage and v-belt fragments**

The rear v-belt was severed and wrapped around the drive sheaves, but there was no evidence of the forward v-belt in the wreckage. Subsequently, almost all of the forward v-belt was found in two adjacent locations about 60 m from the main wreckage (Figure 4). Black rubber marks – consistent with a flailing drive belt - were found on the sides and lower surface of the engine. There were also deposits of fine rubber particles around the drive system area.

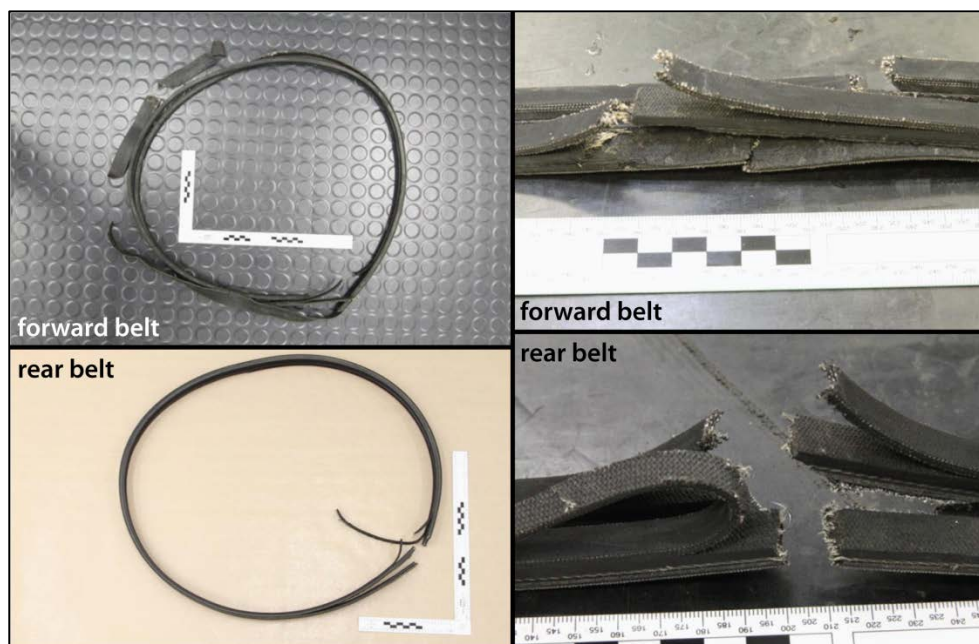
**Figure 5: Recovered v-belts**

An initial examination of the v-belts showed that the polyester tensile cords on both belts were exposed and had pulled out of the rubber binding matrix. This indicated that both v-belts had been subjected to gross tensile overstress conditions and had been literally ‘ripped apart’. The front v-belt had a permanent ‘kink’ around its centreline, consistent with the belt having been forced forwards over the forward-most shoulder of the drive sheaves.

Despite the significant physical damage to each v-belt, their circumferences were measurable and each was found to be within specification (Figure 5).

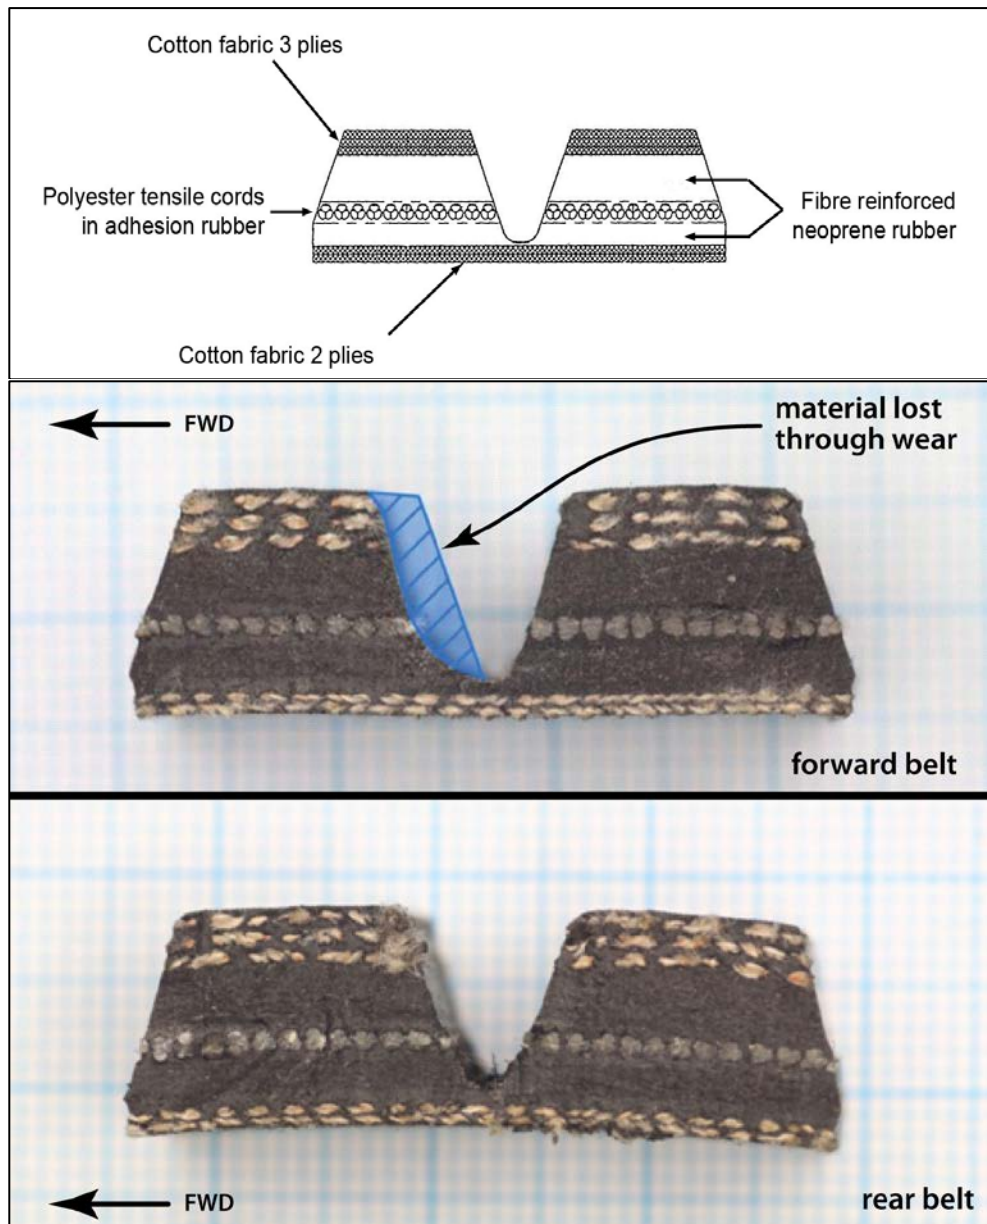
**Figure 6: V-belt cross-sections**

Both v-belts were sectioned (Figure 6). The rear v-belt displayed almost no evidence of abnormal wear. In contrast, the forward v-belt had lost a considerable amount of material where its front half had been worn away. Two of its 12 polyester tensile cords were lost, as well as a considerable quantity of the neoprene rubber that encased them.

The wear to the forward v-belt showed that the belt had rolled forward at some stage during the accident flight and continued to operate while abnormally positioned on the front edge of the drive sheaves (Figure 7). Both of the sheaves were coated with black dust originating from v-belt rubber material, indicative of rapid wear to the belt.

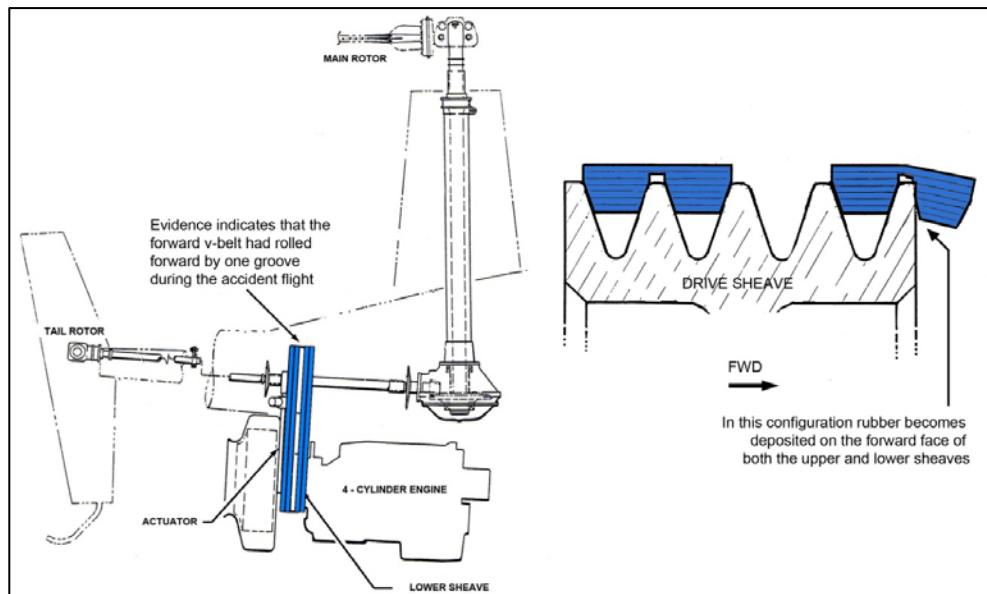
**Figure 7: Indicative forward displacement of the forward v-belt**

Given the available evidence, the ATSB was unable to establish any airworthiness factors in the partial dislodgement of the forward v-belt. However, the ATSB concluded that the forward v-belt partially dislodged with consequent deterioration and failure of the v-belt, contributing to failure of the rear v-belt, complete loss of drive to the rotor system, and high rate of descent.
