Operational non-compliance Airbus A320-232, VH-VNG

17 km ENE of Melbourne Airport, Victoria | 7 June, 2011

ATSB Transport Safety Report
Aviation Occurrence Investigation
AO-2011-070
Final

Operational non-compliance
17 km ENE of Melbourne Airport, Victoria
7 June 2011
VH-VNG
Airbus A320-232

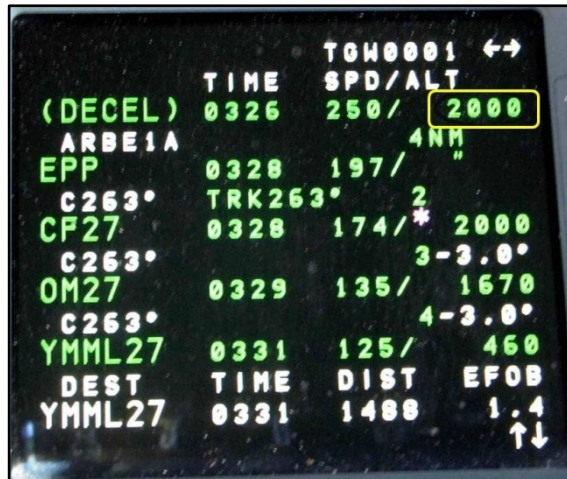
Figure 1: MCDU display

The PIC reported then briefing the copilot on the planned approach by reading out the details from the paper format charts, and that the copilot checked the details as displayed on the MCDU. The limiting altitude for this segment of the arrival procedure was 2,500 ft above mean sea level (AMSL). The paper format charts reflected this, while the data that was displayed on the MCDU, which was drawn from the FMGS internal navigation database, showed a limiting altitude of 2,000 ft (Figure 1). The flight crew did not notice this discrepancy.

Note: The yellow box (added for clarity) indicates the displayed limiting altitude.

When the pilot in command (PIC) entered the arrival and approach data into the Multipurpose Display and Control Unit (MCDU), he did not notice the discrepancy between the altitude on the paper-based approach plate and that drawn from the digital database and displayed on the MCDU. This was a missed opportunity to identify the anomaly.

The action by the copilot to check the PIC's briefing against the information displayed on the MCDU may have been affected by the expectation that the figures would match, in part due to the frequent nature of this task. In addition, and based on an expectation of seeing 2,500 ft, the copilot may have 'seen' the figure of 2,000 ft but not comprehended that it was incorrect against the PIC's briefed chart figure of 2,500 ft. Had this verification process been successful, it would have identified the database anomaly at this point.

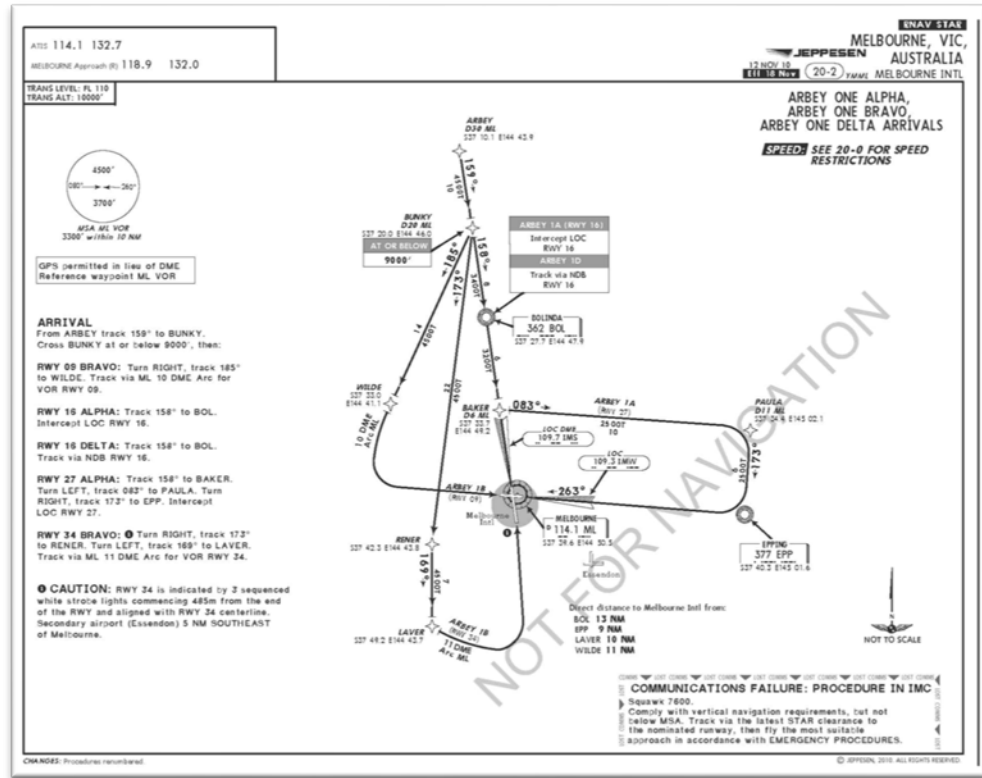
Figure 2: ARBEY ONE ALPHA arrival procedure

As the aircraft descended from 2,500 ft to 2,000 ft between waypoint PAULA and the Epping Locator⁷ (Figure 2), the copilot queried the limiting altitude on the FCU. The PIC verified that altitude by referring to the MCDU display. As the aircraft approached 2,000 ft, ATC advised the flight crew that '...you're below the lowest safe there climb to two thousand five hundred'.

The ARBEY ONE ALPHA arrival procedure described the specific criteria for descent and routing for an approach to runway 27 at Melbourne. The runway 27 Instrument Landing System (ILS)¹³ approach normally started at 3,000 ft as an aircraft overflew the Epping Locator. However, a runway 27 ILS approach from the ARBEY ONE ALPHA arrival allowed flight crews to turn as required to intercept the ILS approach at 2,500 ft (Figure 2 and overlaid on a terrain map at Appendix A). This provided for a minimum of 1,000 ft vertical clearance from the highest obstacle during that segment of the arrival procedure.

The Type 1 data supplier stated that the first altitude limit in the digital database for a runway 27 ILS approach following an ARBEY ONE ALPHA arrival was 2,000 ft about 5 NM (9 km) from the runway threshold. The supplier advised that an aircraft conducting a runway 27 ILS would be on profile at that time, and that the 2,000 ft altitude limit had been in the database since 2007. However, this 'digital' altitude limit was not reflected in the paper documentation, having been included by the Type 1 supplier as an extra en route protection during the approach. It also contrasted with the minimum entry altitude of 2,500 ft for the 27 ILS approach from an ARBEY ONE ALPHA arrival, which was maintained until the aircraft was established on the ILS.

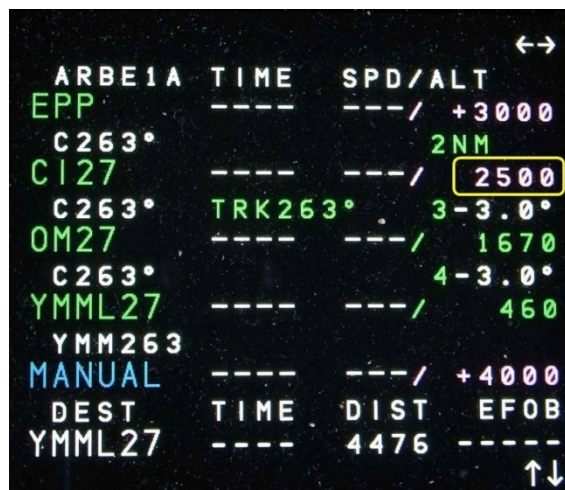
Figure 3: Multipurpose Control and Display Unit

The yellow box indicates the displayed limiting altitude.

Although no organisational or systemic issue was identified in respect of the compilation of the database by the Type 1 provider, the operator, in collaboration with its database suppliers has modified the navigational database. This modification ensures that aircraft will not descend below 2,500 ft on the ARBEY ONE ALPHA arrival/runway 27 Instrument Landing System (ILS) approach until intercepting the ILS glideslope at Melbourne Airport, Victoria if the aircraft is operated in the correct flight mode in compliance with the standard operating procedures (Figure 3).

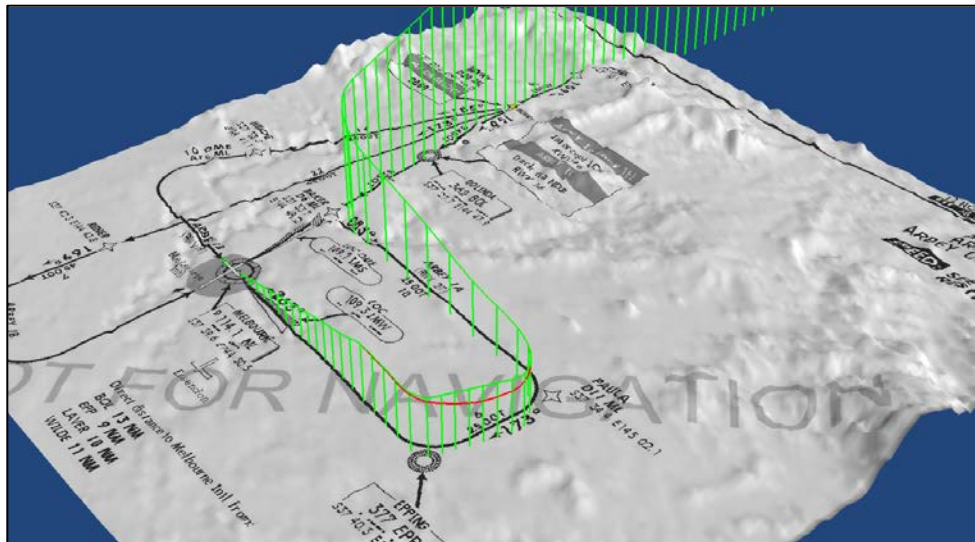
APPENDIX A: MELBOURNE ARBEY ONE ALPHA ARRIVAL/RUNWAY 27 INSTRUMENT LANDING SYSTEM APPROACH¹⁴

The descent profile from the ARBEY ONE ALPHA arrival/runway 27 Instrument Landing System approach chart has been overlaid in green on a depiction of the terrain. The orange/red line depicts the altitude change (descent to and recovery from 2,000 ft) during the occurrence flight.
