# Collision with terrain, VH-FOZ

## 22km WSW of Dirranbandi, Queensland

### 19 July 2011

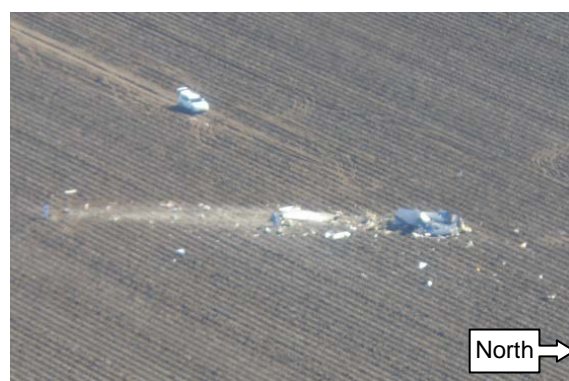
Figure 2: Aircraft wreckage

The aircraft wreckage was lying in a flat, furrowed field about 240 m from the field's southern boundary (Figure 2). Ground impact marks and the distribution of the wreckage indicated that the aircraft had been on a track of about due north, and impacted the ground in a left wing-low and nose-down attitude. Both wings separated from the fuselage during the impact sequence.

The aircraft's fuselage came to rest about 50 m from the initial ground impact. The forward fuselage had separated at the hopper, forward of the cockpit. The propeller and gearbox had separated from the engine.

The soil in the vicinity of the wreckage was contaminated by a significant quantity of spilt fuel and spray chemical. There was no evidence of any fuel or chemical spill prior to the initial ground impact.
