# Take-offs without runway lighting

Gladstone Airport – 16 and 17 May 2012

**ATSB Transport Safety Report**  
Aviation Occurrence Investigation  
AO-2012-069  
Final

**Report No.** AO-2012-069

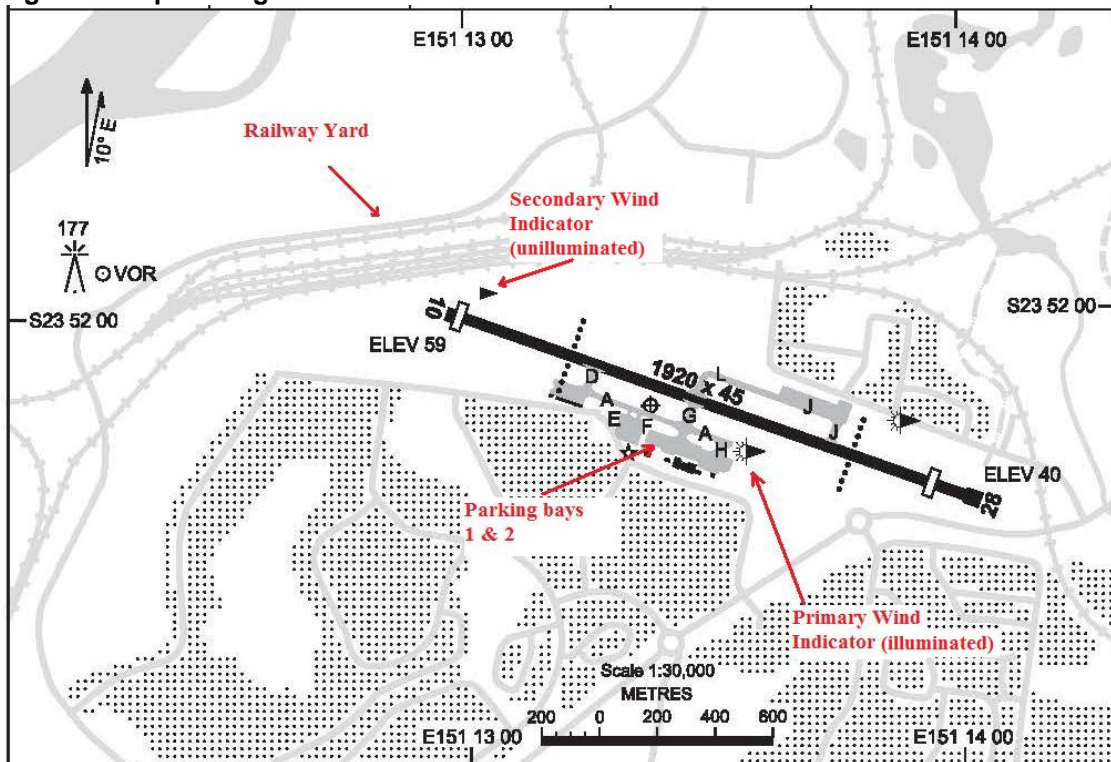
Figure 1: Airport Diagram

The primary wind indicator (windsock) was located adjacent to the eastern most corner of the apron (Figure 1). It was behind all aircraft parked on bays 1 to 4. The windsock was situated in low ground relative to the apron. From parking bays 1 and 2, the windsock was partially obscured by a lighting control cabinet (Figure 3). The windsock lights were grouped at the top of the pole.

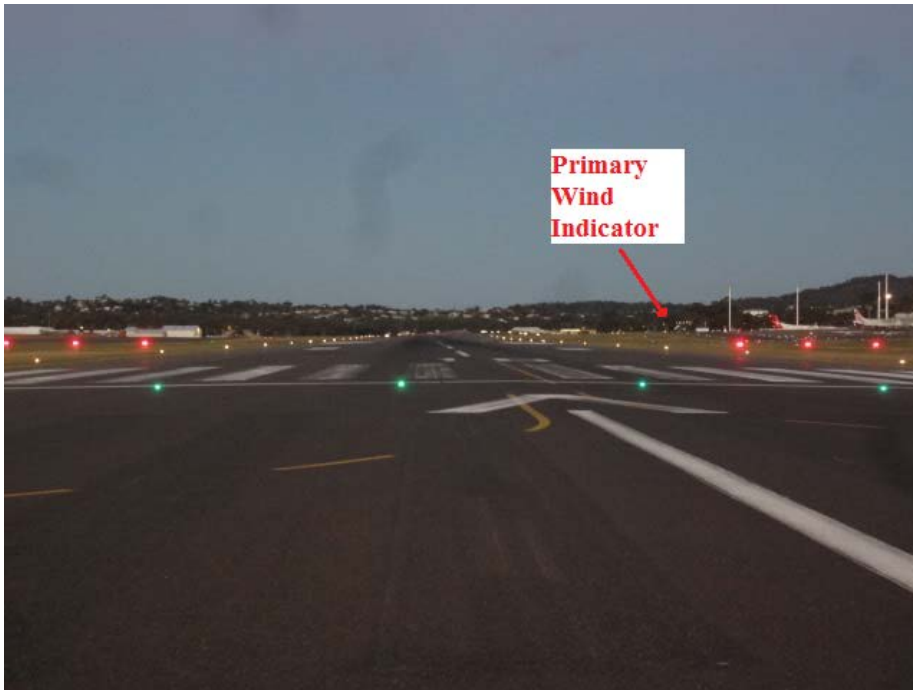
**Figure 2: Gladstone runway 10 threshold – lights on**

All crew also noted that on line up for runway 10, the illuminated primary windsock is over half way down the runway and behind the terminal flood lighting. There was higher ground containing bright lighting behind the windsock. The combination of these things obscured any flashing warning (Figure 2). All crew stated that they would be more likely to look to the closer unlit windsock located on the threshold of runway 10 as a final confirmation of the wind direction on line up at runway 10.

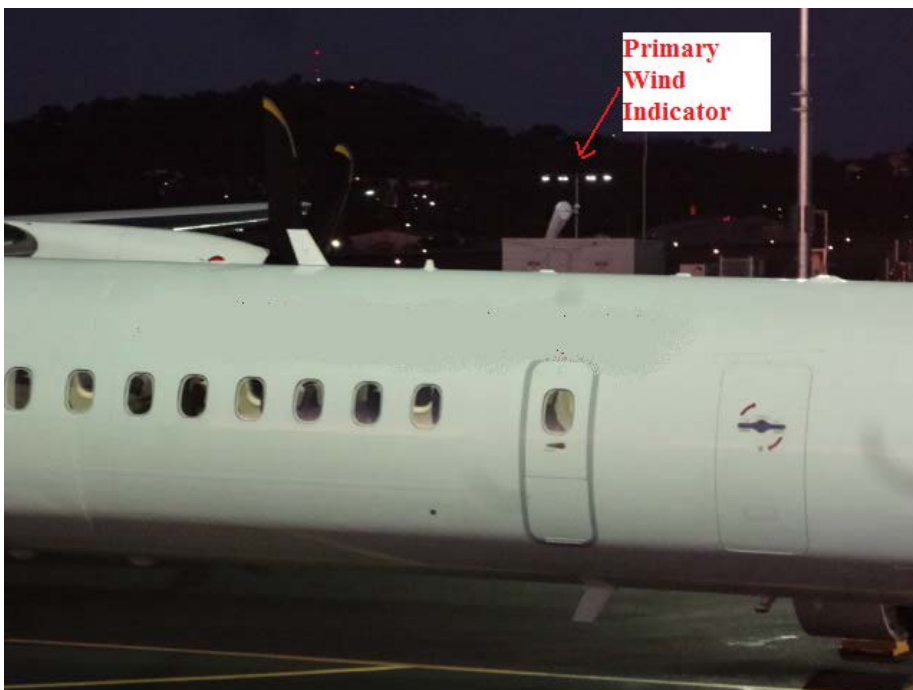
**Figure 3: Windsock view from parking bay 2**

The crews commented that they could not recall seeing or specifically looking for the windsock flashing warning, indicating the runway lights were about to turn off. However, all crew noted that the windsock was difficult to see from the parking bays and on taxi out to the runway. In addition, all crew stated that the presence of an aerodrome weather information service (AWIS), which provided actual weather conditions via a radio broadcast on a frequency separate to the CTAF and PAL frequency, made it unnecessary for them to turn their attention to the windsock to obtain information on wind speed and direction.

As a result of this occurrence, Gladstone Airport has advised the ATSB that they will be investigating the viability of installing a reflective sign, stating ‘Are the runway lights on?’, to prompt pilots before entering the airport manoeuvring areas.
