Loss of control involving Robinson R44 helicopter VH-HWQ

Bulli Tops, New South Wales | 21 March 2013

ATSB Transport Safety Report
Aviation Occurrence Investigation
AO-2013-055
Final – 4 June 2015

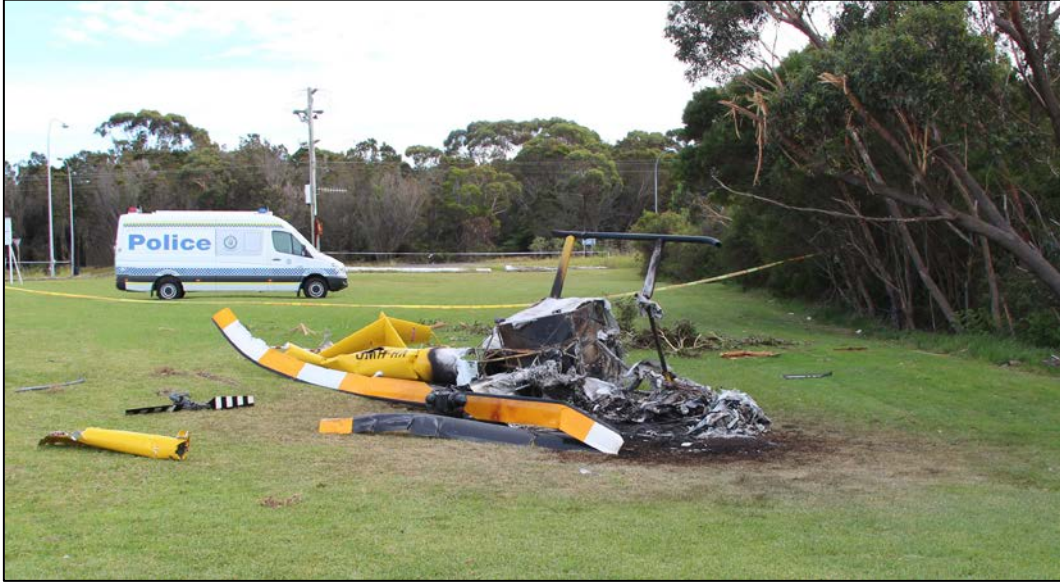
Figure 2: Helicopter wreckage with the broken tree branches in the background

Following the tree contact, the helicopter was observed to descend onto the grass in a right side down, nose-low attitude and roll onto its right side. A number of the nearby witnesses approached

the helicopter to render assistance to the occupants. The first person to reach the helicopter recalled that a large quantity of fuel was pouring out from underneath the helicopter and that soon after, a fire started on the grass under the rotor mast and the cabin area and rapidly engulfed the helicopter. A number of people attempted to extinguish the fire and assist the occupants but, due to the fire's intensity, without success. The pilot and three passengers were fatally injured and the helicopter was destroyed.

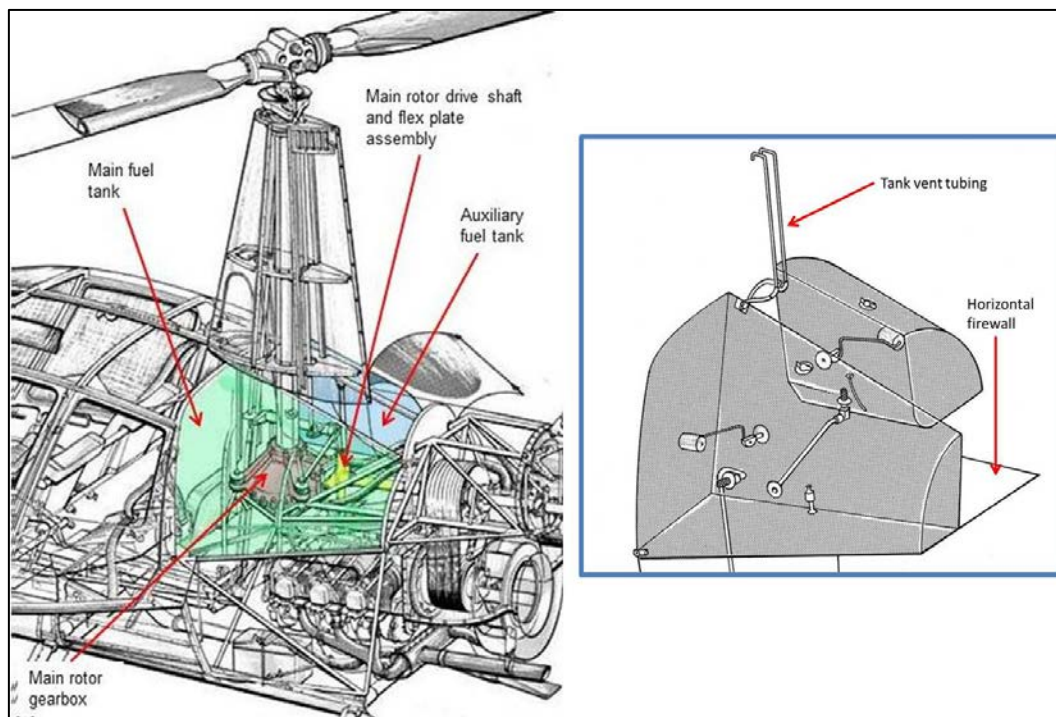
Figure 4: R44 helicopter fuel tanks surrounding the lower main rotor gearbox assembly and main rotor driveshaft. Inset - fuel tank system diagram showing the inter-tank plumbing and vent tubes

The R44 was originally manufactured with two all-aluminium fuel tanks installed above the engine on either side of the main rotor gearbox (Figure 4). Both tanks were interconnected by rigid-tubing fuel lines, with the right-side-mounted auxiliary tank draining into the left-side-mounted main tank. The main tank had a maximum capacity of 120 L and the auxiliary tank a maximum of 70 L. Both tanks vented to atmosphere in the area inside the main rotor mast fairing, above the tanks (Figure 4).

To improve the R44 fuel system's resistance to a post-accident fuel leak, this retrofit must be performed as soon as possible.

The manufacturer advised that, compared to the all-aluminium tanks, the bladder-type tanks provided improved resistance to post-accident fuel leaks due to their improved cut and tear resistance and the ability of the bladders to sustain large deformations without rupture. SB-78 also incorporated the fitment of:

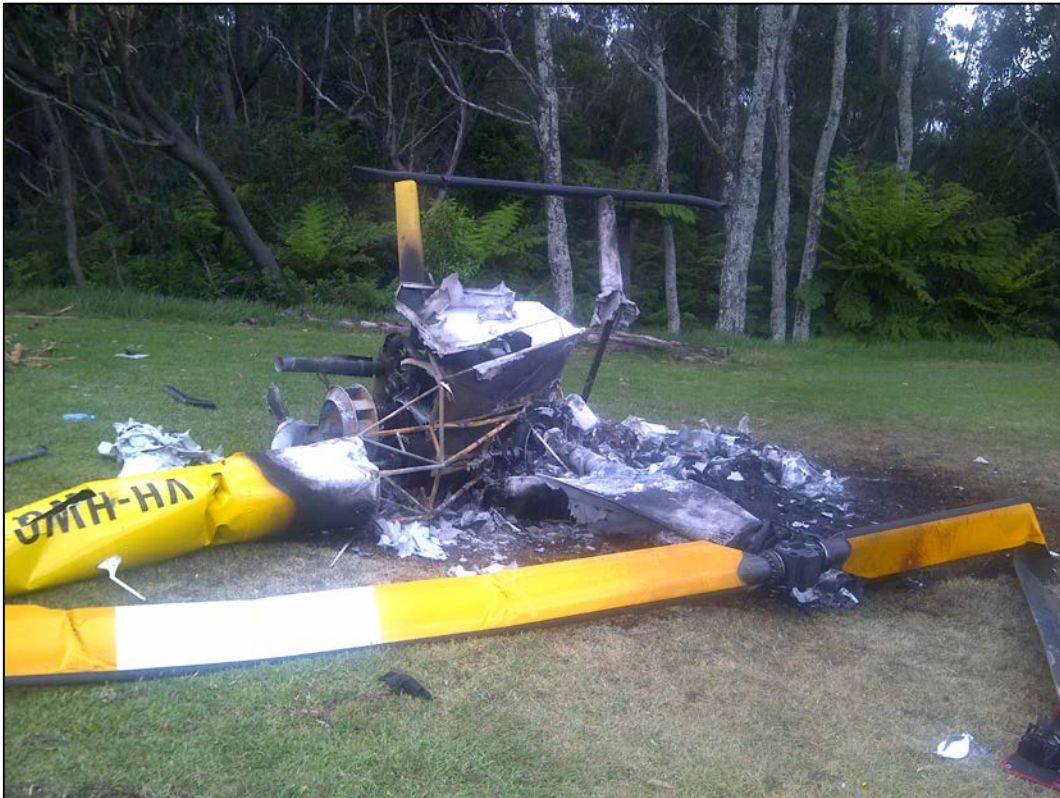
Figure 9: Main wreckage

Examination of the flight controls found no pre-existing defect. However, significant portions of the flight controls were consumed by the post-impact fire. In addition, the hydraulic reservoir and associated components and the cyclic-mounted HYD/OFF switch were destroyed in the fire. This

precluded a full assessment of their immediate post-impact condition. The fire also destroyed the cabin area.

During the impact sequence the main rotor mast and gearbox assembly moved, forcing the rotating flex plate assembly on the clutch shaft out of alignment.¹¹ The displaced assembly then heavily contacted the upper frame structure and firewall assembly. The extent of the post-impact fire damage meant that it was not possible to determine whether the flex plate assembly also breached the metal skin of one or both fuel tanks. The metal to metal contact during the impact sequence may have provided an ignition source for the leaking fuel. Other possible sources of ignition included hot engine components or electrical system arcing. Due to the degree of fire damage, identification of the ignition source was not possible.

Overall, the witness and physical evidence were consistent, indicating a relatively low-energy impact. Assessment of the wreckage, although hampered by the extent of the post-impact fire damage, did not identify any pre-existing defects with the helicopter.

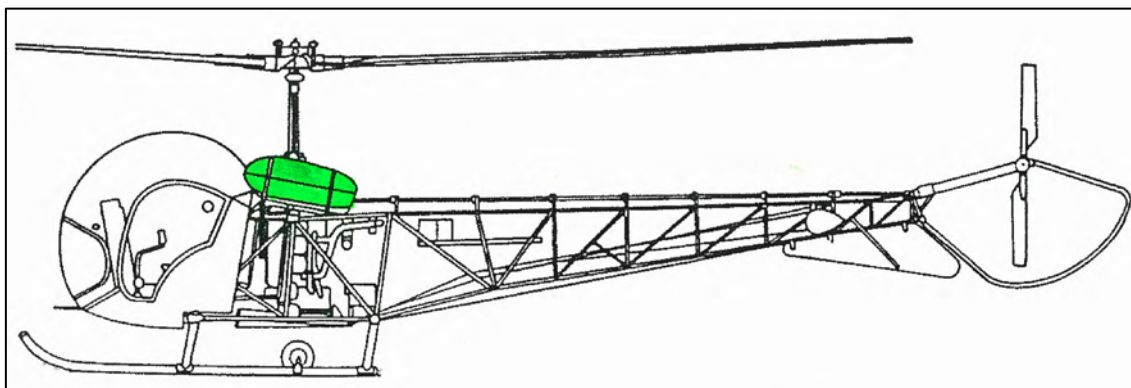
Figure 12: Bell 47, left fuel tank highlighted in green (typical), which is duplicated on the right

The 47G has two 'saddle' fuel tanks mounted high behind the cockpit bubble (Figure 12), and it was reported that these were relatively easy to breach during an impact (Dugan and Delamer 2005). Bell released Service Bulletin 47-76-6 in 1976 to replace the Bell 47G fuel system with a more crashworthy type, including tanks that were wrapped with nylon fabric and had frangible fittings. This service bulletin was not associated with an airworthiness directive in the US or Australia. According to the type certificate holder, many Bell 47Gs were retrofitted with new tanks but a lower proportion were retrofitted with the frangible fittings.

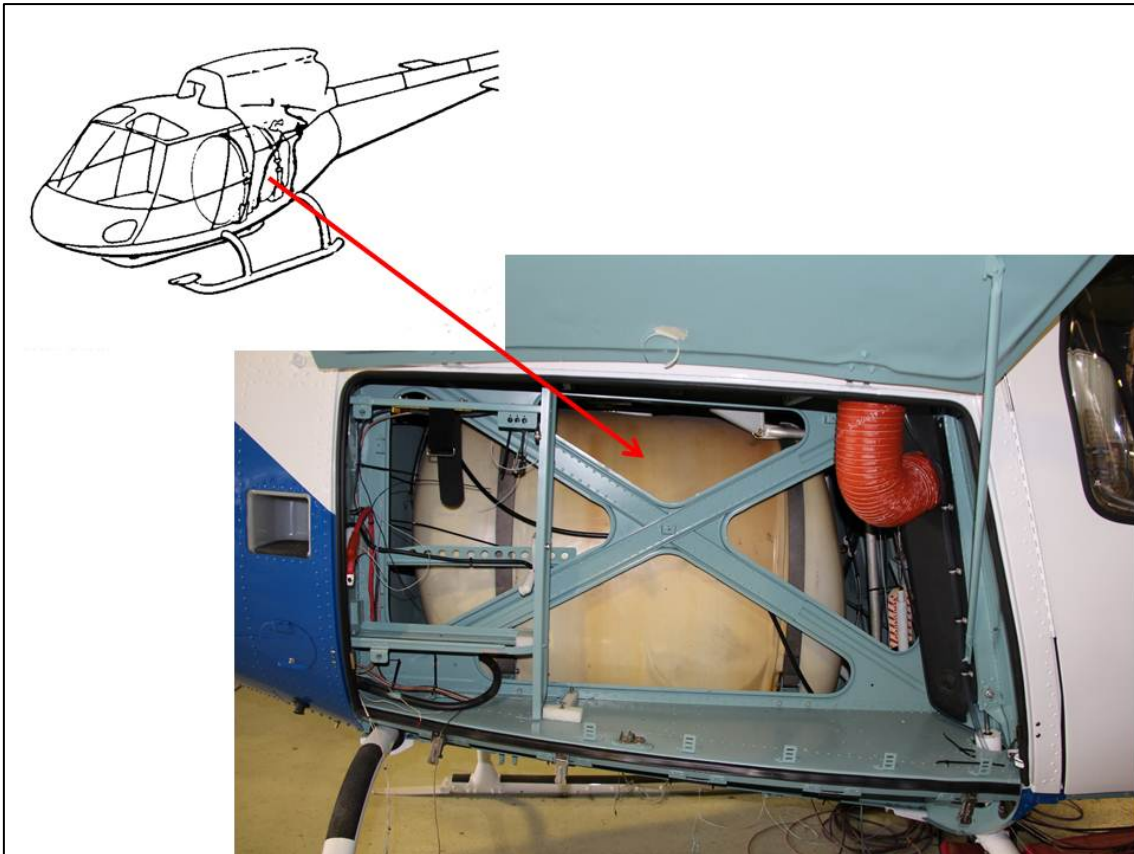
Figure 13: AS350 fuel tank in situ

The Airbus Helicopters AS350 appeared to have higher PIF proportions compared to the other common turbine-engine types with a similar size and role (that is, the Bell 206 manufactured up to 1981 and the Hughes 369), although not all of the differences for each level of accident severity were statistically significant. However, the PIF proportions for other turbine-engine helicopters without a CRFS combined were similar to that of the AS350 (see appendix A).
