VFR flight into dark night conditions and loss of control involving Cessna T210N, VH-MEQ

2 km north-west of Roma Airport, Queensland | 25 March 2013

ATSB Transport Safety Report
Aviation Occurrence Investigation
AO-2013-057
Final – 16 September 2014

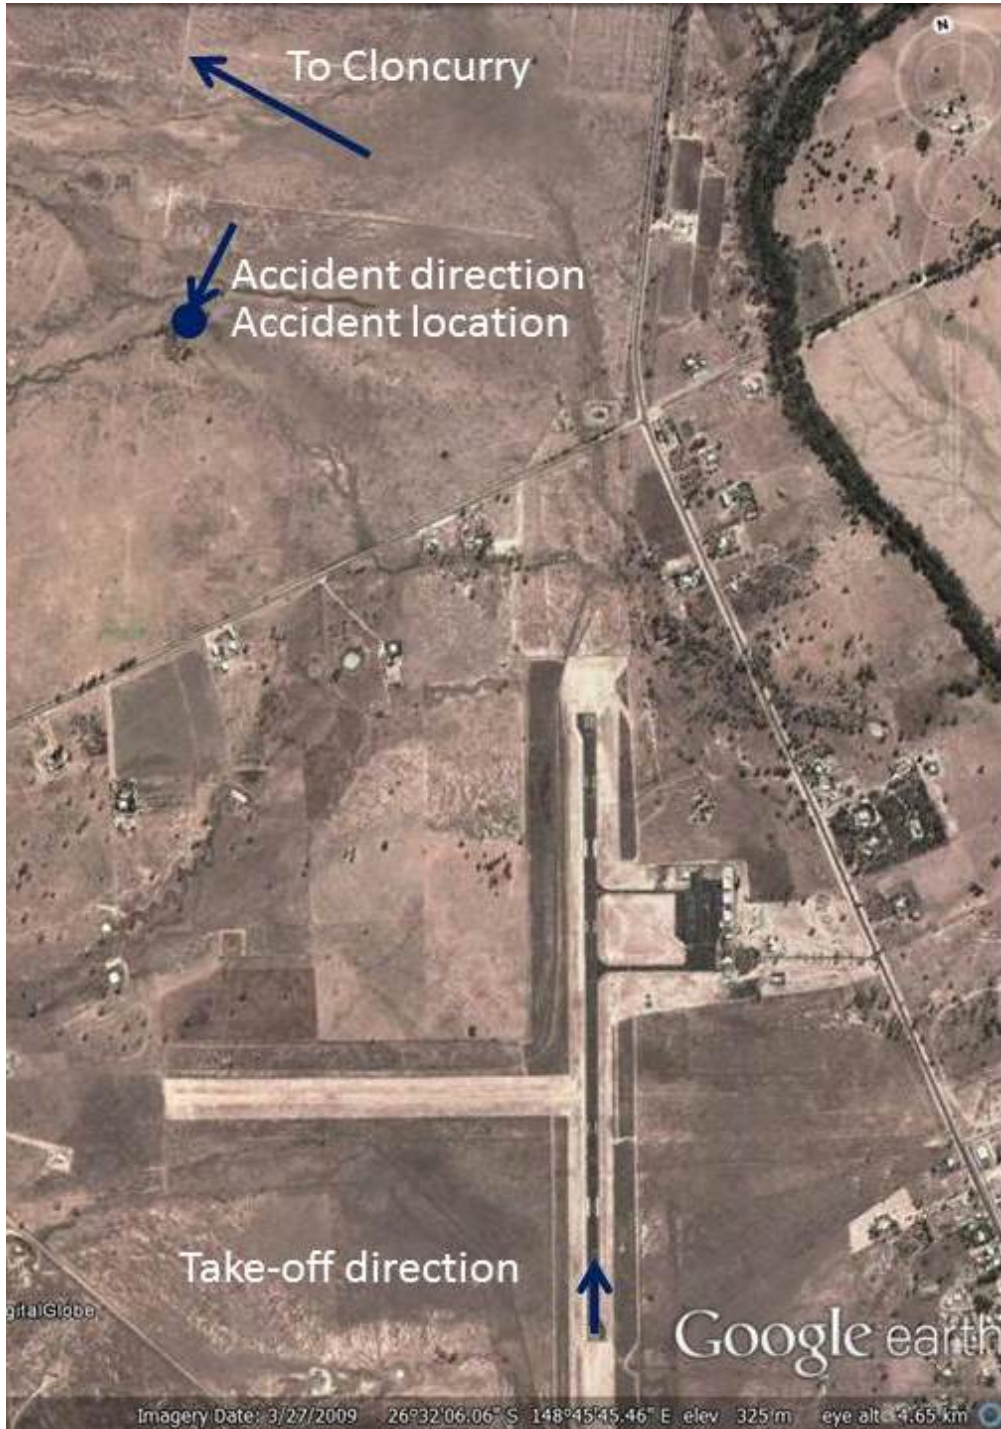
Figure 1: Location of the accident with the track to Cloncurry and the directions of take-off and impact highlighted

The only runway that was suitable for operations in darkness at Roma was runway 18/36, as the other runway was not equipped with runway lighting (see the section titled *Aerodrome information*). The track from Roma to Cloncurry was 305° magnetic.

There is no significant ground lighting beyond the northern end of runway 36 when taking off on that runway. However, there is extensive ground lighting associated with the township when taking off on runway 18.

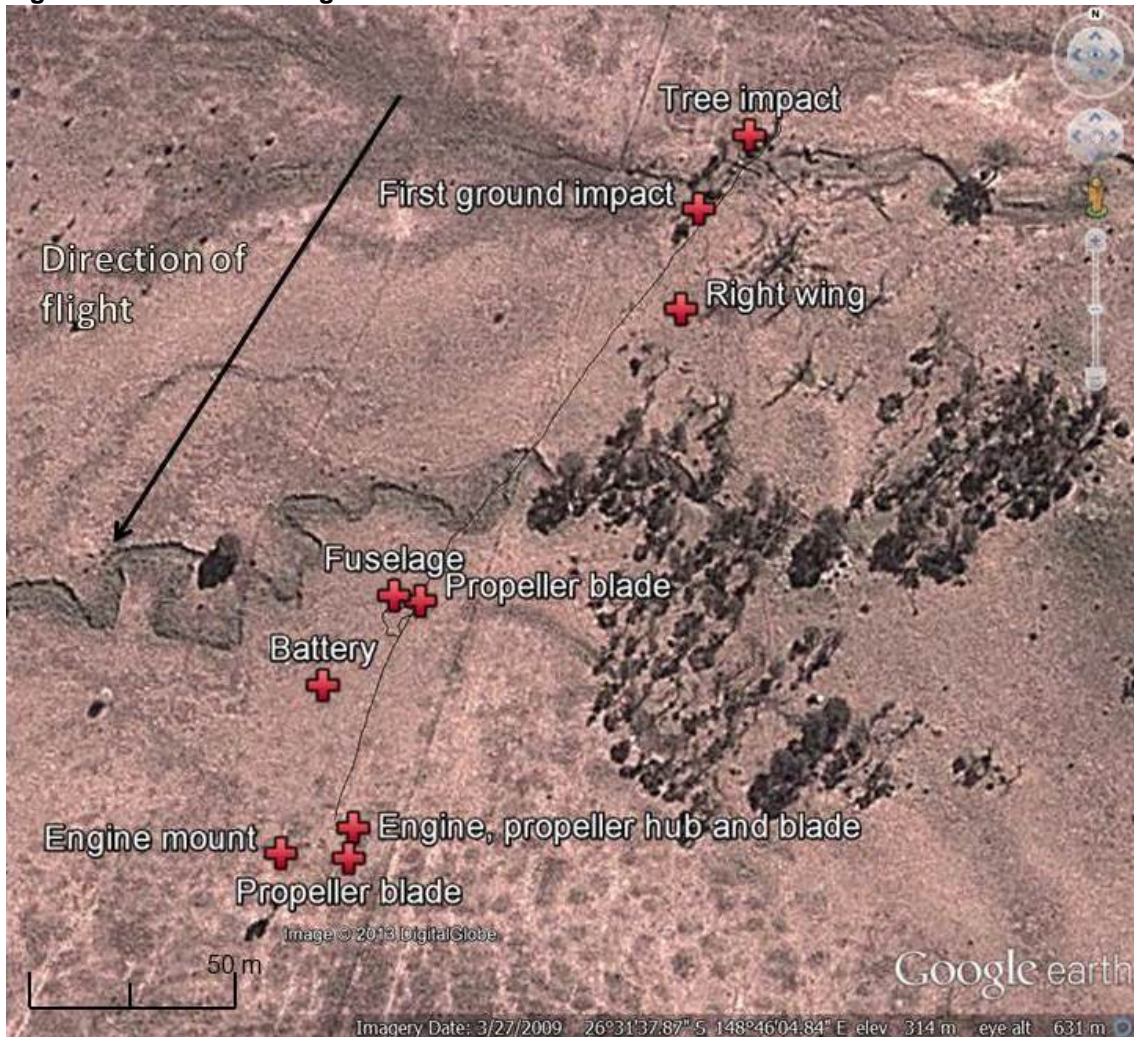
Figure 2: Aircraft wreckage overview

The accident site was located 1.4 km to the north-west of the departure end of runway 36,⁸ close to a stand of large trees surrounded by an area of open, relatively flat terrain. The wreckage trail was about 200 m long with a minimal splay to the left and right of the trail (Figure 2), consistent with a relatively high forward speed at impact. The aircraft's direction of flight was about 210 °M at that time and the aircraft's descent angle relative to the slightly rising terrain was calculated to be about 13°.

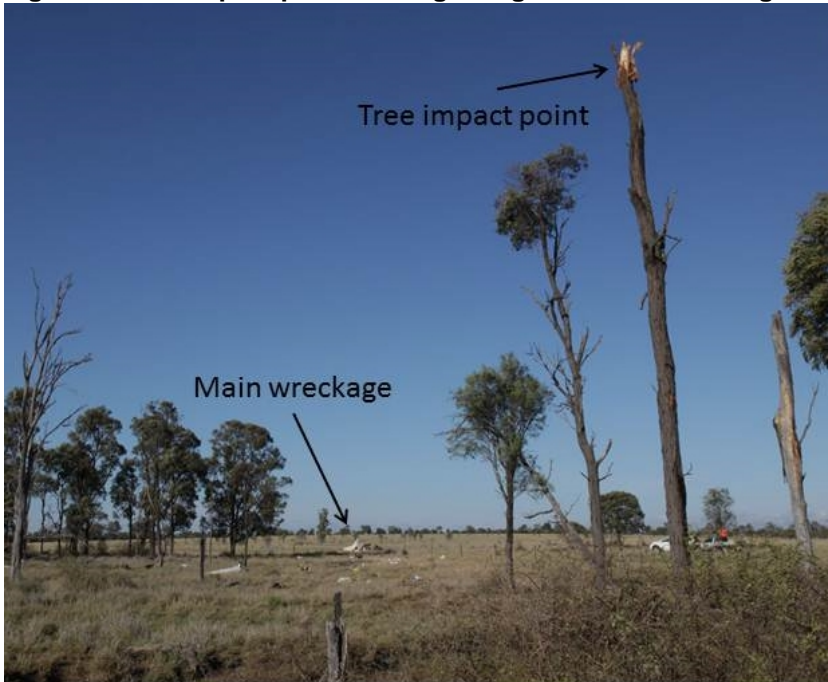
Figure 3: Tree impact point looking along the direction of flight

The aircraft's initial impact was with a tree that was struck approximately 8 m from its base by the right wing (Figure 3). The right wing outboard section separated from the aircraft before the aircraft impacted the ground.

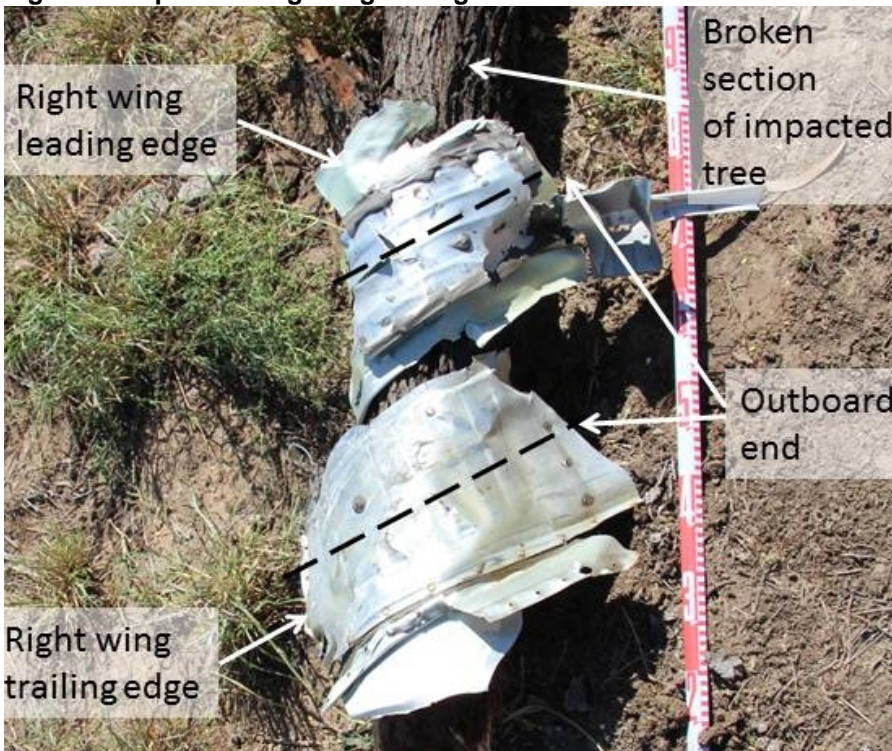
Figure 4: Impact damaged right wing sections

Sections of the right wing leading and trailing edges showed damage consistent with the shape of the tree that was struck in the initial impact (Figure 4). Examination of these wing sections revealed that the aircraft struck the tree at a bank angle of about 30° left wing-low.

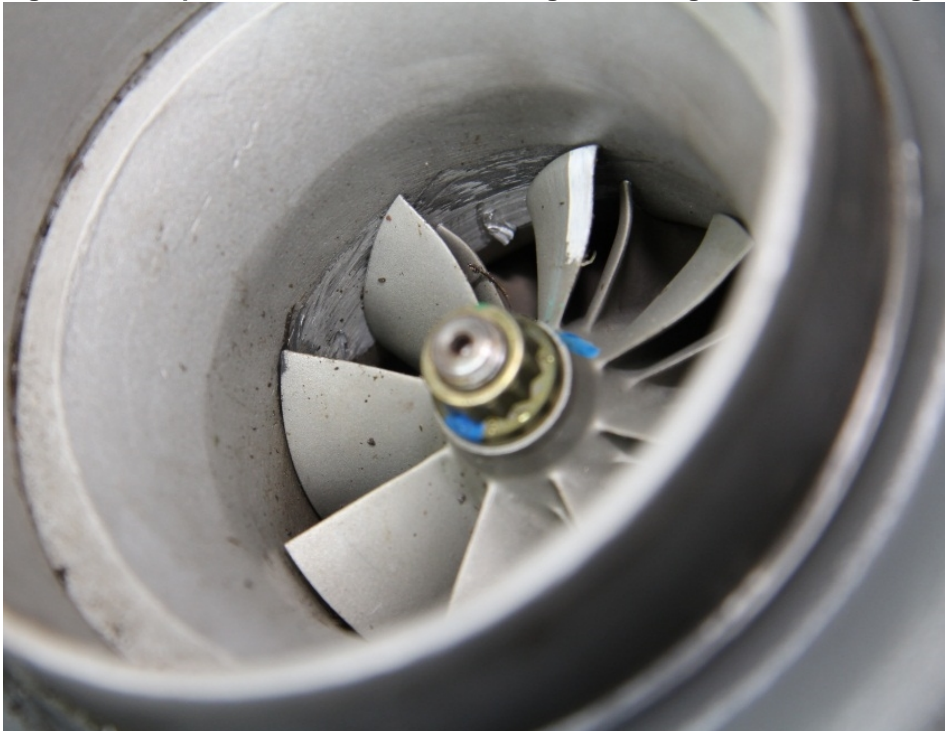
Figure 5: Compressor section of turbocharger showing rotational damage

Propeller and spinner damage indicated that the engine was driving the propeller at medium-to-full power when the aircraft impacted terrain. The engine turbocharger and its components were inspected externally and no pre-impact defects were identified. The turbocharger sustained a significant impact during the accident sequence that deformed the compressor section case such that the compressor blades contacted the deformed case. The contact marks made by the compressor blades showed rotational scoring that was consistent with turbocharger rotation at significant speed when the aircraft impacted terrain (Figure 5).

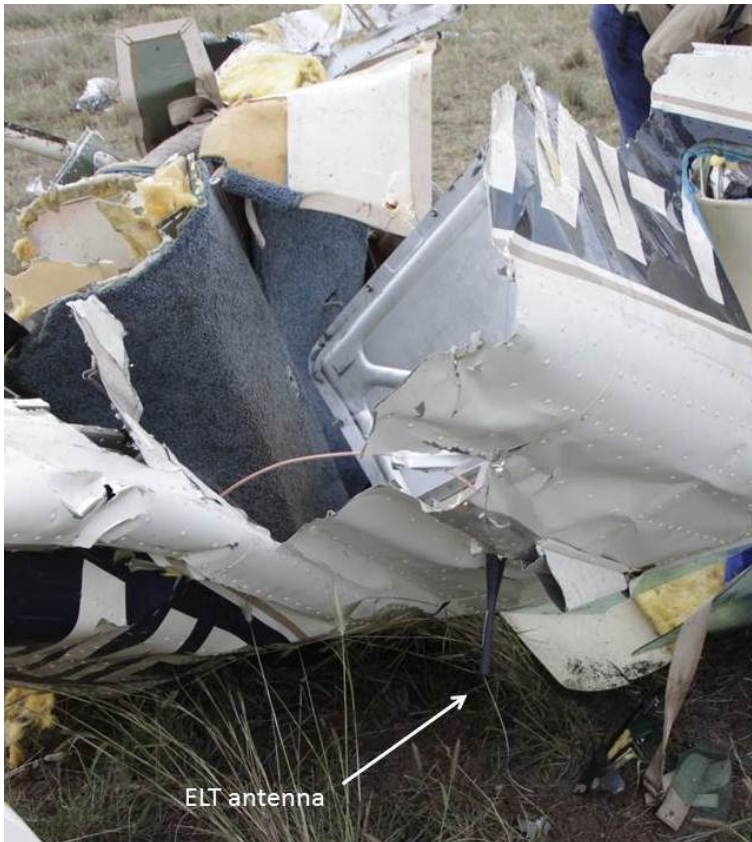
Figure 6: ELT antenna

The ELT was identified by the ATSB intact in the wreckage, although the aircraft skin with the ELT antenna attached was partly torn away from the airframe. However, the antenna was still connected to the ELT and functional because the installation design incorporated a connecting cable that was much longer than required. This allowed the two components to move apart during the accident sequence without severing the cable (Figure 6).

- The aircraft's emergency locator transmitter did not provide precise accident site location information because it did not have global position system capability.
- No mechanical defect was identified with the aircraft or its systems that may have contributed to the accident.
